TEST AND EVALUATION PROJECT STATUS SHEET

PROJECT NUMBER	PROJECT TITLE		
A-18	B-58 Flight Control System Reliability Improvement (U)		
REPORT SECTION	PROJECT OFFICERS		
C-1 of Part IV	Major V. M. Kummel and Capt T. P. Crichton		
<p>PROBLEM The B-58 Flight Control System has not reached the degree of reliability desired for an operational tactical weapon system. Discrepancies are being reported on approximately 50% of all flights and occur most frequently in the autopilot or control surface dampers. Because there are numerous electronic and electro-mechanical components in the system whose failure can result in the types of discrepancies being encountered, a special malfunction analysis effort is needed so that faulty components needing improvement can be identified. (U)</p>			
REQUEST AGENCY	DATE INITIATED	COMPLETION DATE	AUTHORIZATION
43rd Bomb Wing	1 September 1960	Indefinite	AFR 80-14 SACR 80-2

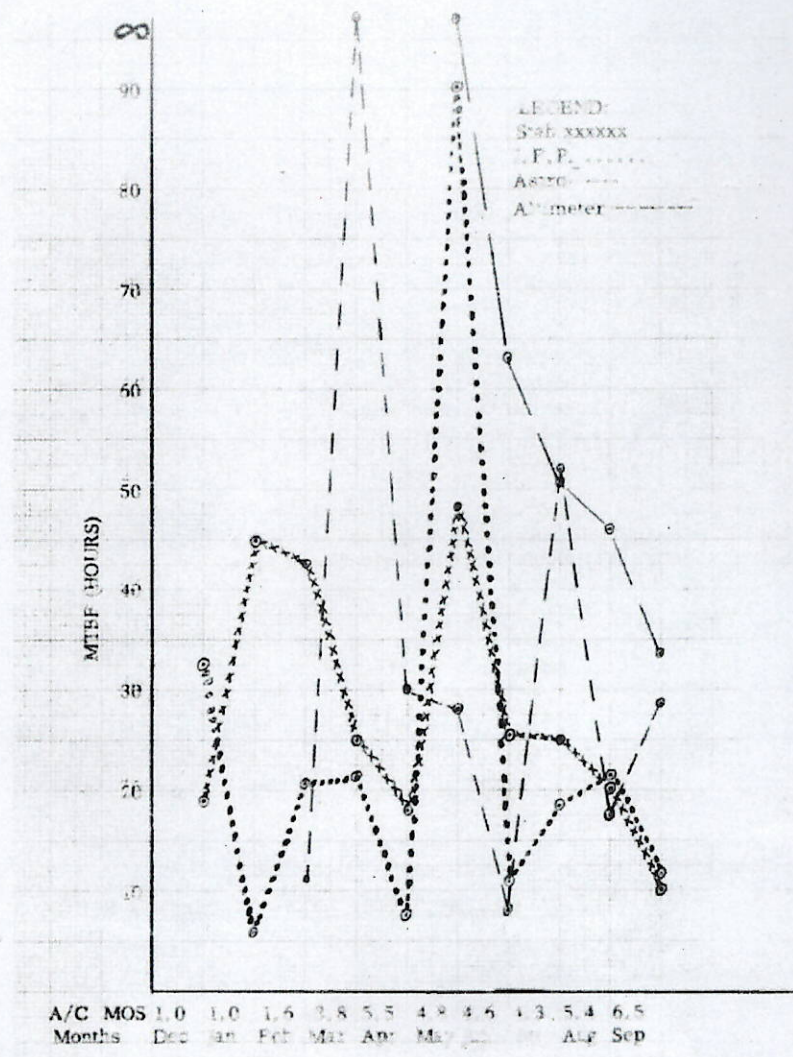
Fig 4 Operational Reliability

(c) Large deviations in MTFB's from month to month can be expected for some sub-systems due to large amounts of ground "on time" being imposed on the sub-system with few or no failures occurring. As an example: Figure 4 shows an MTFB of 110 hours on the astrotracker in February and an indefinite MTFB in March because there were no failures on the astrotracker in March.

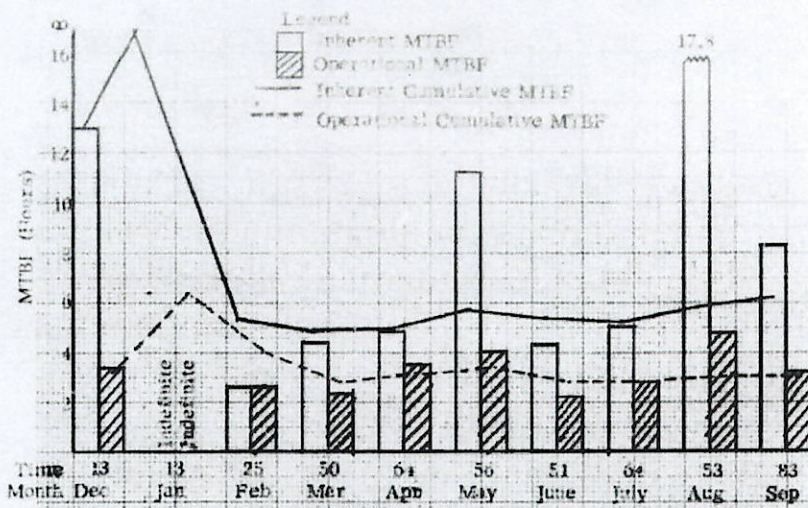
(b) Both types of reliability are indicated as a reactive between failure (MIBF) in hours (See Figure 5).

1. Figure 5 gives the meantime between failures (MTBF) for the Active Defense System. As an aid in establishing trends both the monthly MTBF and cumulative MTBF are shown. The inherent and operational MTBF are indicated on the same graph.
