TEST AND EVALUATION PROJECT STATUS SHEET

PROJECT NUMBER E-5	PROJECT TITLE Service test of the Improved Magnetron (L-1951/7208 for the B-58 Search Radar (U)		
REPORT SECTION C-3 of Part IV	PROJECT OFFICER SMS James R. Freeman		
PROBLEM An excessive number of magnetron failures are being experienced on the search radar system of the B-58 aircraft (U)			
REQUEST AGENCY B-58 Test Force	DATE INITIATED June 1960	COMPLETION DATE Est Jan 61	AUTHORIZATION AFR 80-14 SACR 80-2

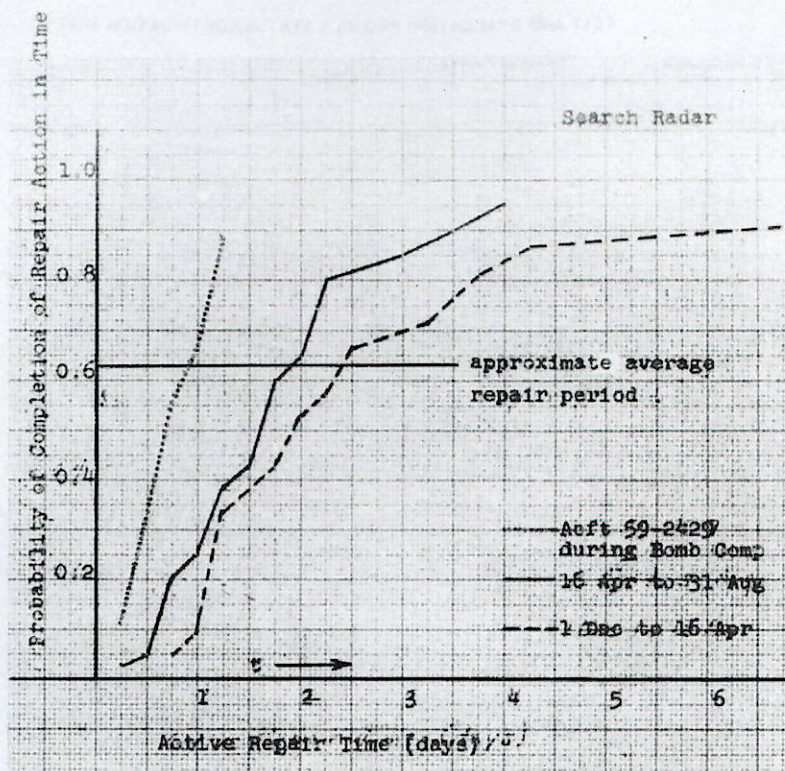
Repairability Chart for the Search Radar

Data from 20 repair periods: 1 Dec to 15 Apr

39 repair periods: 16 Apr to 31 Aug

8 repair periods on Aft 59-2429 during Bomb Competition Practice
