DAMAGE REPORT, LEONARDO H.A.A.
SITE

DAMAGE REPORT - ENGINEER-CONSTRUCTED FACILITIES
STORAGE EXPLOSION OF 22 MAY 1958
LEONARDO AAA SITE

1. General: Representatives of the USAR District, New York, visited the Leonardo AAA Site at 1030 hours on 23 May 1958 to investigate and report on the extent of damage to Engineer-constructed facilities resulting from the explosion which occurred in the Launcher Area on 22 May 1958.

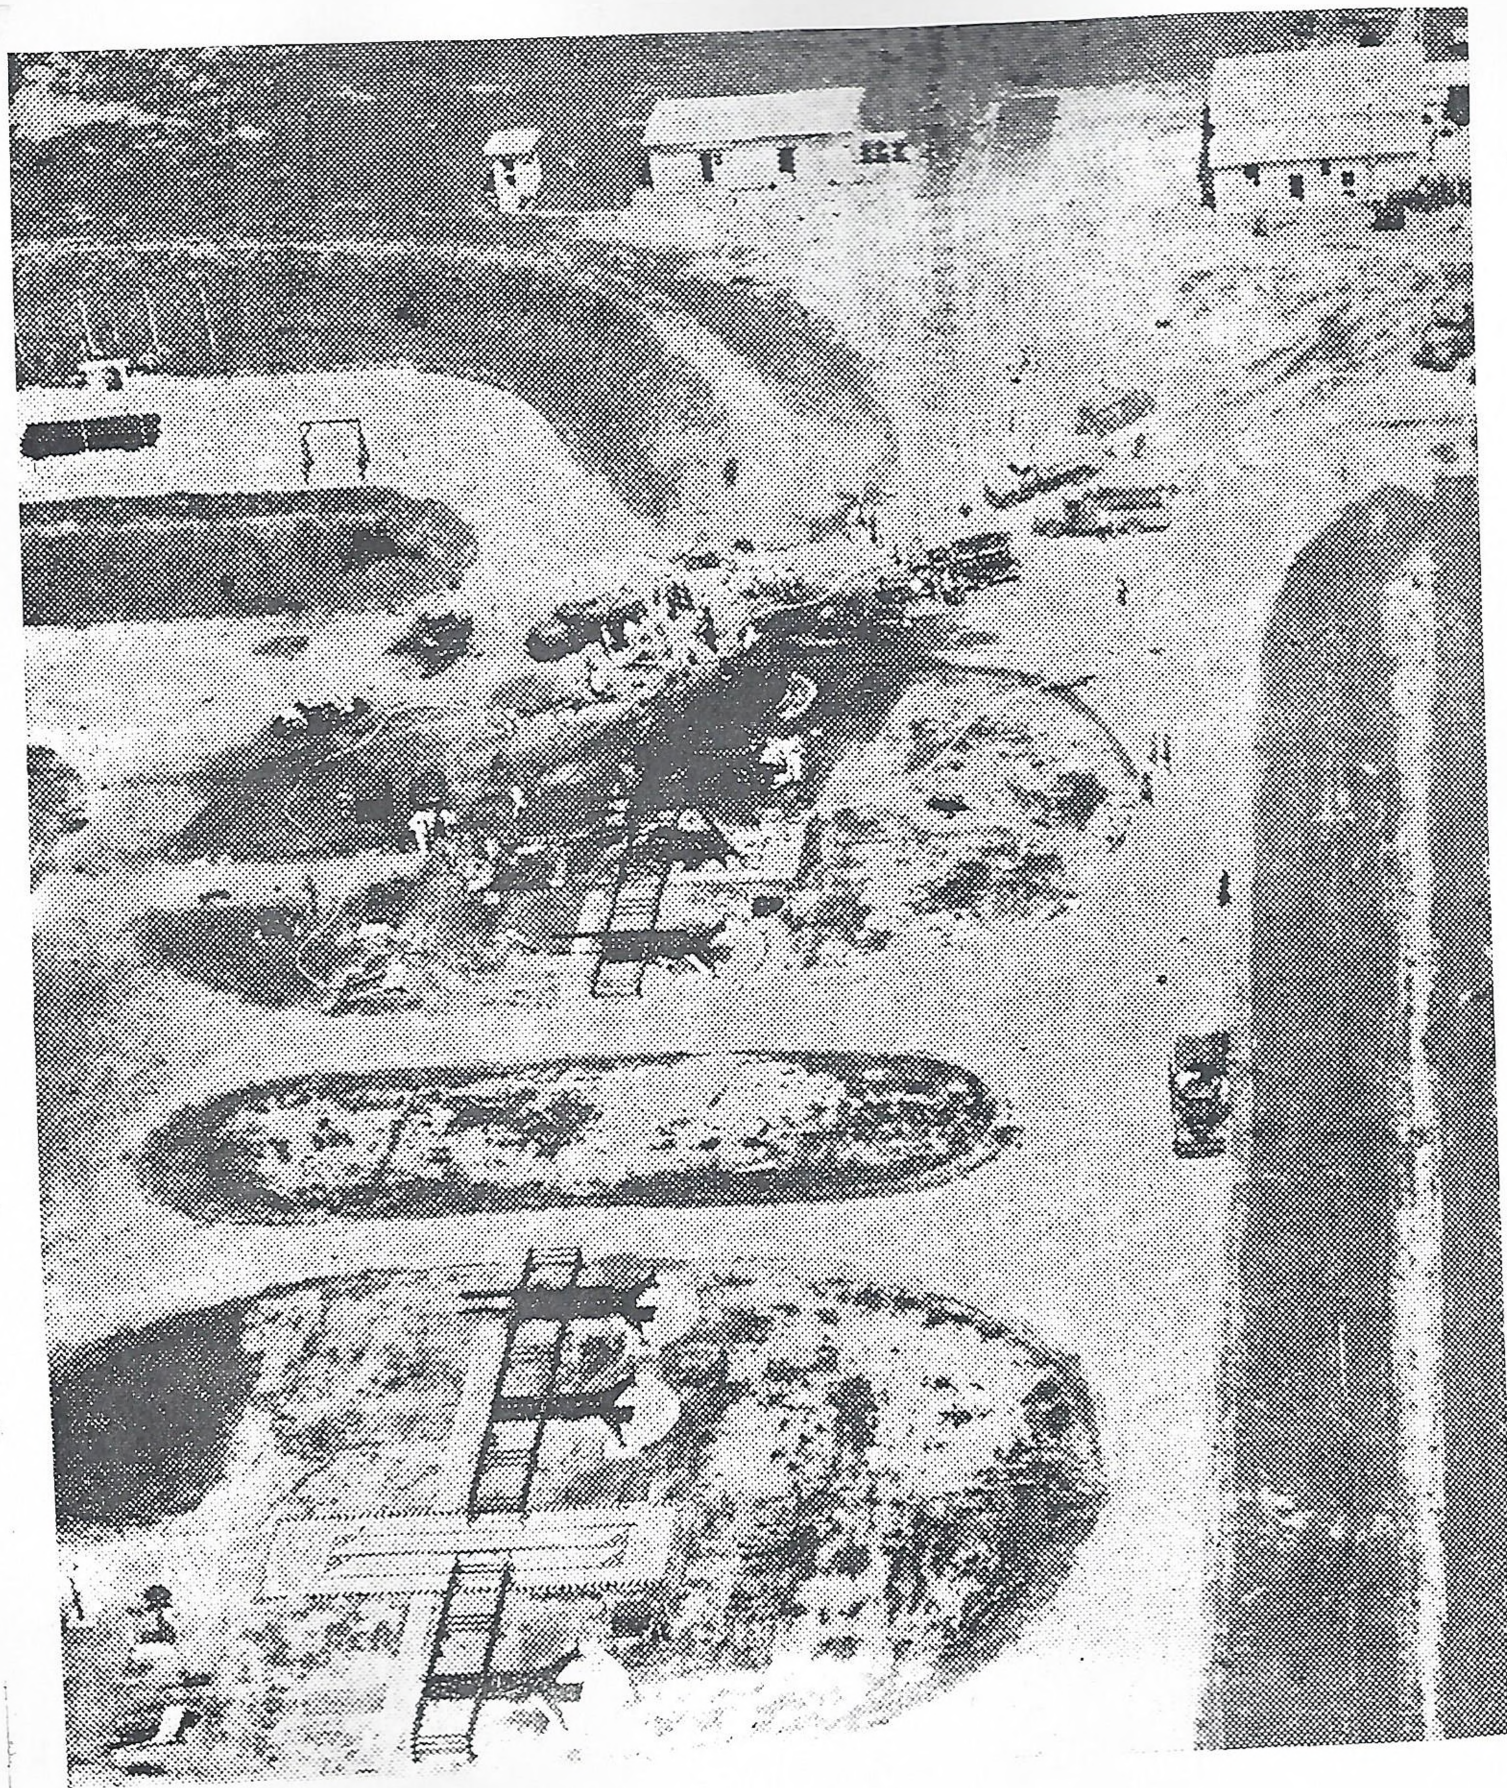
Neg No XA 1361-35

2. The initial explosion reportedly occurred at 1315 hours, at ground level above the most easterly located "type-C" underground storage structure. (Refer to attached Drawing File No. 9604-768 and Drawing File No. 7658-201). The damage in this area is considerable, as may be deduced from the attached New York Times photograph, 23 May 1958 edition (Neg. No. YA 1361-35).

Associated Press Wirephoto (N.Y. Times, 23 May 1958 Edition)
looking east, showing damaged auxiliary launcher No. 1 (upper
center) and operator's shelter, generator building, Missile
Assembly Test Bldg (upper l to r).

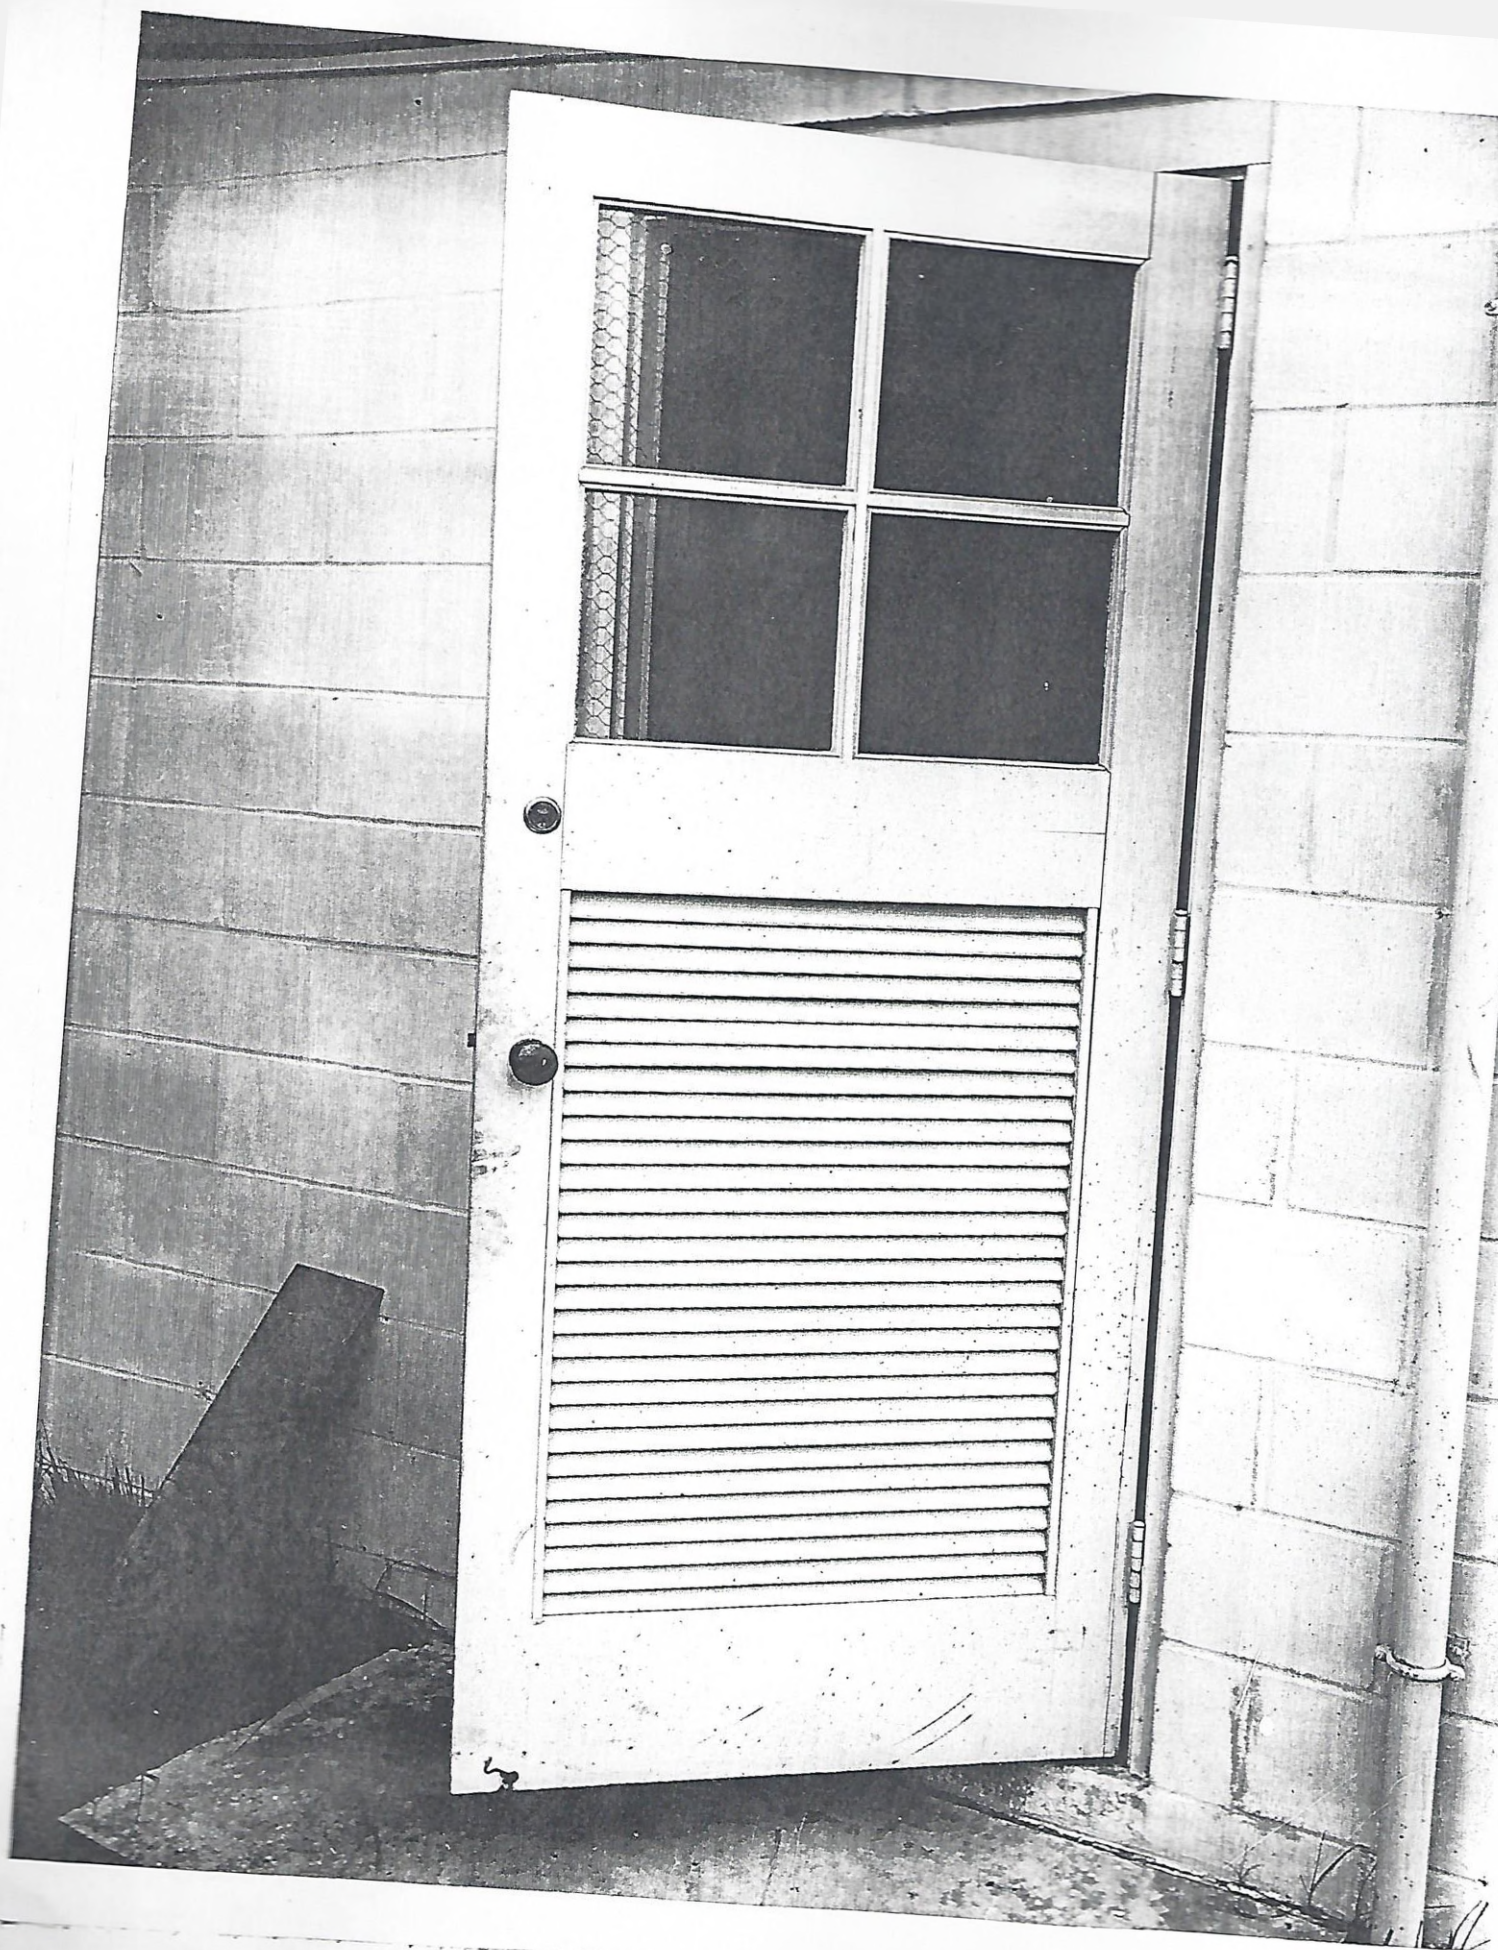
e. E.M. Barracks and BCO (Drawing File No. 9604-751): The E.M. Barracks and Officers' Quarters were generally damaged along the west wall. Windows and doors were damaged, and the bond beam requires repointing. (Refer to Neg. No. XA 1361-3, 4, 12 and 13).

Neg No KA 1361-4
Leonardo, N. J.
Rear of barracks showing bond beam break and
window separation.
5-23-58

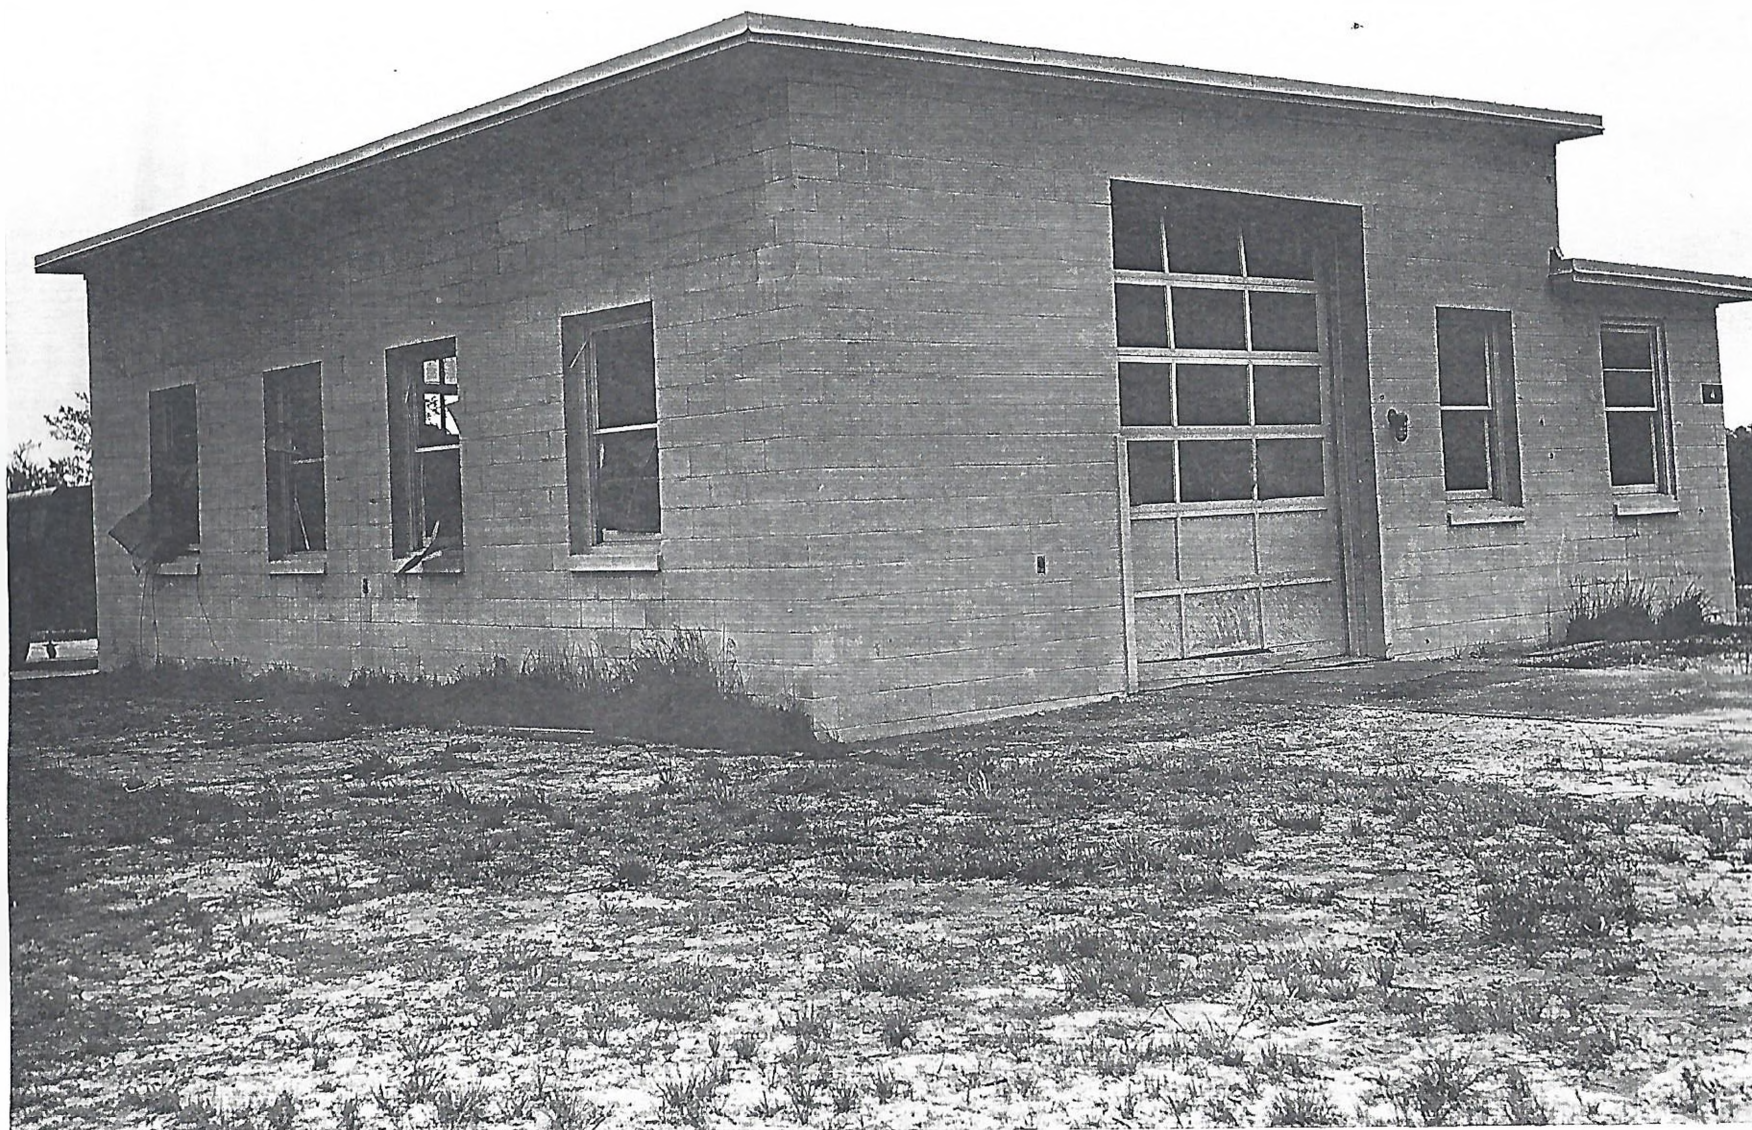
Neg No KA 1361-5

b. Missile Assembly & Test Building (Drawing File No. 9604-828): Damage to the west side of building (facing the explosion area) was general. Doors and windows were blown out; the roof was raised and separated from the bond beam; the heater room (including breeching and warm air furnace) was severely damaged; the first-aid room was severely damaged, the metal chimney pierced by metal fragments; the west wall was displaced outward about four inches and other walls were cracked, plumbing and plumbing fixtures were damaged; miscellaneous electrical repairs required, warm air heating ductwork damaged. (Refer to Neg. Nos. YA 1361-5, 6, 7, 8 and 9).

Leonardo, N. J.
Missile Assembly Bldg. showing overall damage.

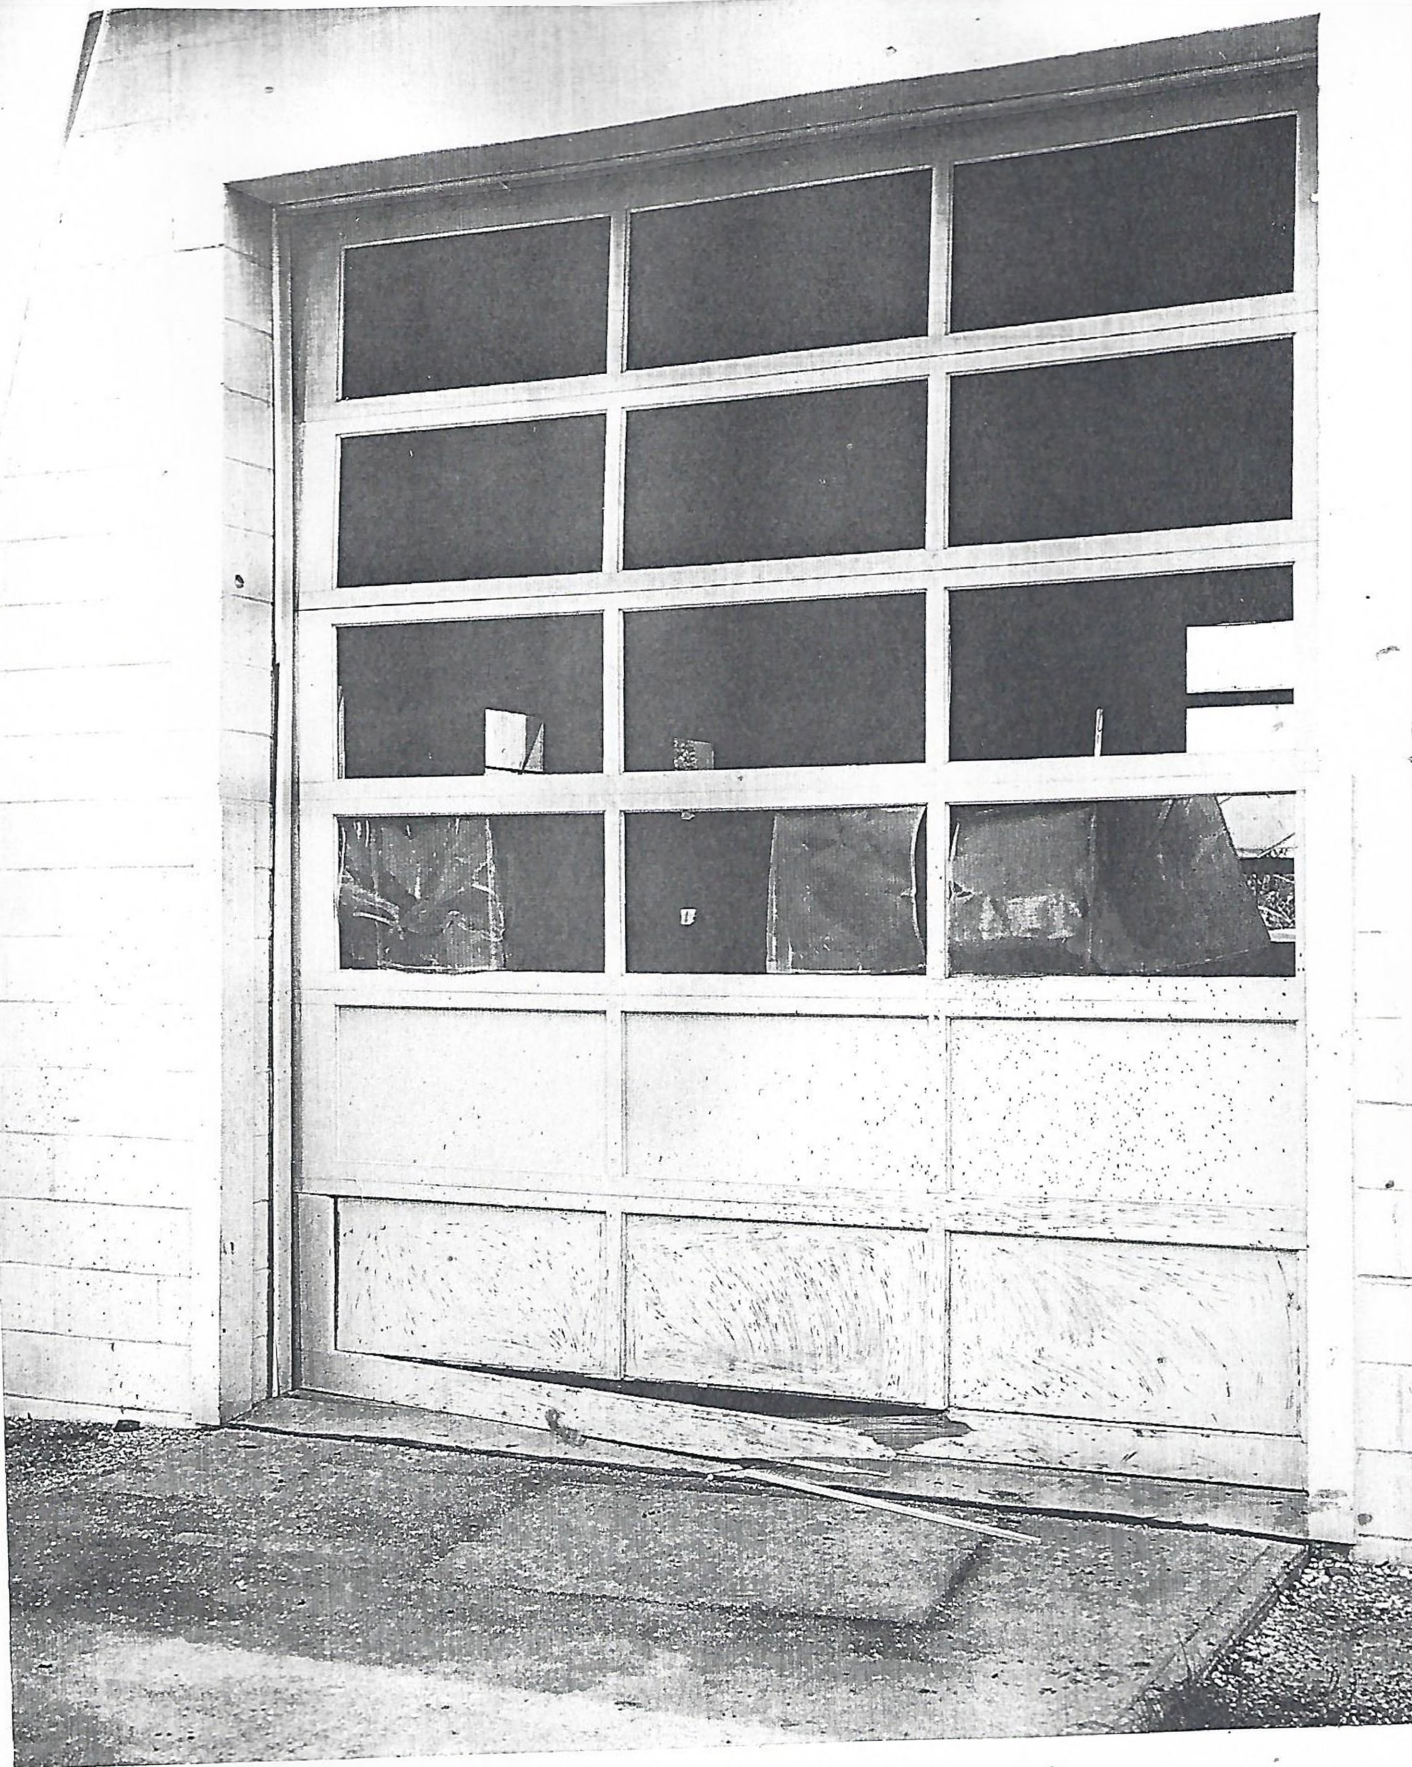
Neg No XA 1361-6

Leonardo, W. J.
Overhead door of Missile Assembly Bldg damaged.
(North side)

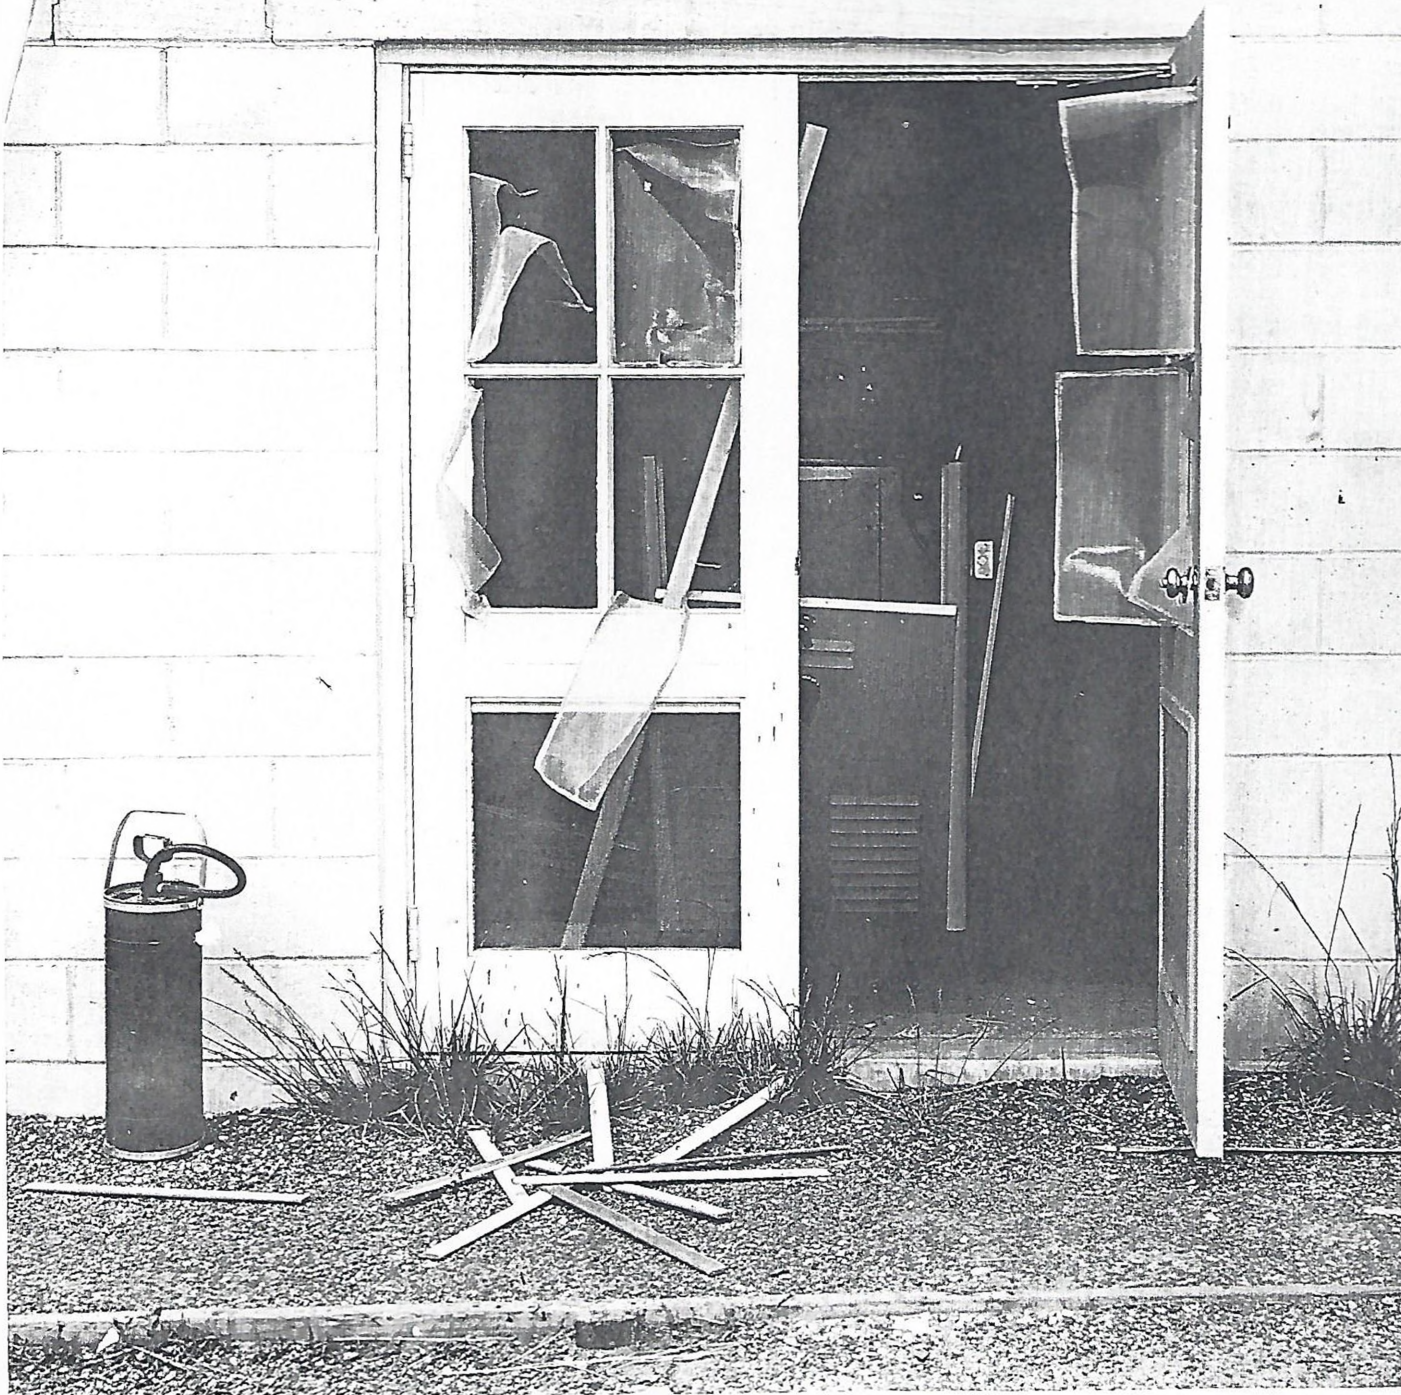
Neg No. XA 1361-7

Leonardo, N. J.
Heater room damaged rear of Missile Assembly Bldg.

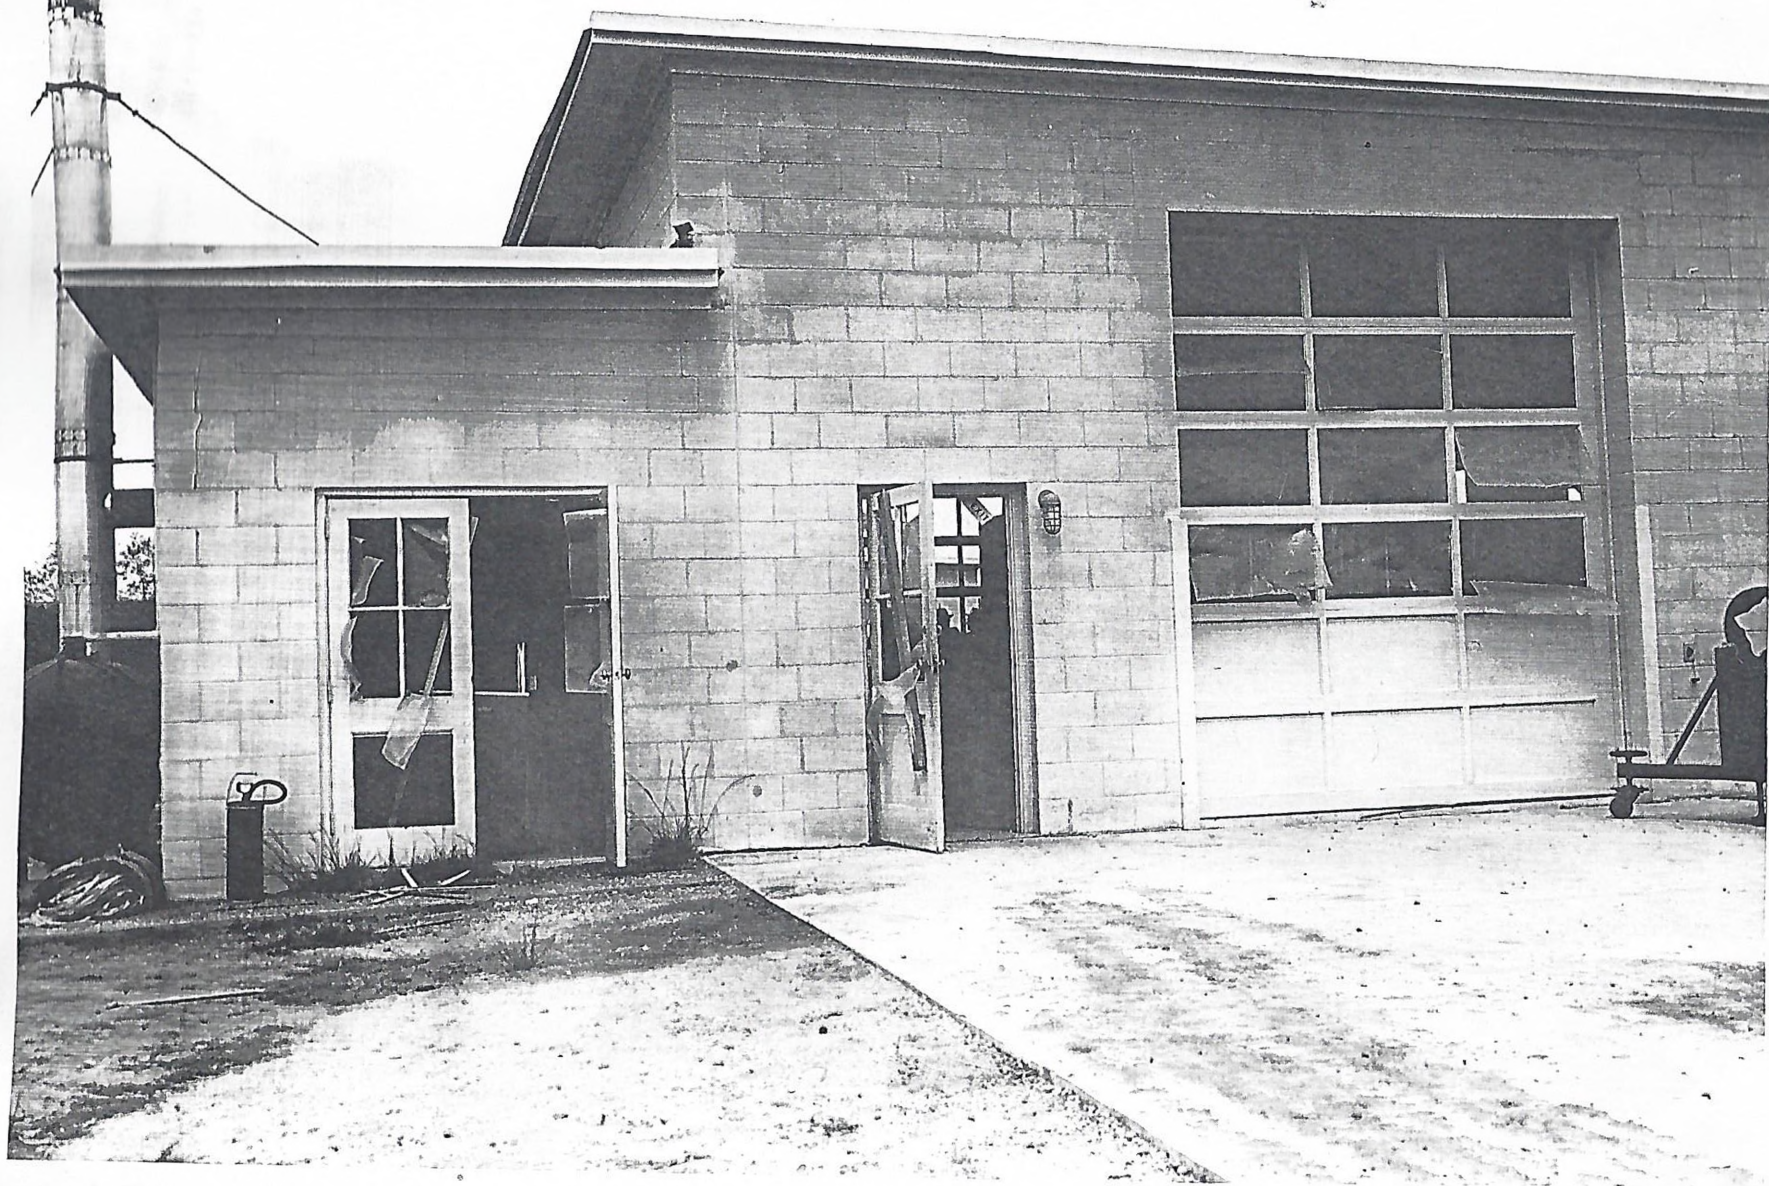
Neg No KA 1361-8

Leonardo, N. J.
Missile Assembly Bldg. south side showing overall
damage.

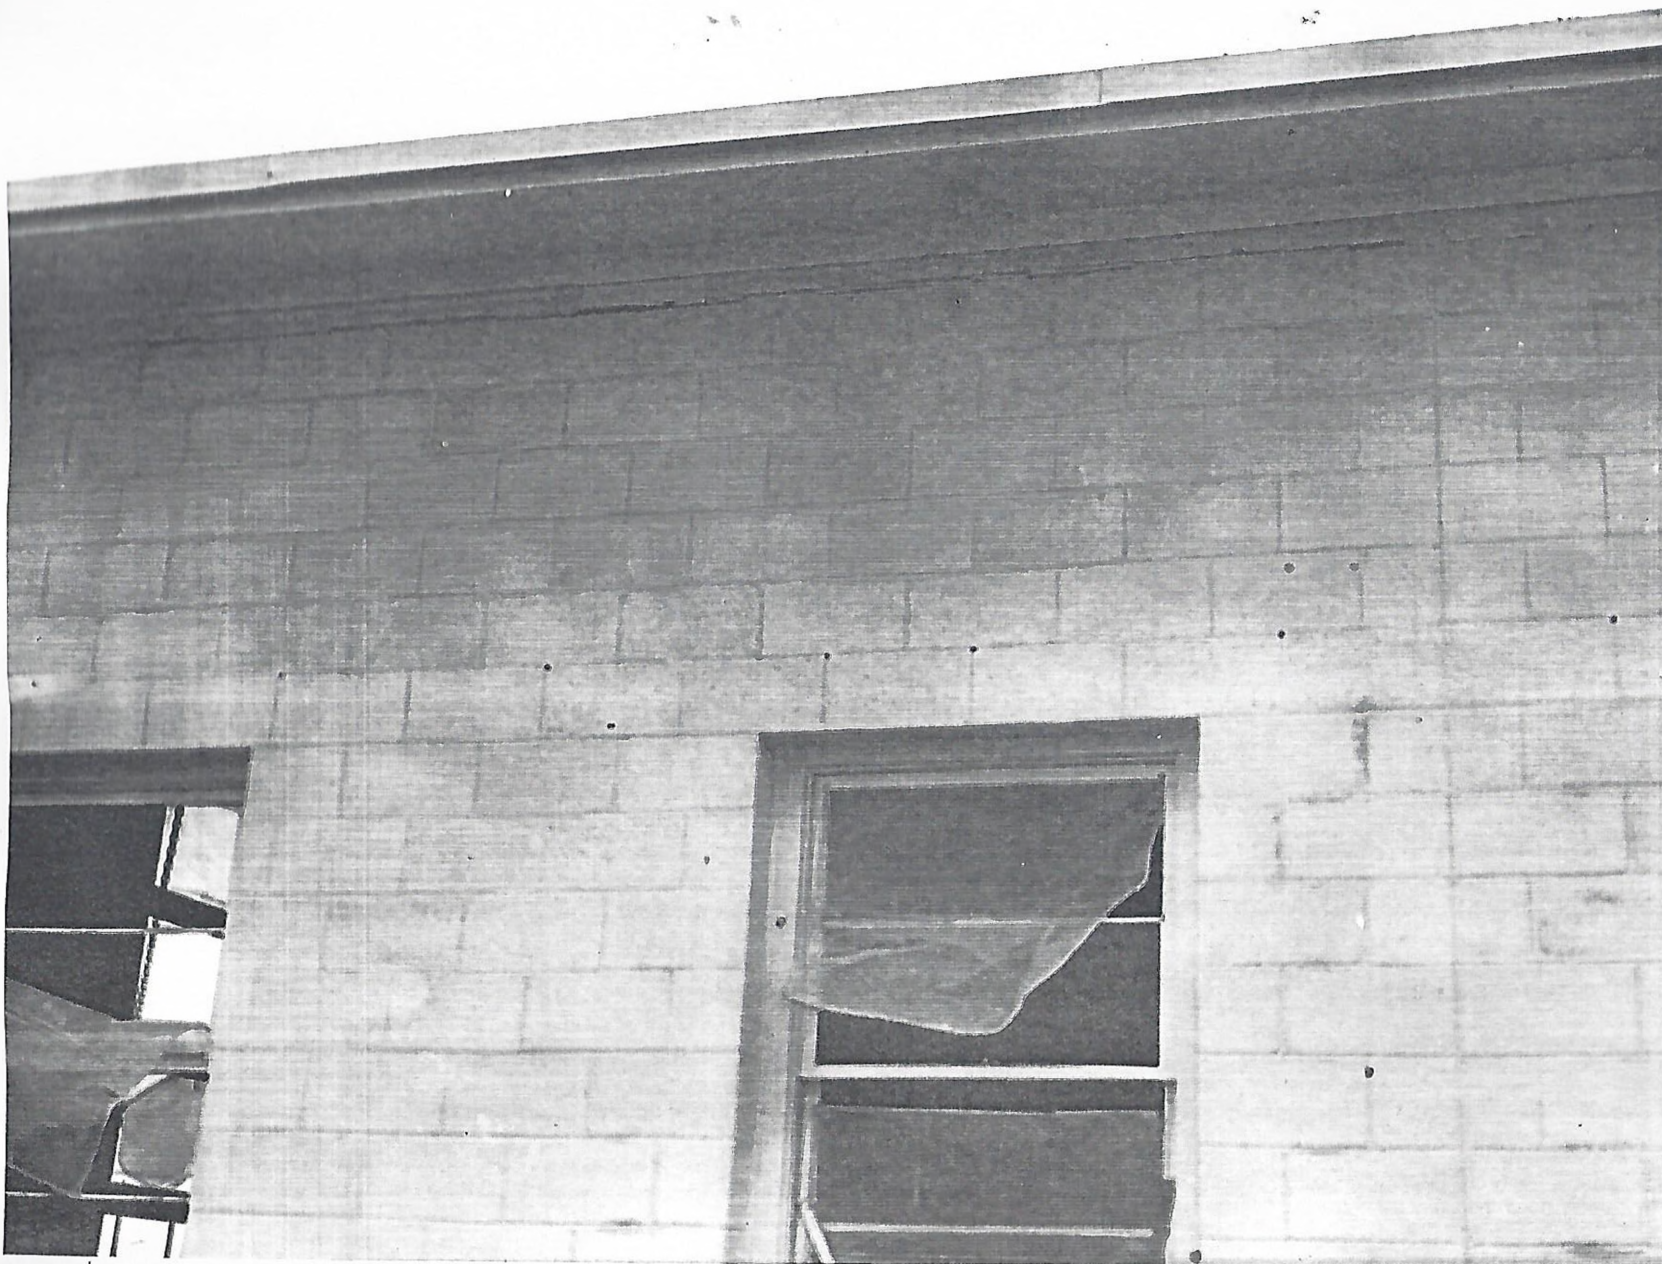
Neg No KA 1361-9

East side of Missile assembly Bldg showing wall
and window damage.

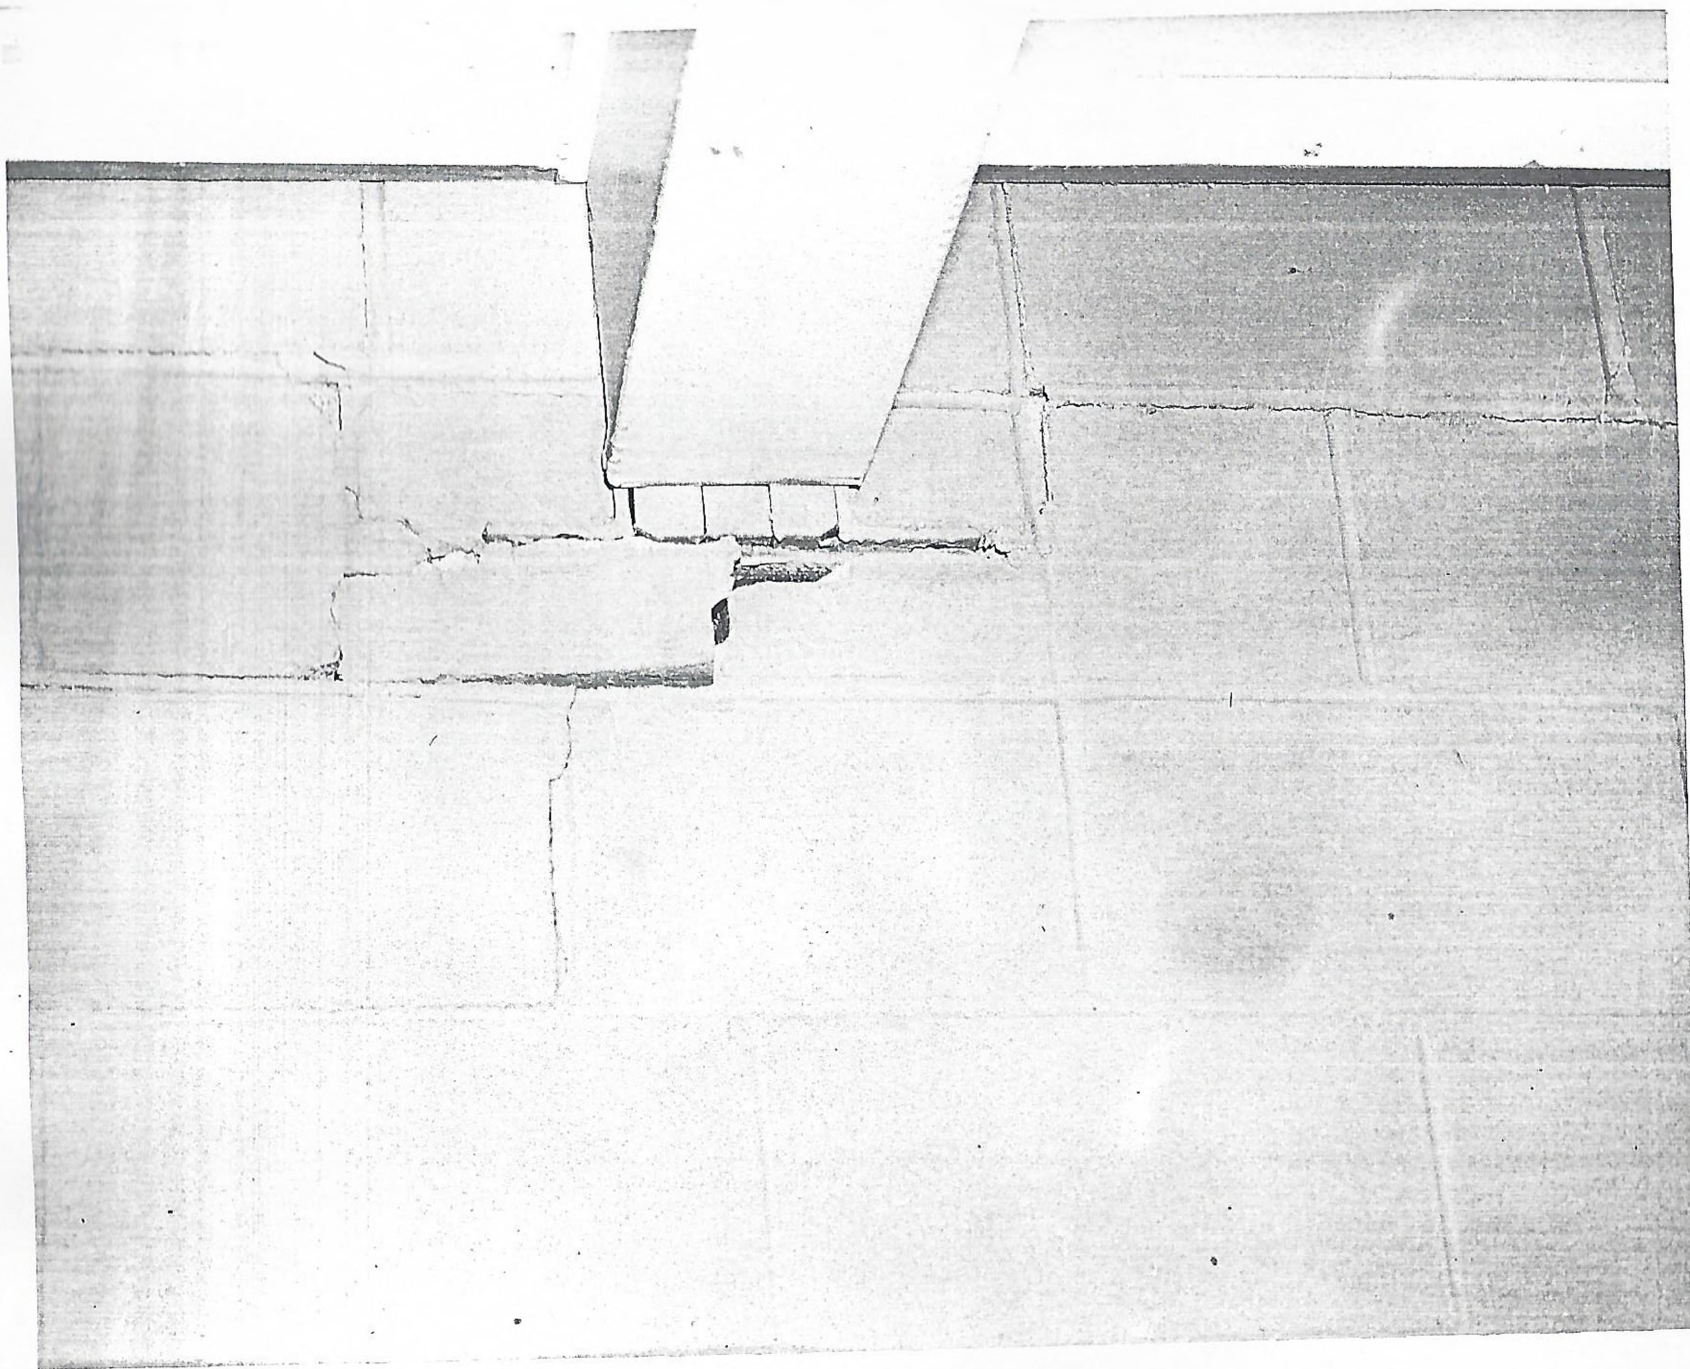
Neg No KA 3361-10

d. Administration, Recreation and Storage Building (Drawing File No. 9604-774): The Administration, Recreation and Storage Building was generally damaged along the west wall. Windows and doors were damaged and the bond beam requires repointing. The main girder was separated from the anchors, requiring repairs and re-anchoring. (Refer to Neg. No. XA 1361-1, 2, 10 and 11).

Admin. Bldg showing beam separation in orderly room.

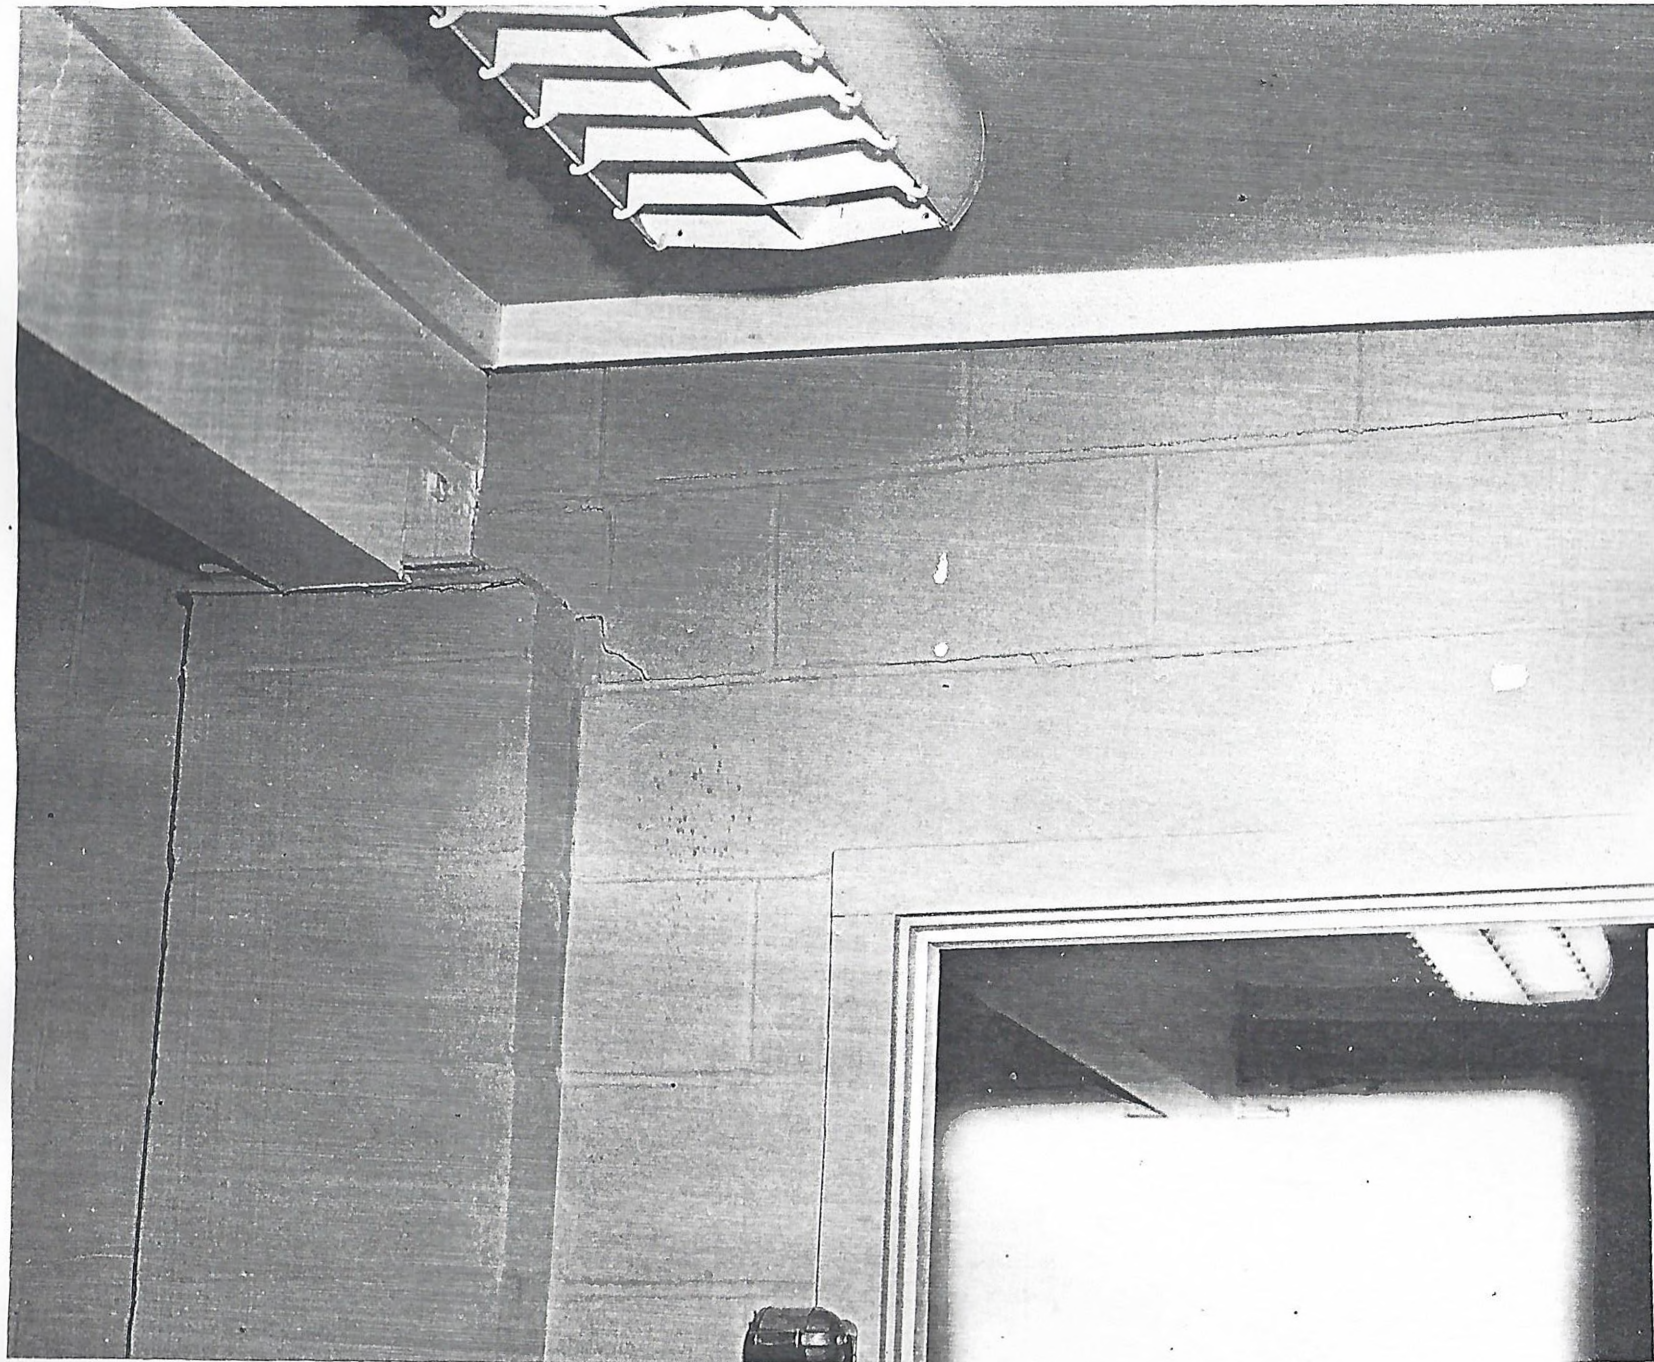
Neg No XA 1361-11

Leonardo, W. J.
Admin Bldg showing beam separation in Exec Office
and orderly room.
