DAMAGE REPORT, LEONARDO H.A.A.
SITE

DAMAGE REPORT - ENGINEER-CONSTRUCTED FACILITIES
STORAGE EXPLOSION OF 22 MAY 1958
LEONARDO AAA SITE

1. General: Representatives of the USAR District, New York, visited the Leonardo AAA Site at 1030 hours on 23 May 1958 to investigate and report on the extent of damage to Engineer-constructed facilities resulting from the explosion which occurred in the Launcher Area on 22 May 1958.

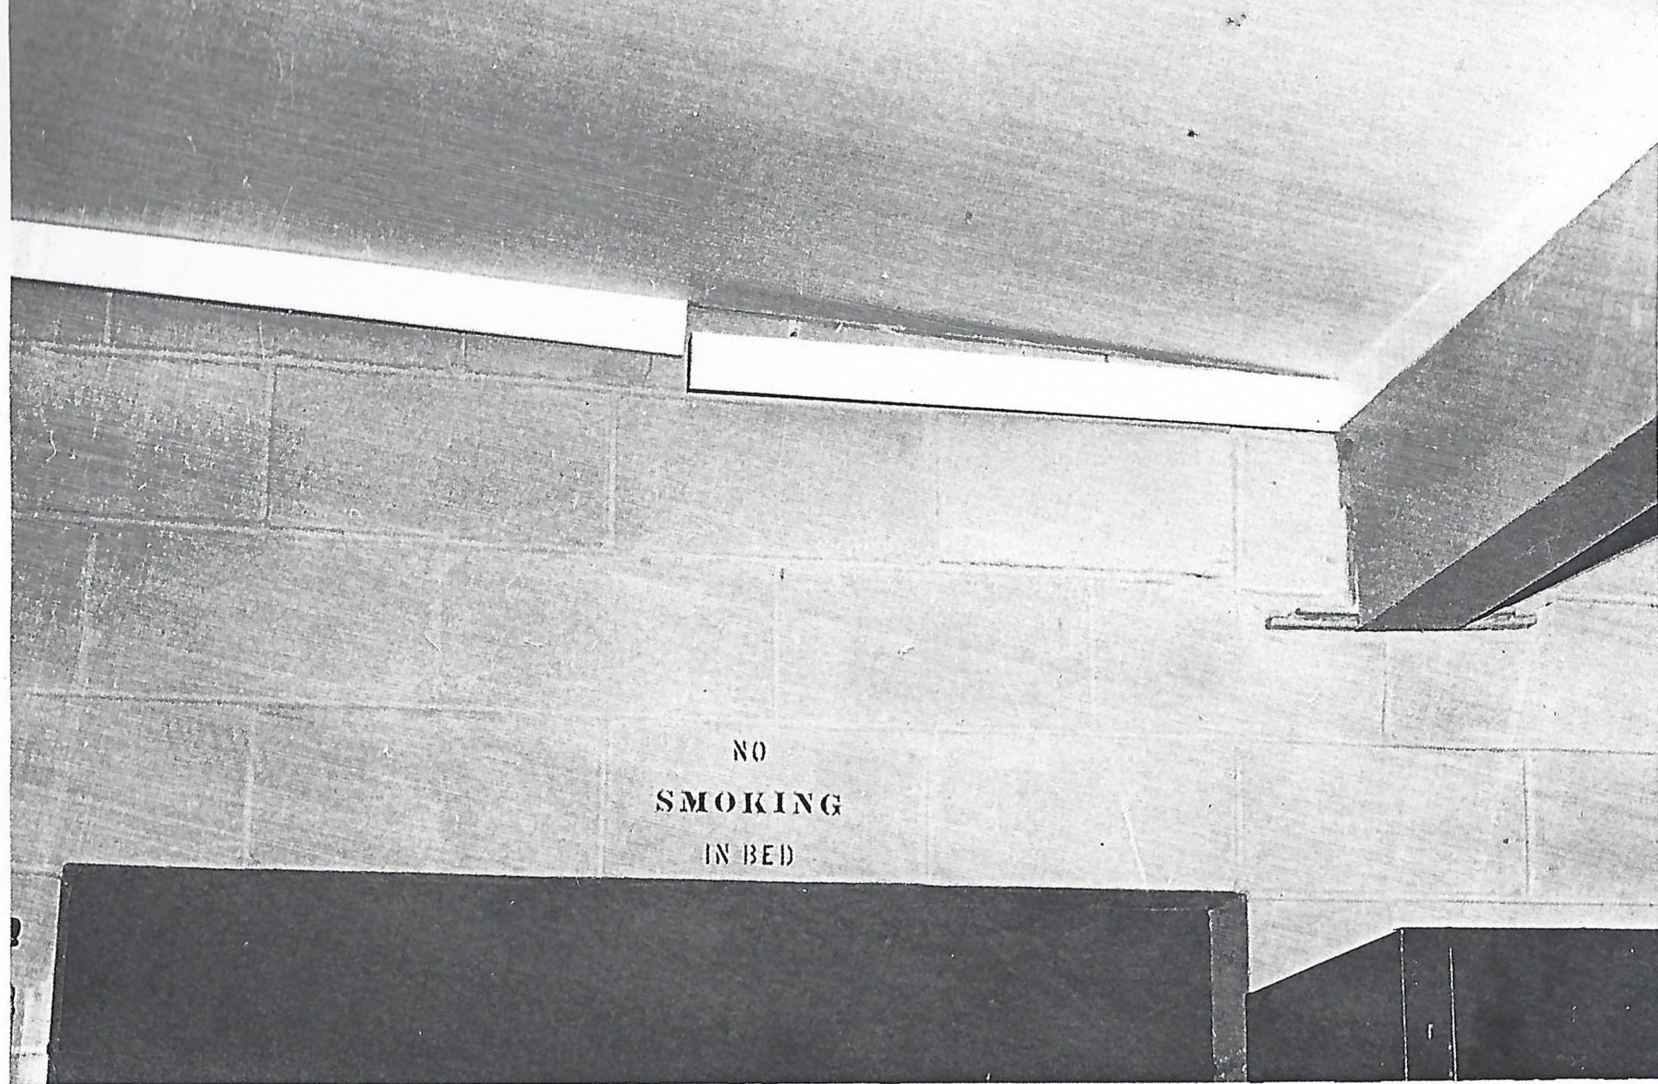
Leonardo, N. J. No Neg XA 1361-12
Interior of Barracks showing Interior beam damage.

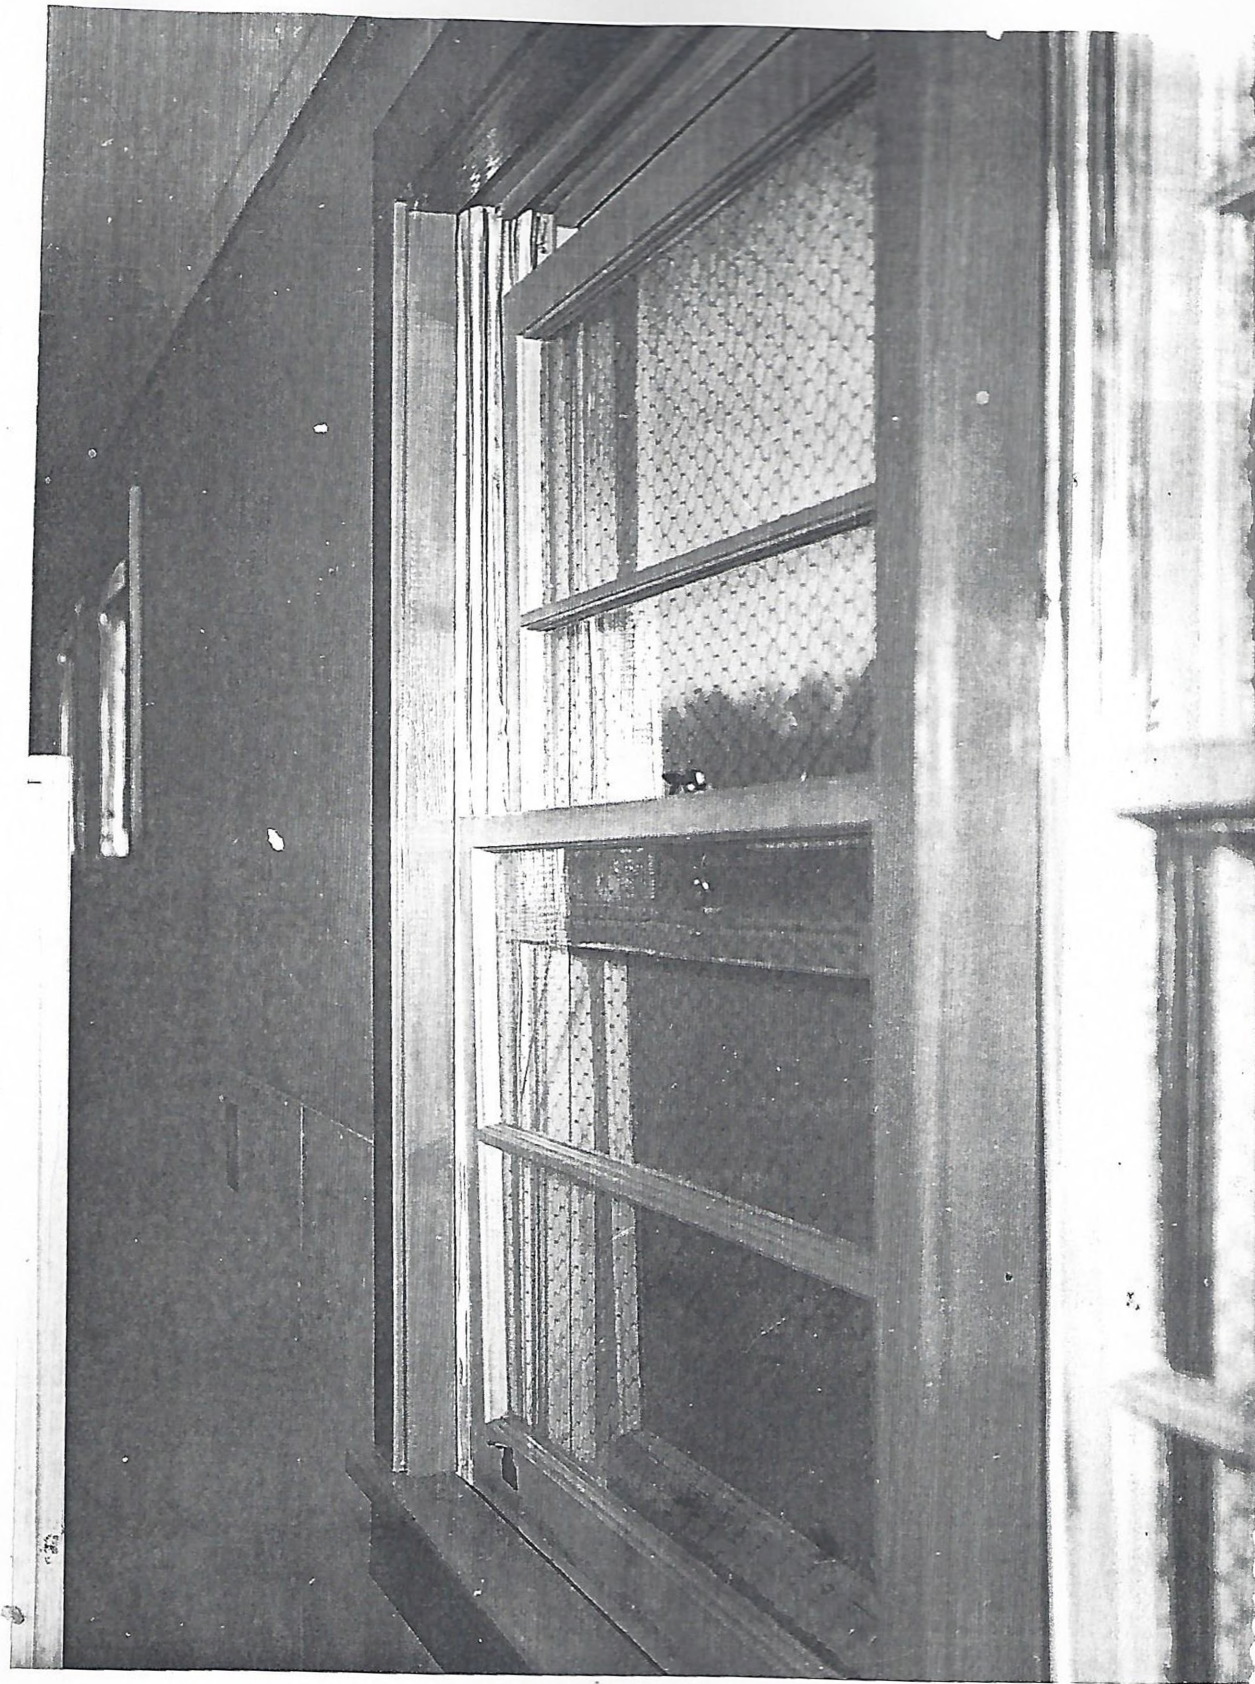
Leonardo, N. J. Neg No EA 1361-73
Interior of E M Barracks showing window damaged.

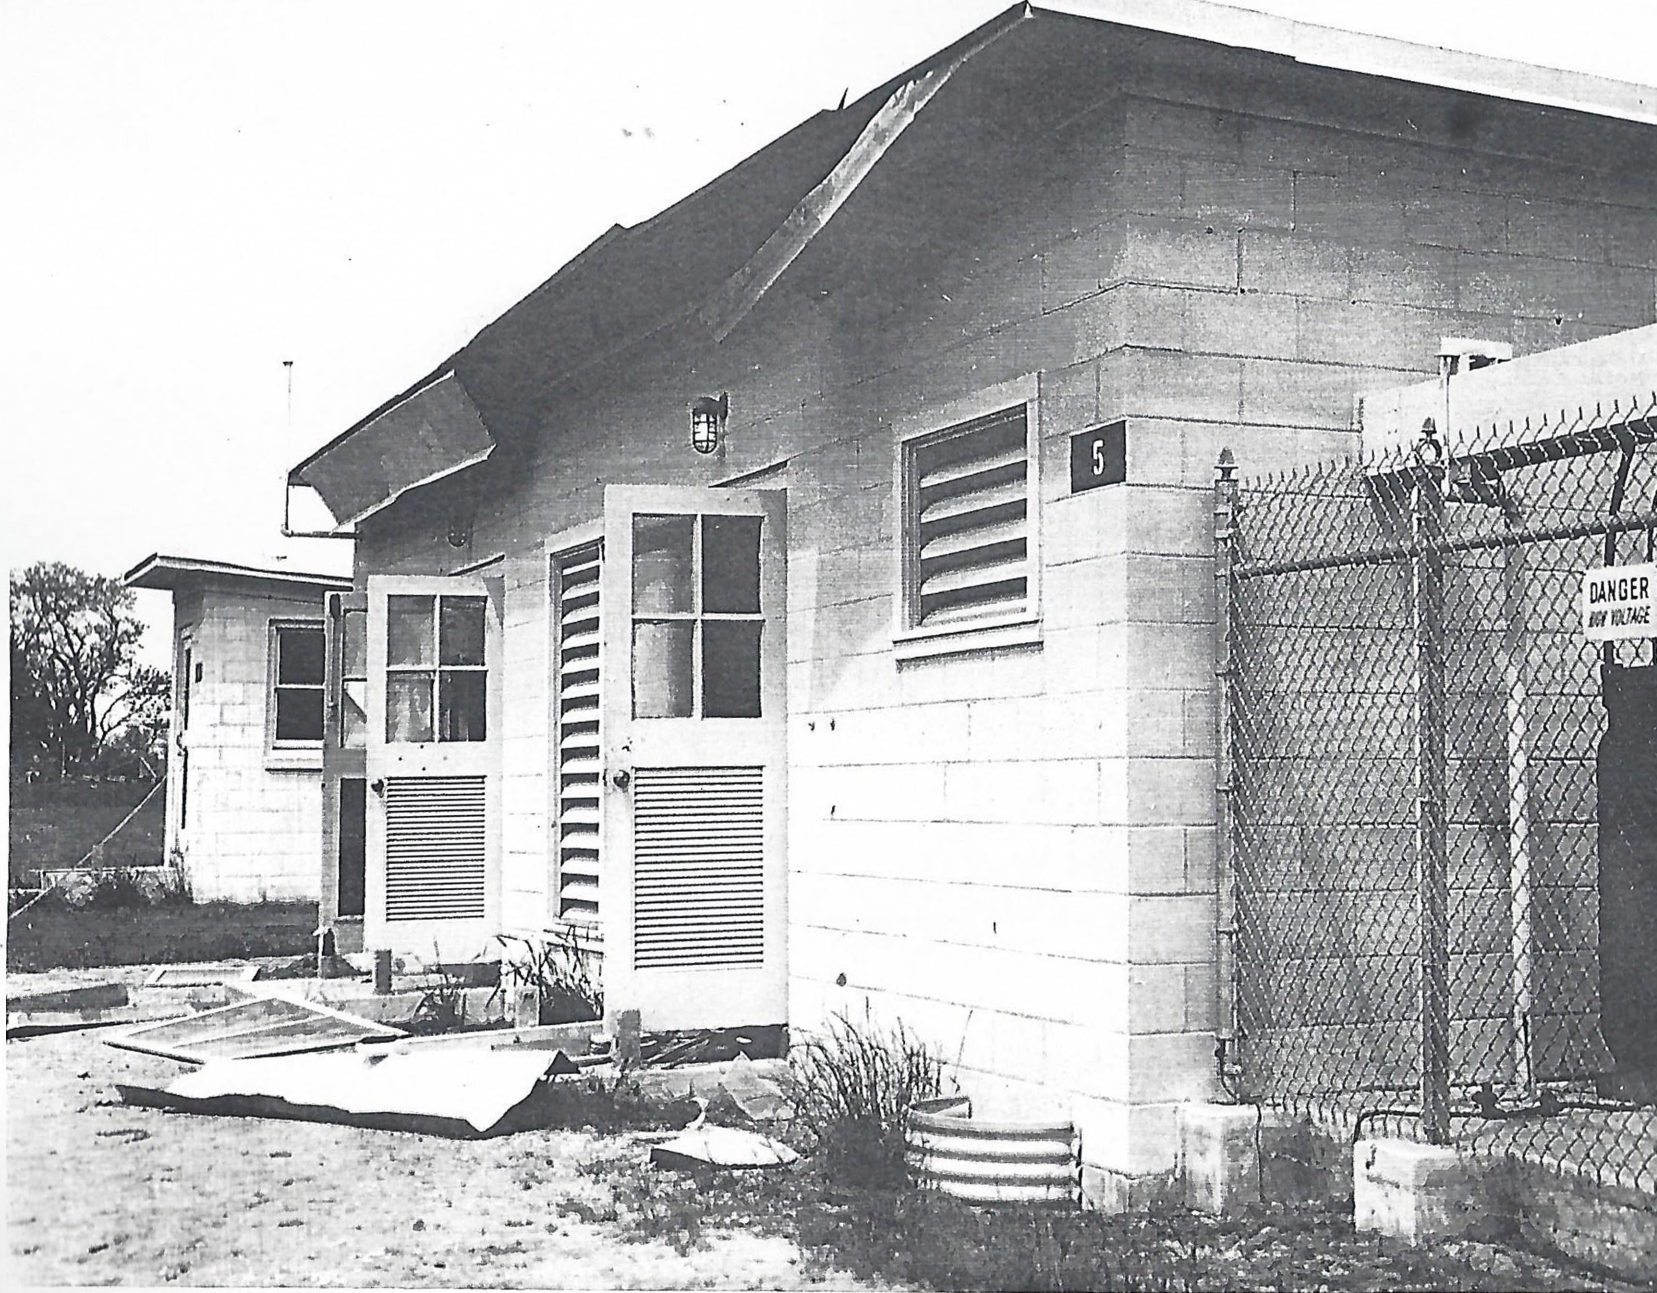
c. Generator Building and Operator's Shelter (Drawing File No. 9604-700): The west exterior wall of Generator Building (facing the explosion area) was cracked. Windows and doors were blown out; one 100-KVA transformer was punctured by metal fragments; the transformer fence was damaged, exhaust and intake louvers damaged, interior ceiling damaged, and miscellaneous electrical repairs required. The three generators will require checking for possible realignment; generator exhaust mufflers were moved, requiring repacking at the exterior wall. In the Operator's Shelter, the windows and door were blown out, and interior electrical work slightly damaged. (Refer to Neg. Nos. XA-1361-14, 15, 16, 29 and 34).

Leonardo, N. J. Neg No XA 1361-14
View showing damage to Generator Bldg. (front)

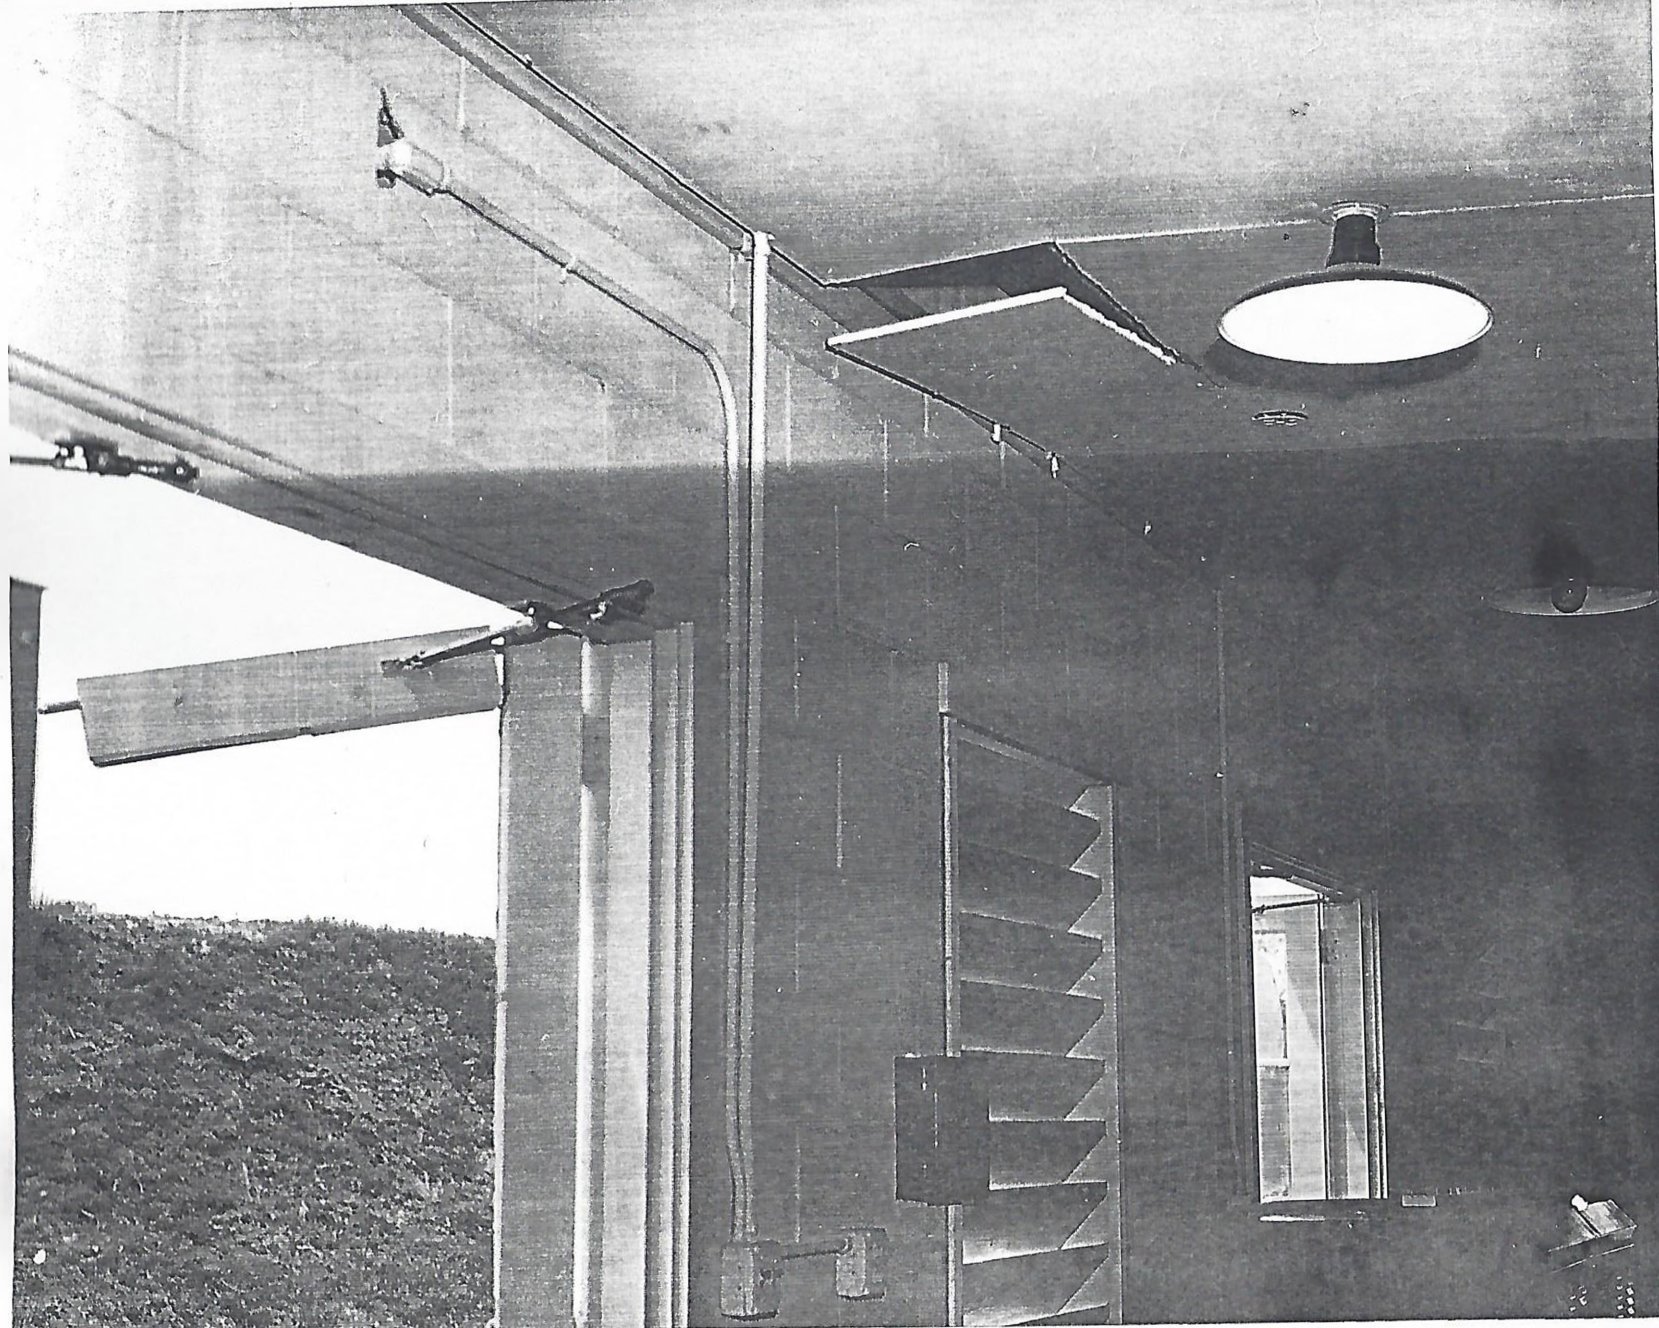
Neg No RA 1361-15

Leonardo, N. J.
Interior of Generator Bldg showing wall bulge
and damaged ceiling.

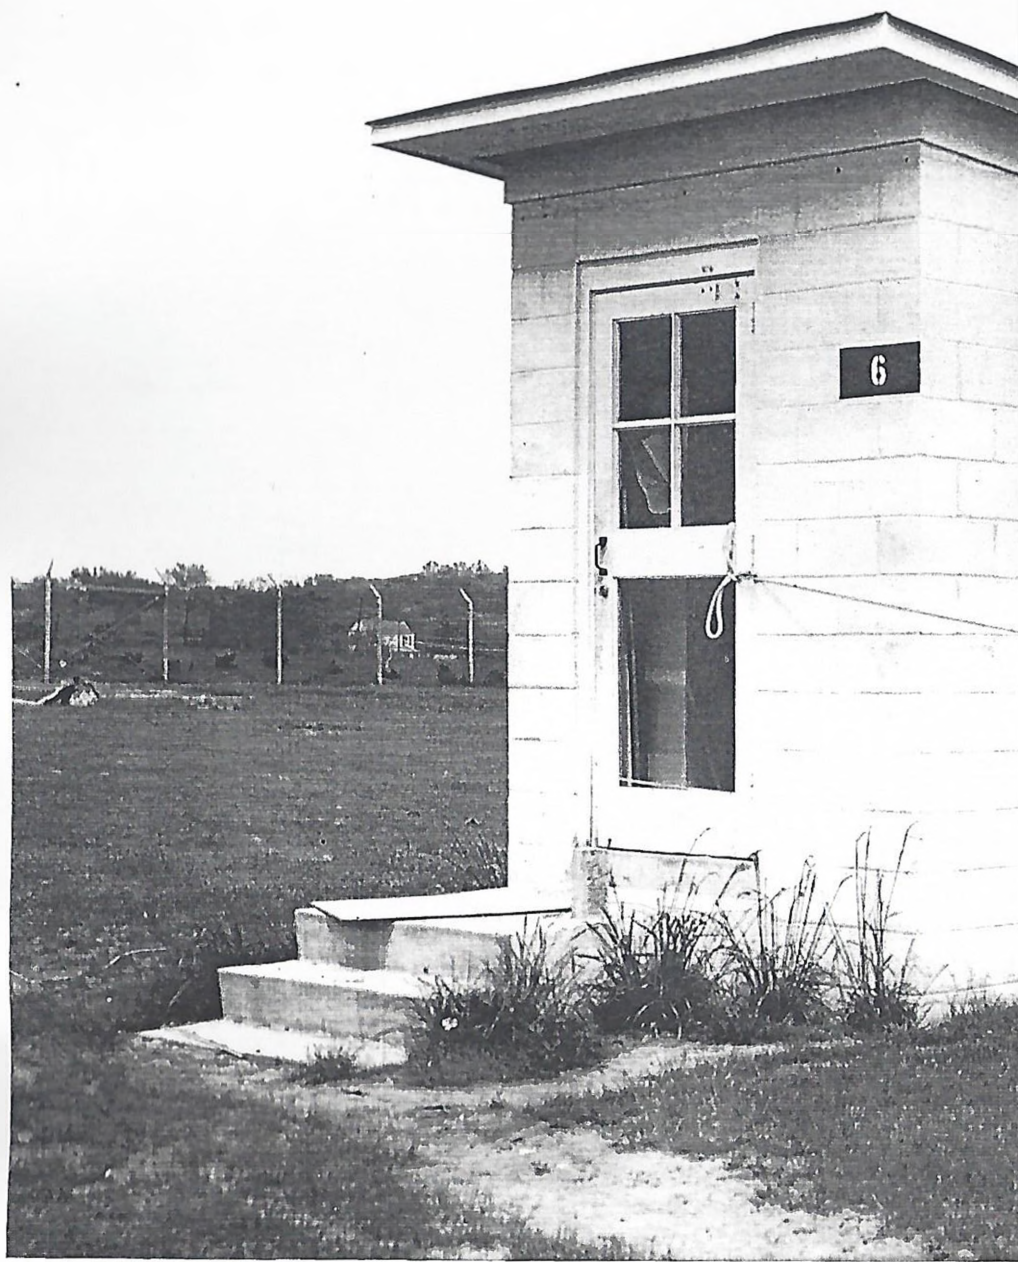
Neg No KA 1361-16

Leonardo, N. J.
Operators shelter Bldg.

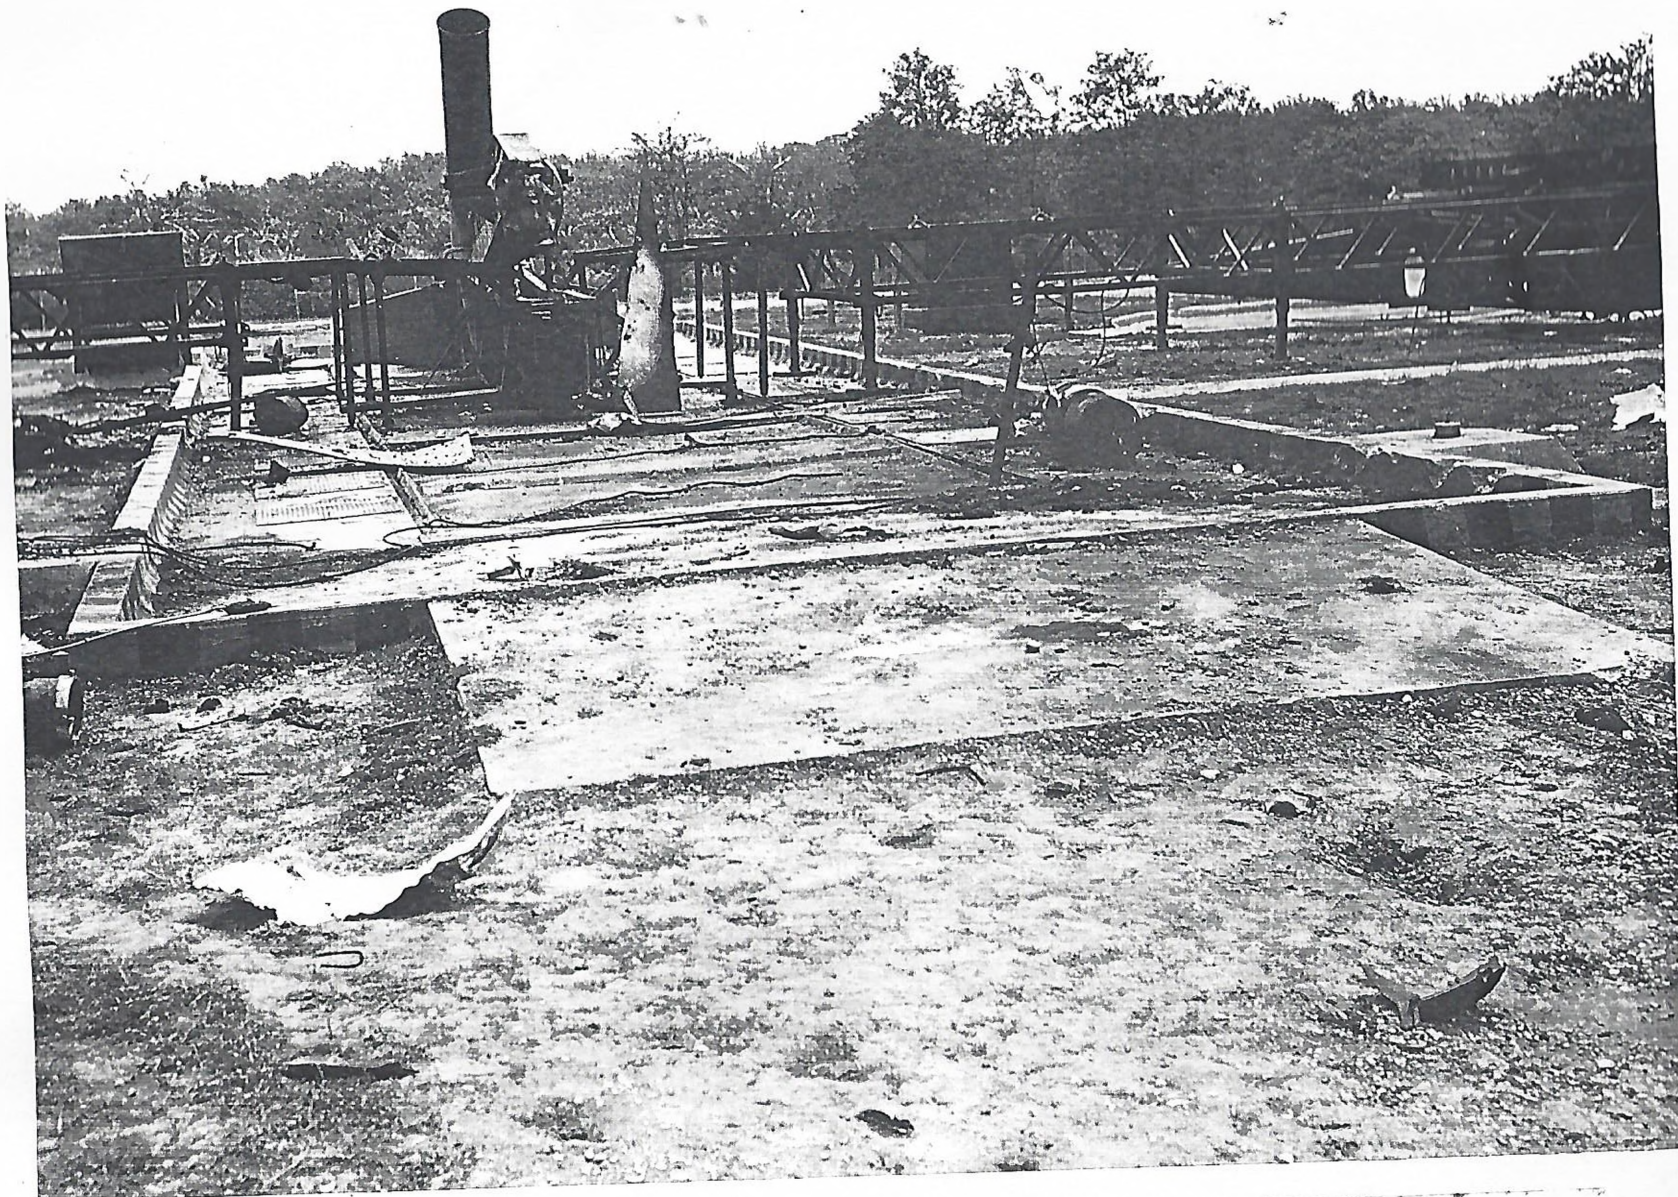
Neg No KA 1361-17

a. Underground Missile Storage Structure (Drawing File No. 9604-810): Limited damage was found at ground level: and negligible structural damage in one "type-C" underground missile storage structure proper. Major reconstruction will be required of the elevator platform, launcher pads, walks, concrete curbs, grading, aboveground safety shower and hydrant, aboveground hose and hose rack, earth mounds, airline terminals, access doors, etc. Damage to the elevator could not be fixed accurately, since the elevator was in the raised position resting on the locking bars at the time of the explosion, and was found inoperative thereafter. Piping for the hydraulic power unit was ruptured with complete loss of hydraulic fluid: ventilation ducts were pierced, locking bars damaged, sump-pump was inoperative, floor drains clogged, and miscellaneous electrical repairs found necessary. (Refer to Neg. Nos. YA 1361-17, 18, 19, 20, 21, 22, 23, 25, 26 and 28).

Leonardo, N. J.
View showing damage to underground box and
Elevator.

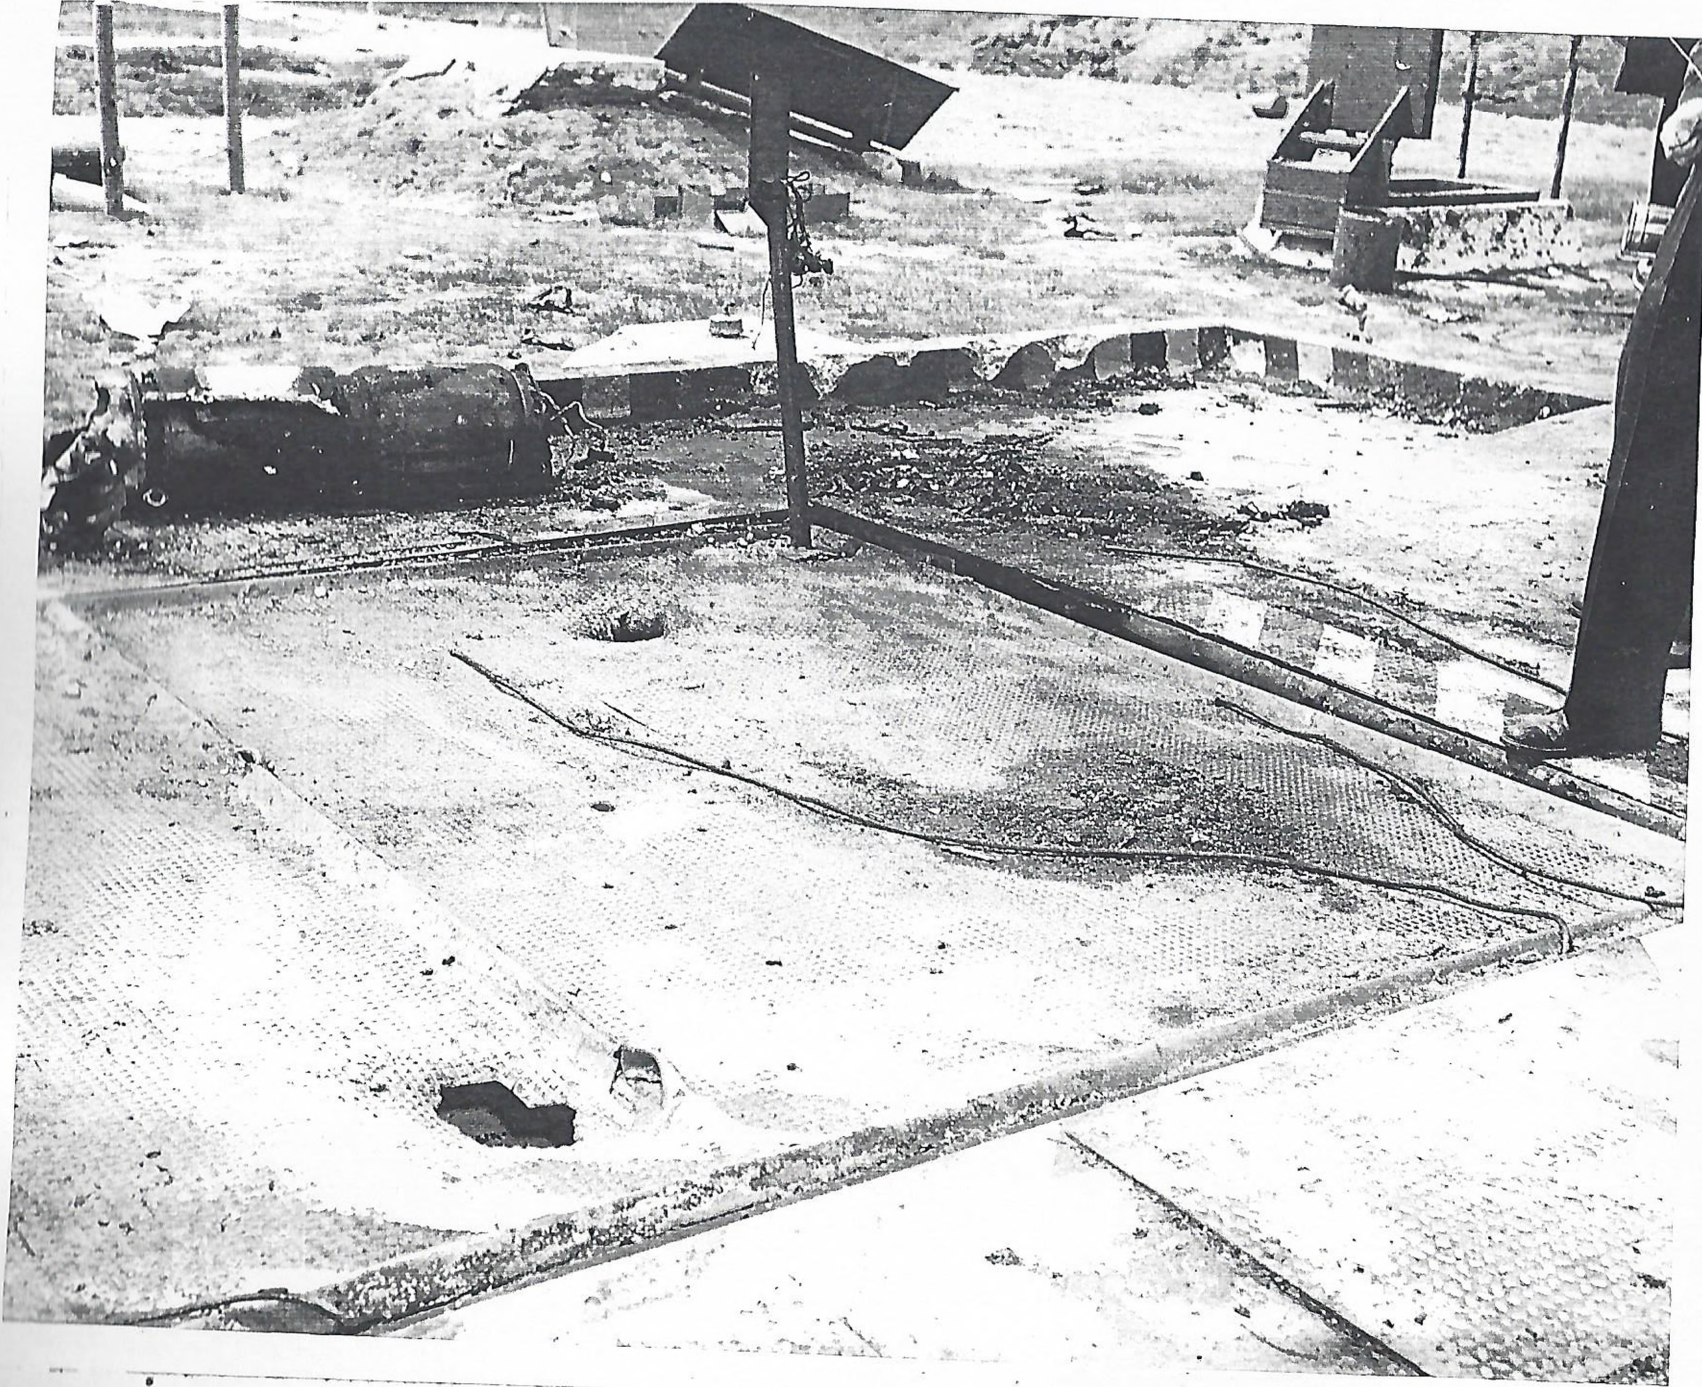
Neg No XA 1361-18

Leonardo, N. J.
Front of elevator showing holes and damaged
concrete.

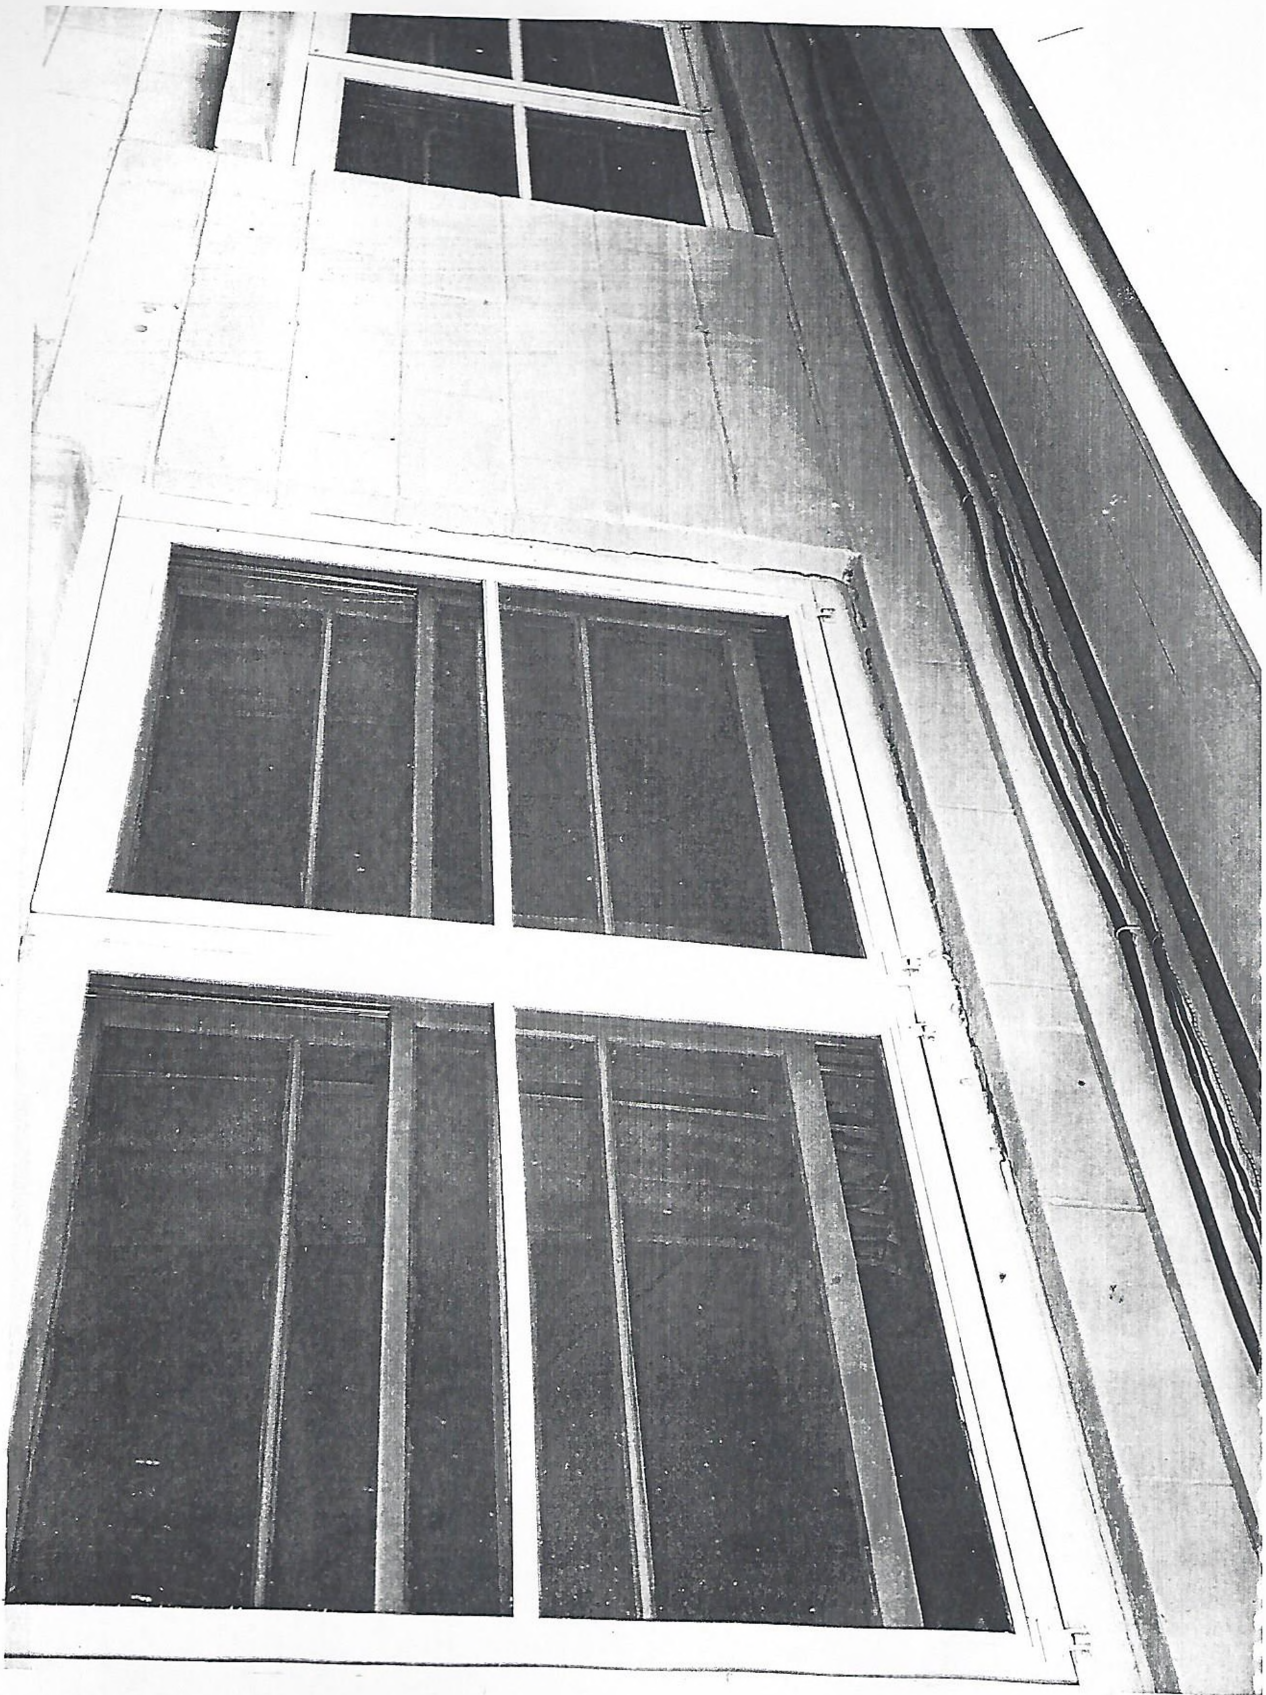
5-23-58 Leonardo, W. J.
Rear of Admin. Bldg. showing beam break and window
separation. Neg No KA 1,261-2

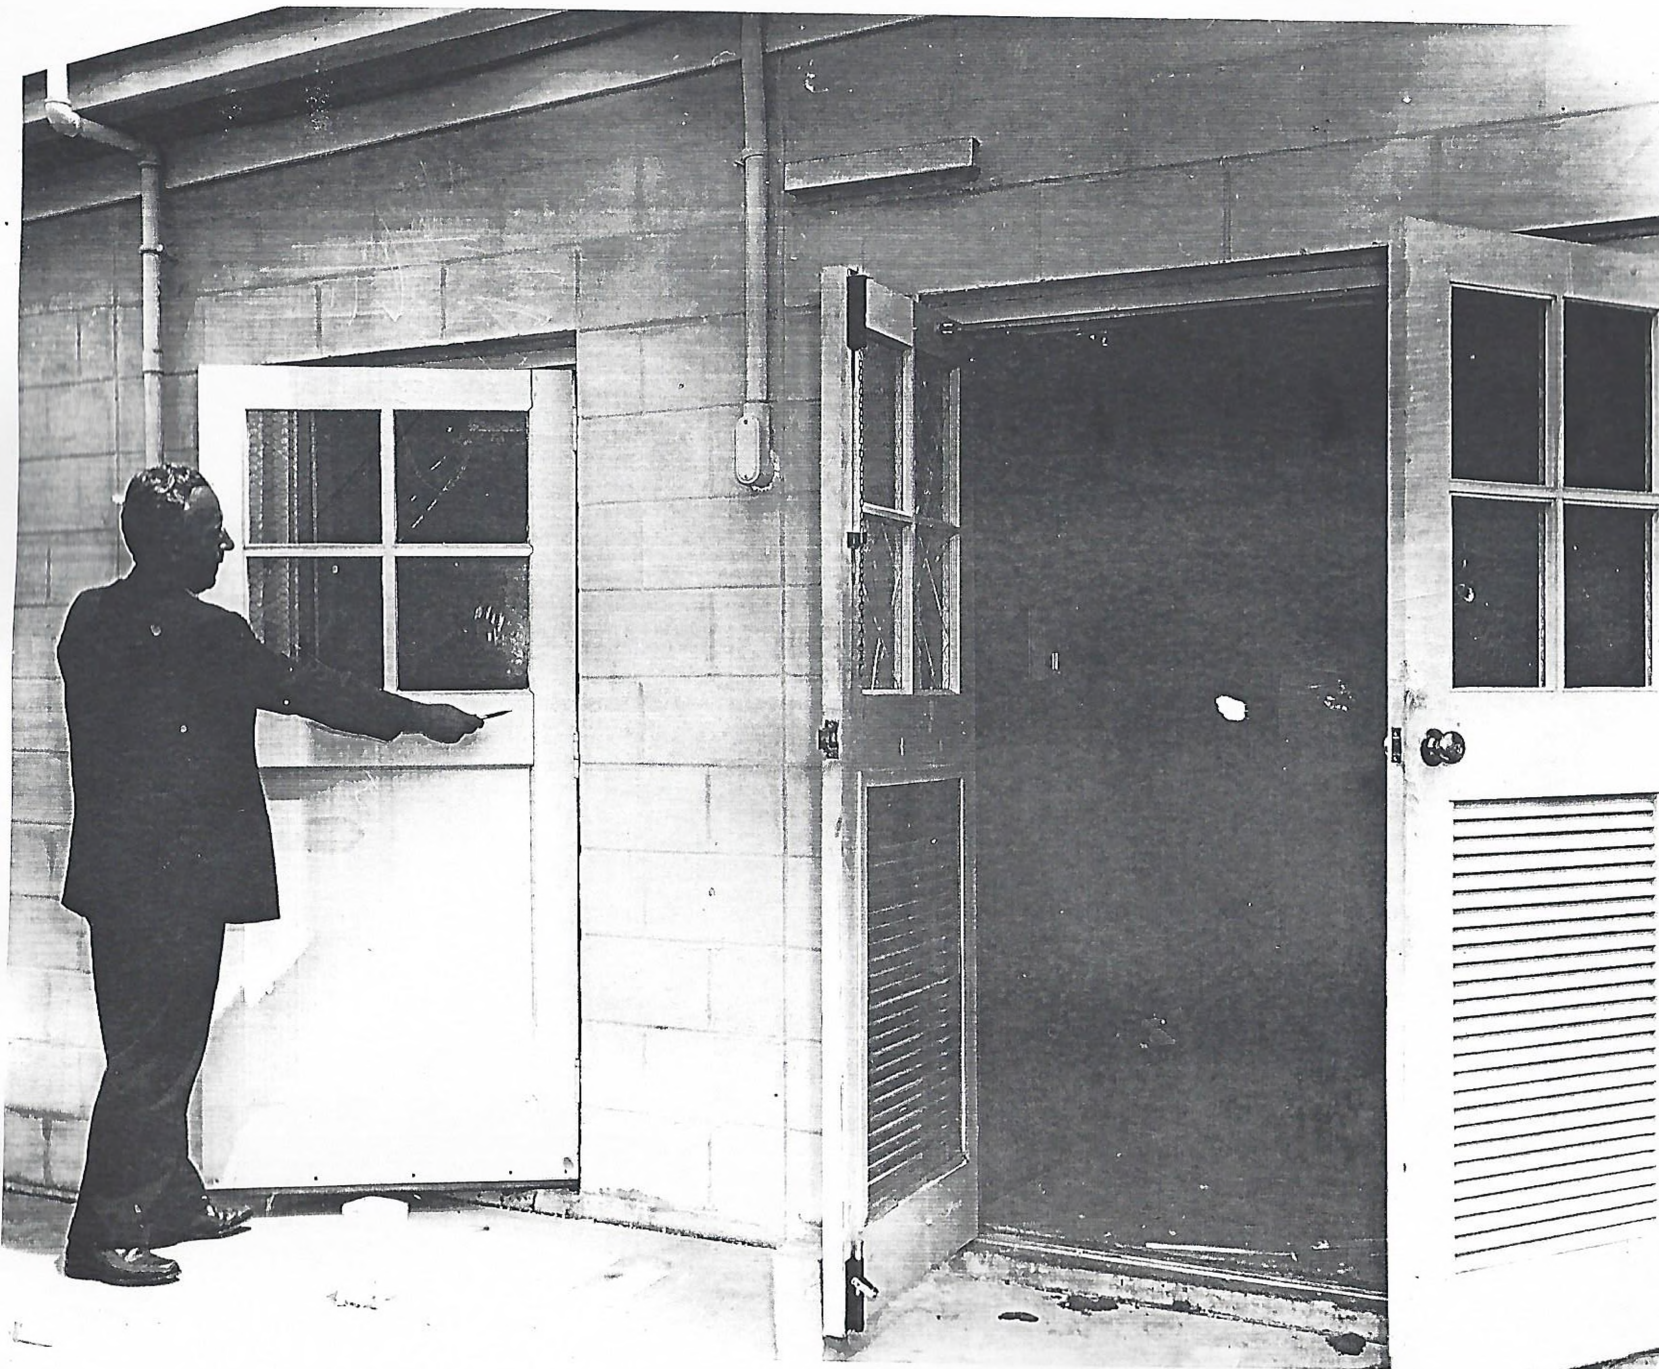
Neg No KA 1561-3

Leonardo, N. J.
Rear of Barracks Bldg. showing doors to Officers Quarters
and Boiler room damaged.

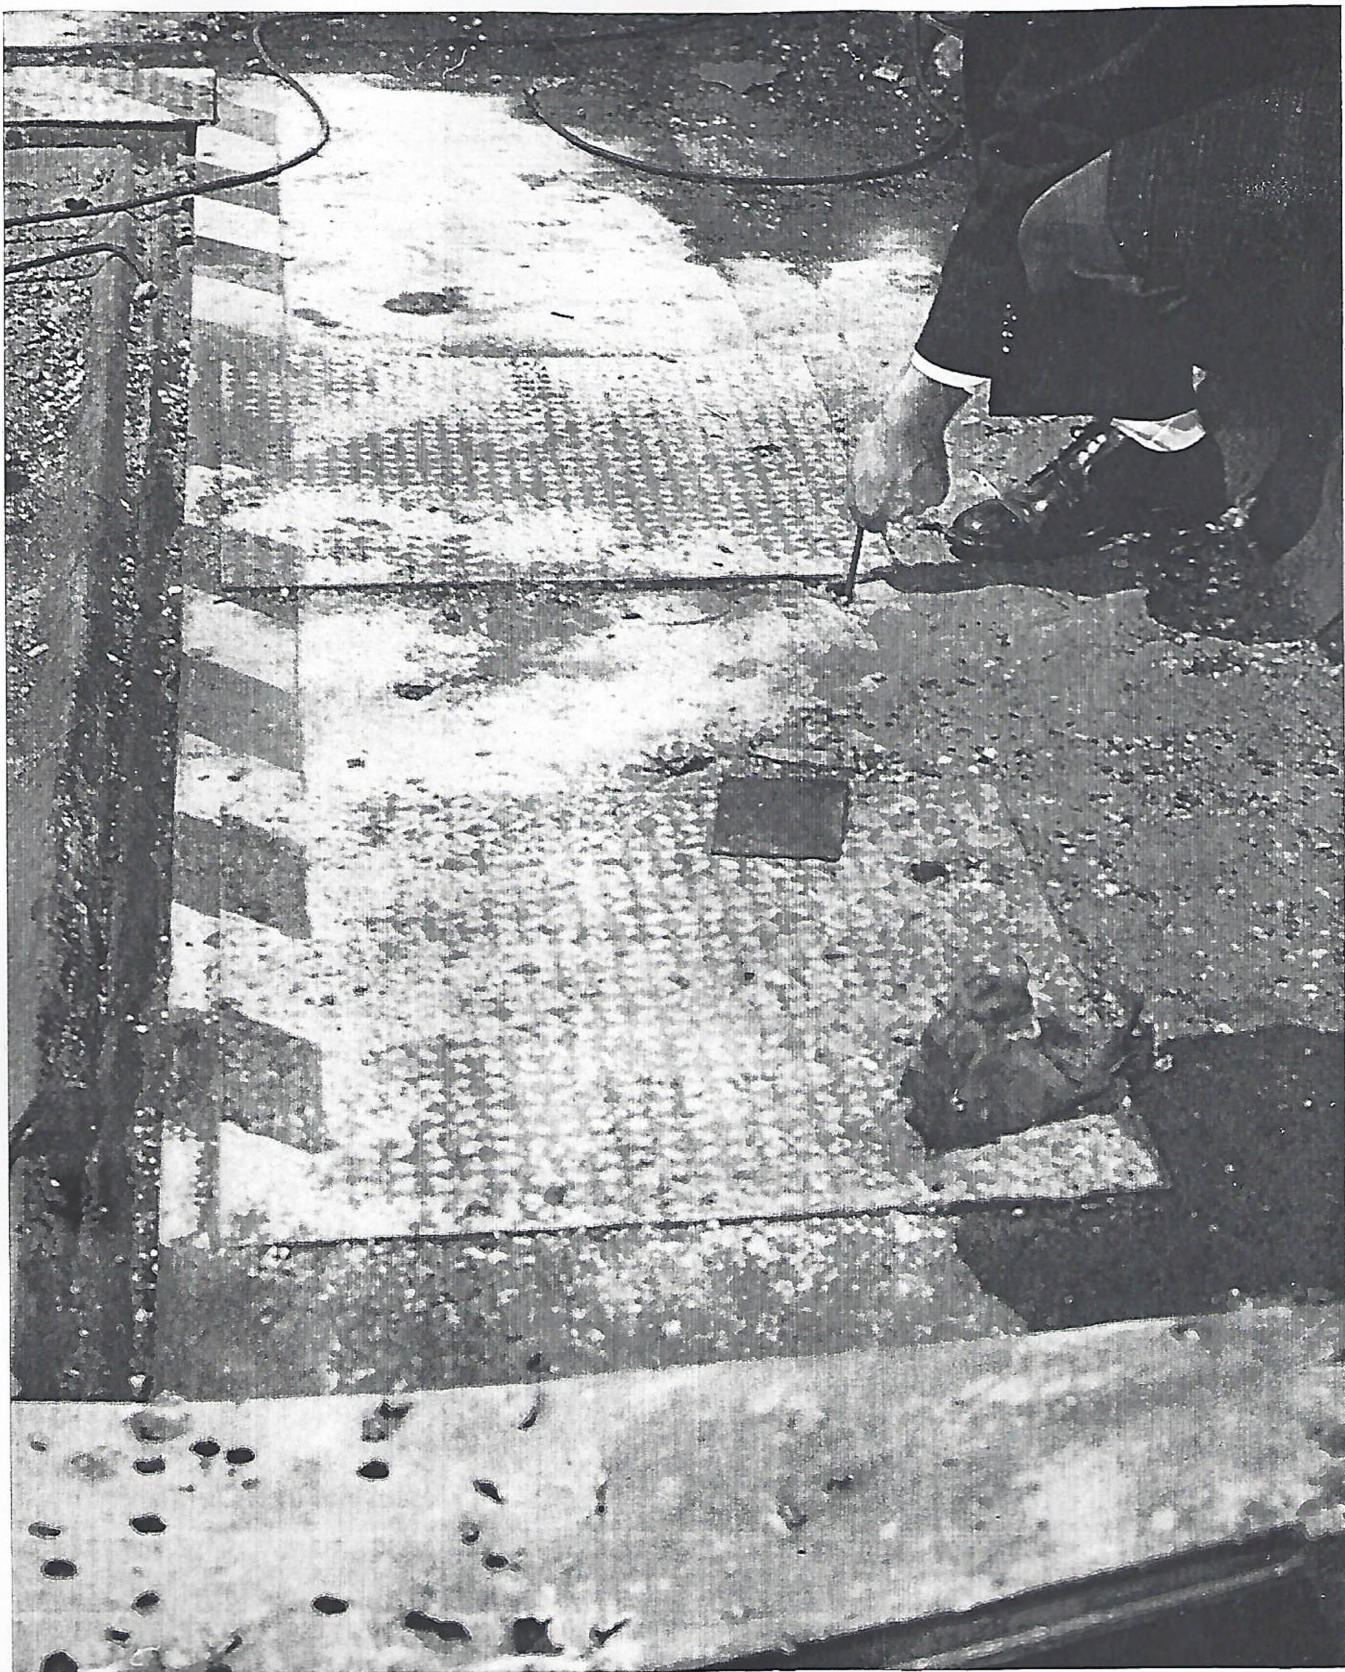
Leonardo, N. J. Neg No KA 1361-19
View showing hole in metal platform and damage
to elevator.
