DAMAGE REPORT, LEONARDO H.A.A.
SITE

DAMAGE REPORT - ENGINEER-CONSTRUCTED FACILITIES
STORAGE EXPLOSION OF 22 MAY 1958
LEONARDO AAA SITE

1. General: Representatives of the USAR District, New York, visited the Leonardo AAA Site at 1030 hours on 23 May 1958 to investigate and report on the extent of damage to Engineer-constructed facilities resulting from the explosion which occurred in the Launcher Area on 22 May 1958.

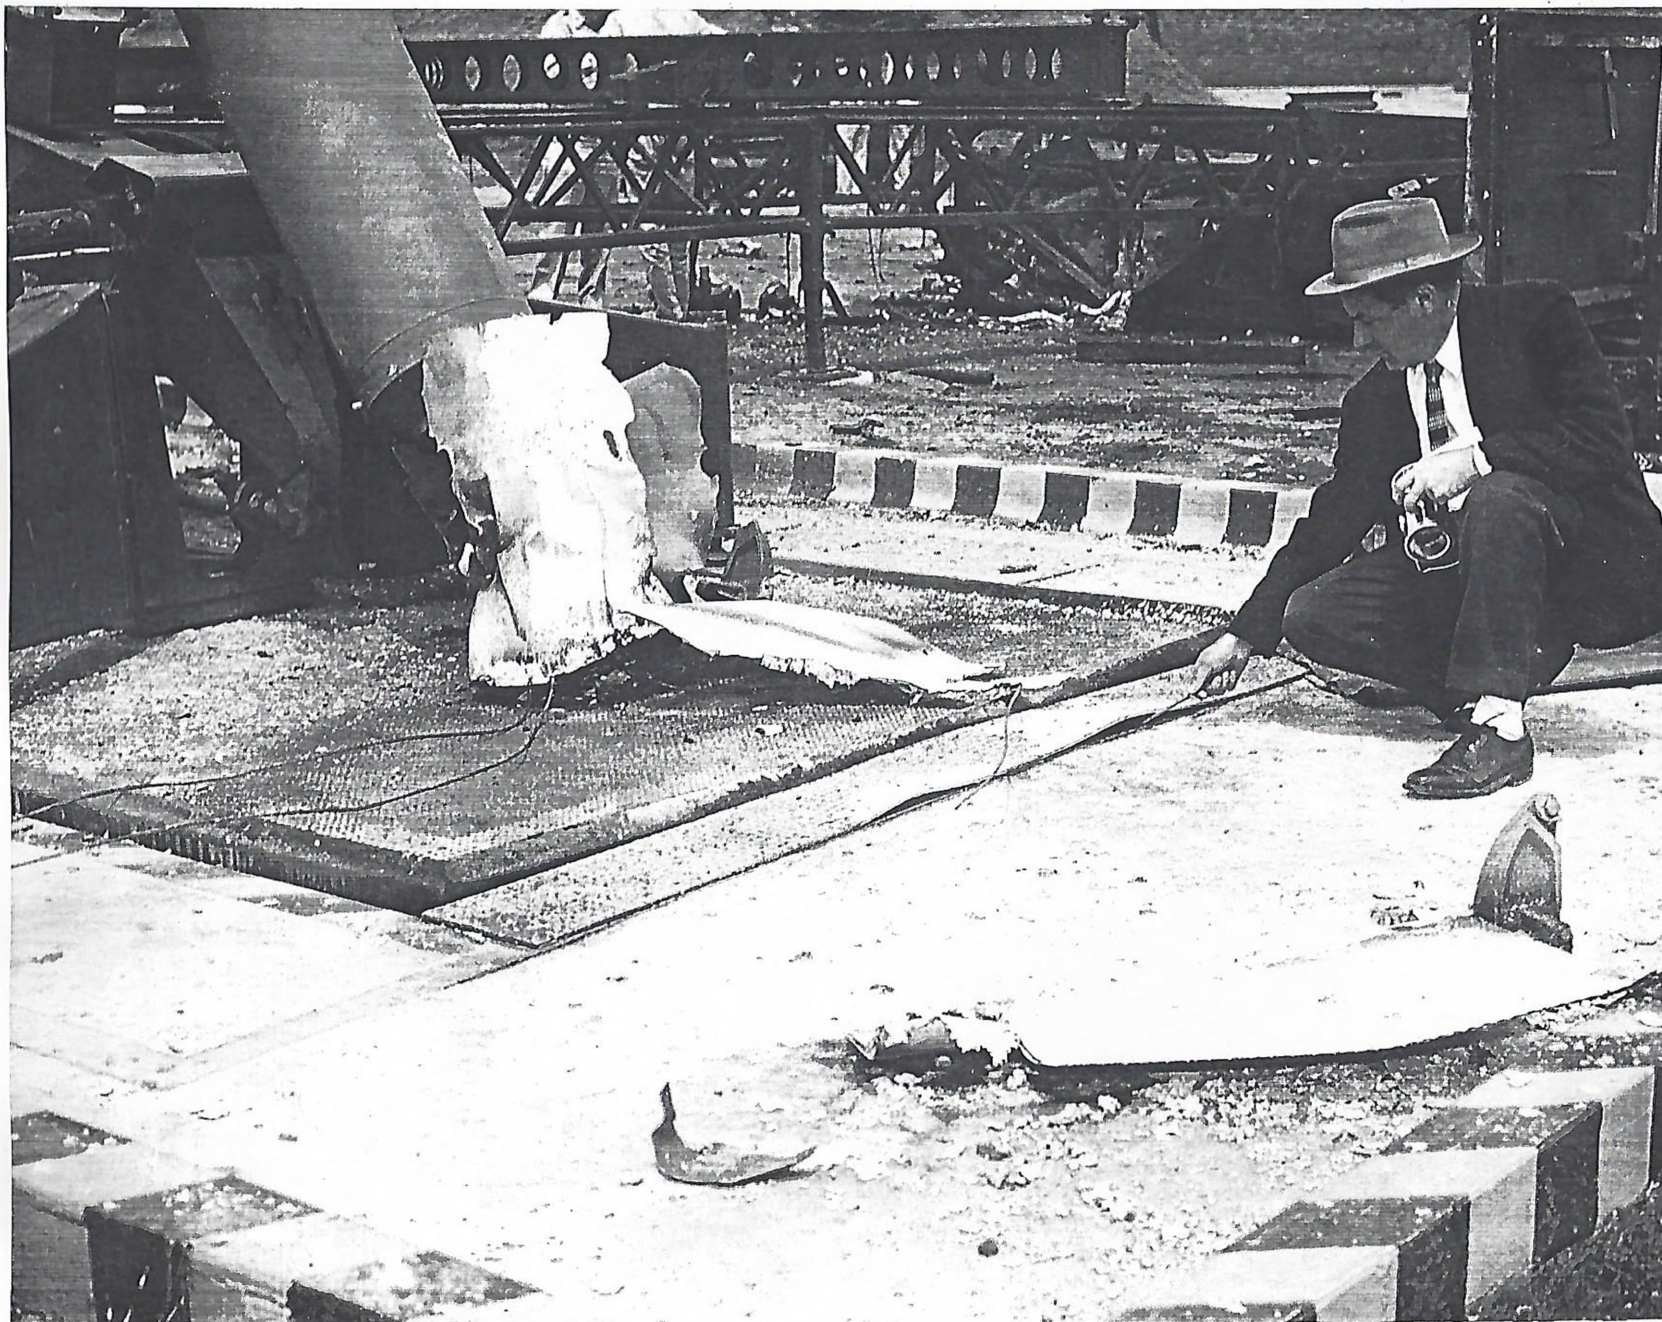
Neg No KA 1361-21

View showing damage to rear of Elevator platform
concrete chopped.

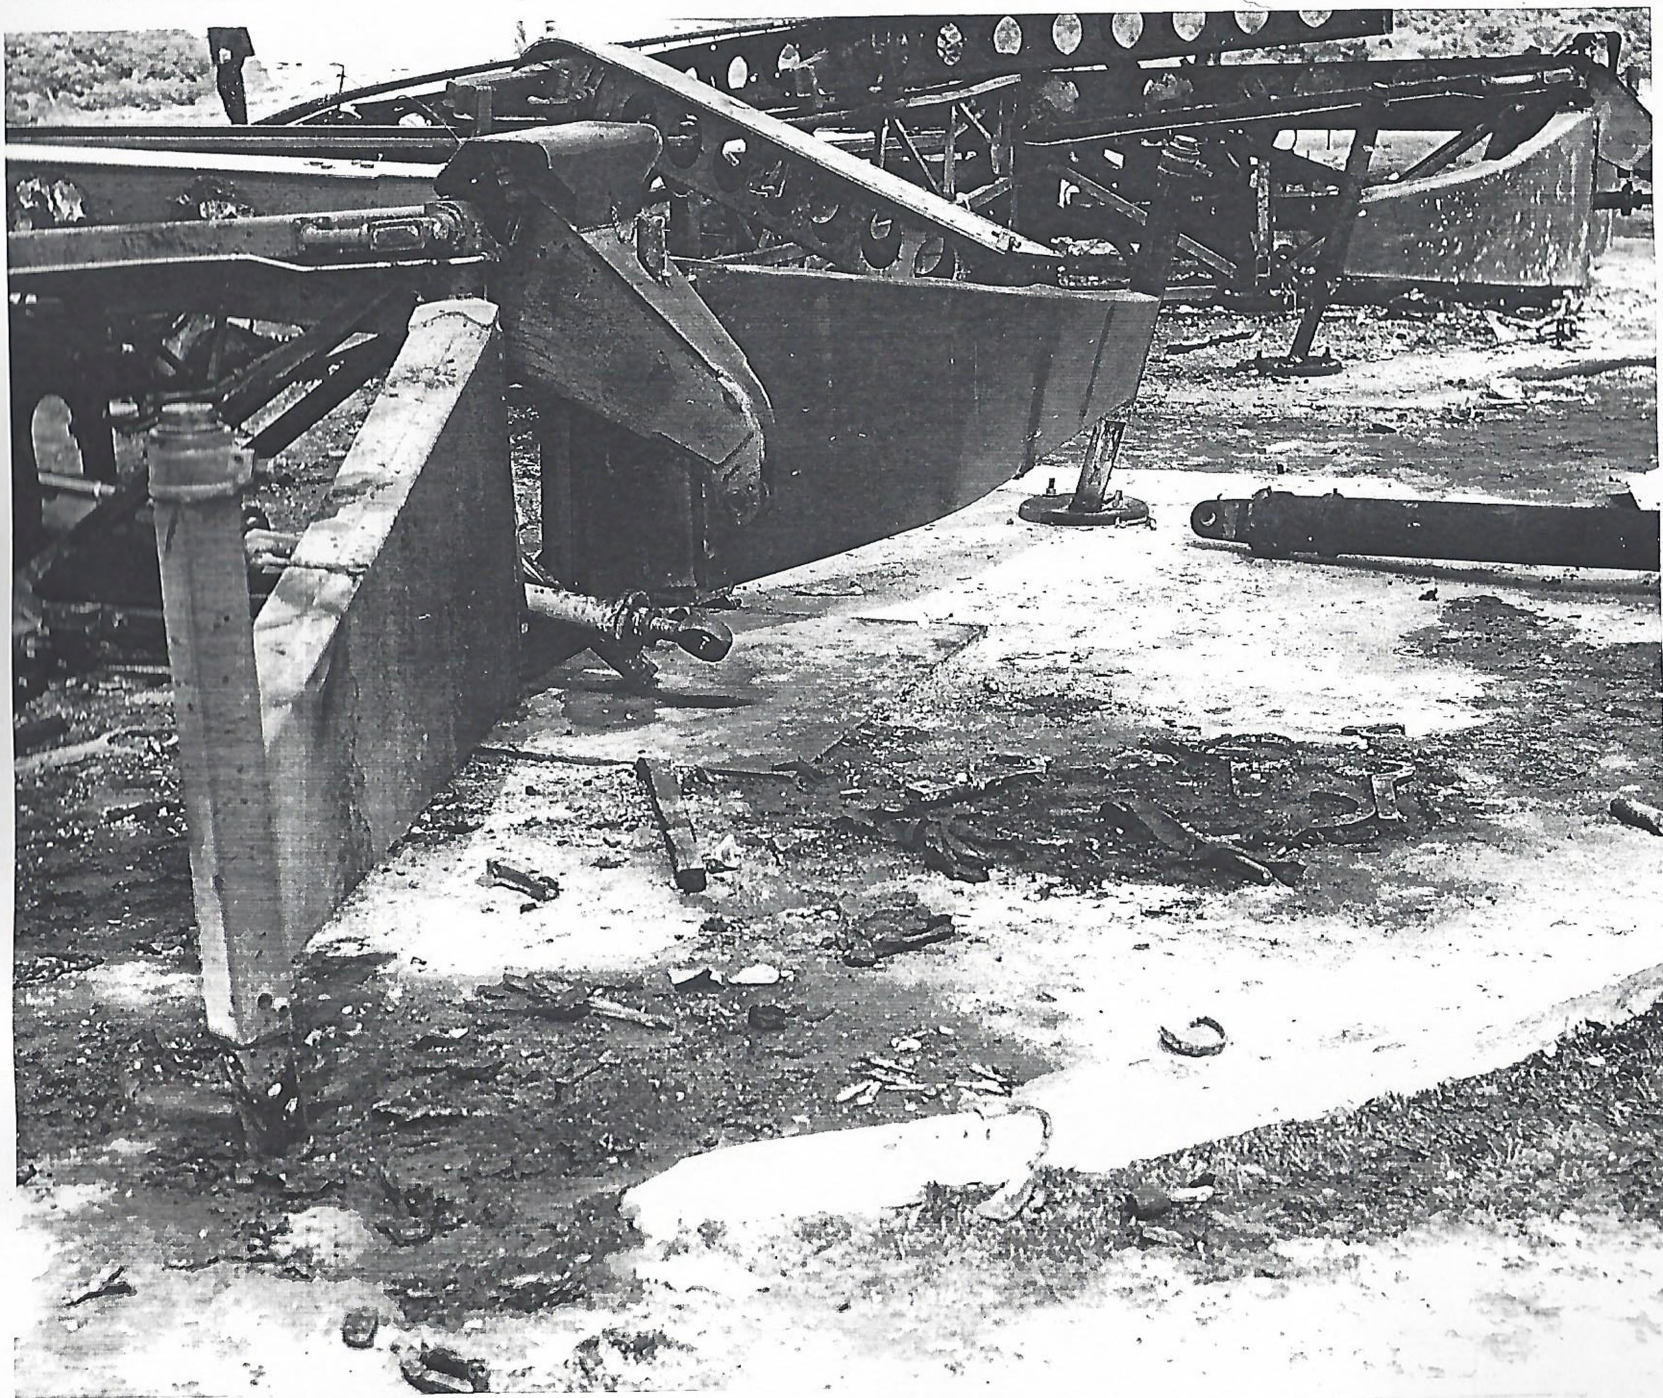
Leonardo, N. J. Neg No KA 1361-22
Rear of Launcher #3 showing pads and bolts
intact.

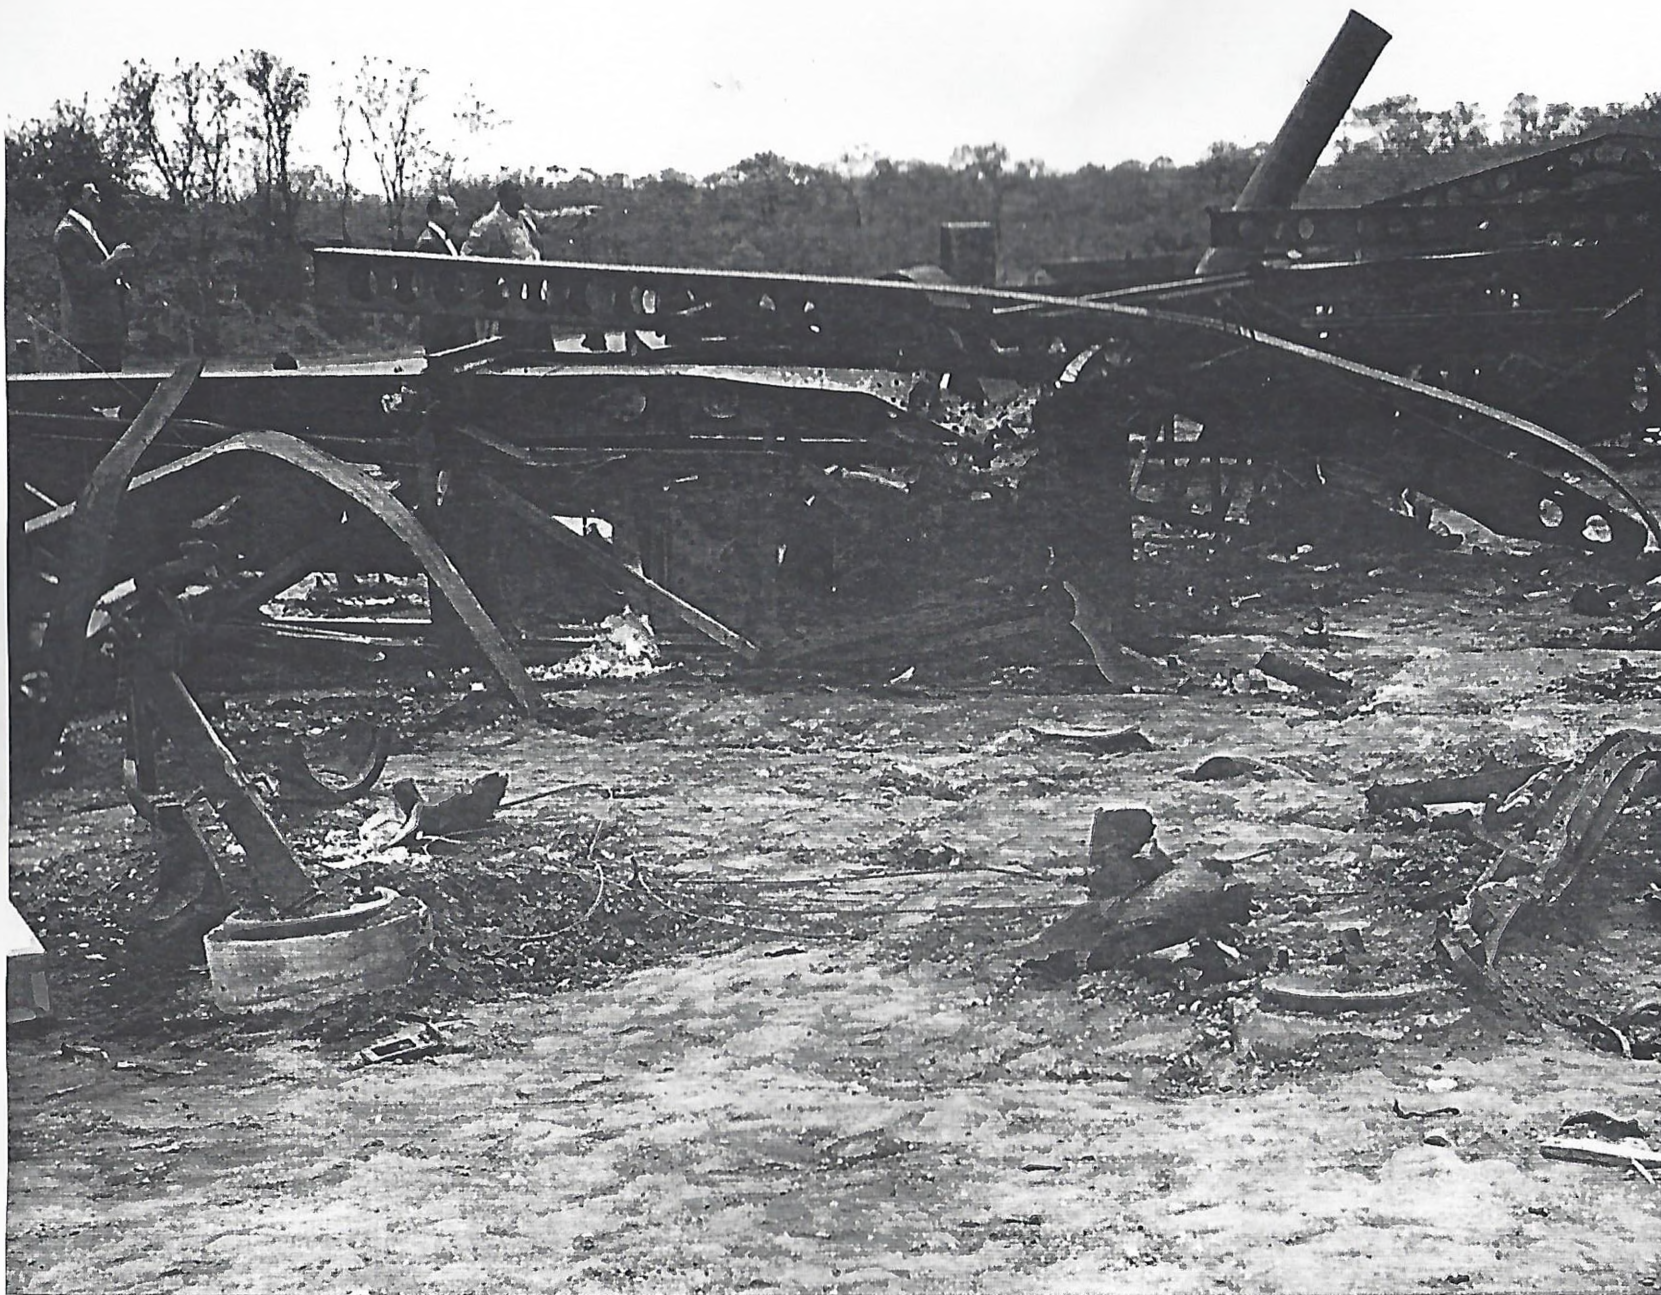
Leonardo, N. J. Neg No XA 1361-23
Front of Launcher #1, showing pads and bolts intact
concrete walk damaged.

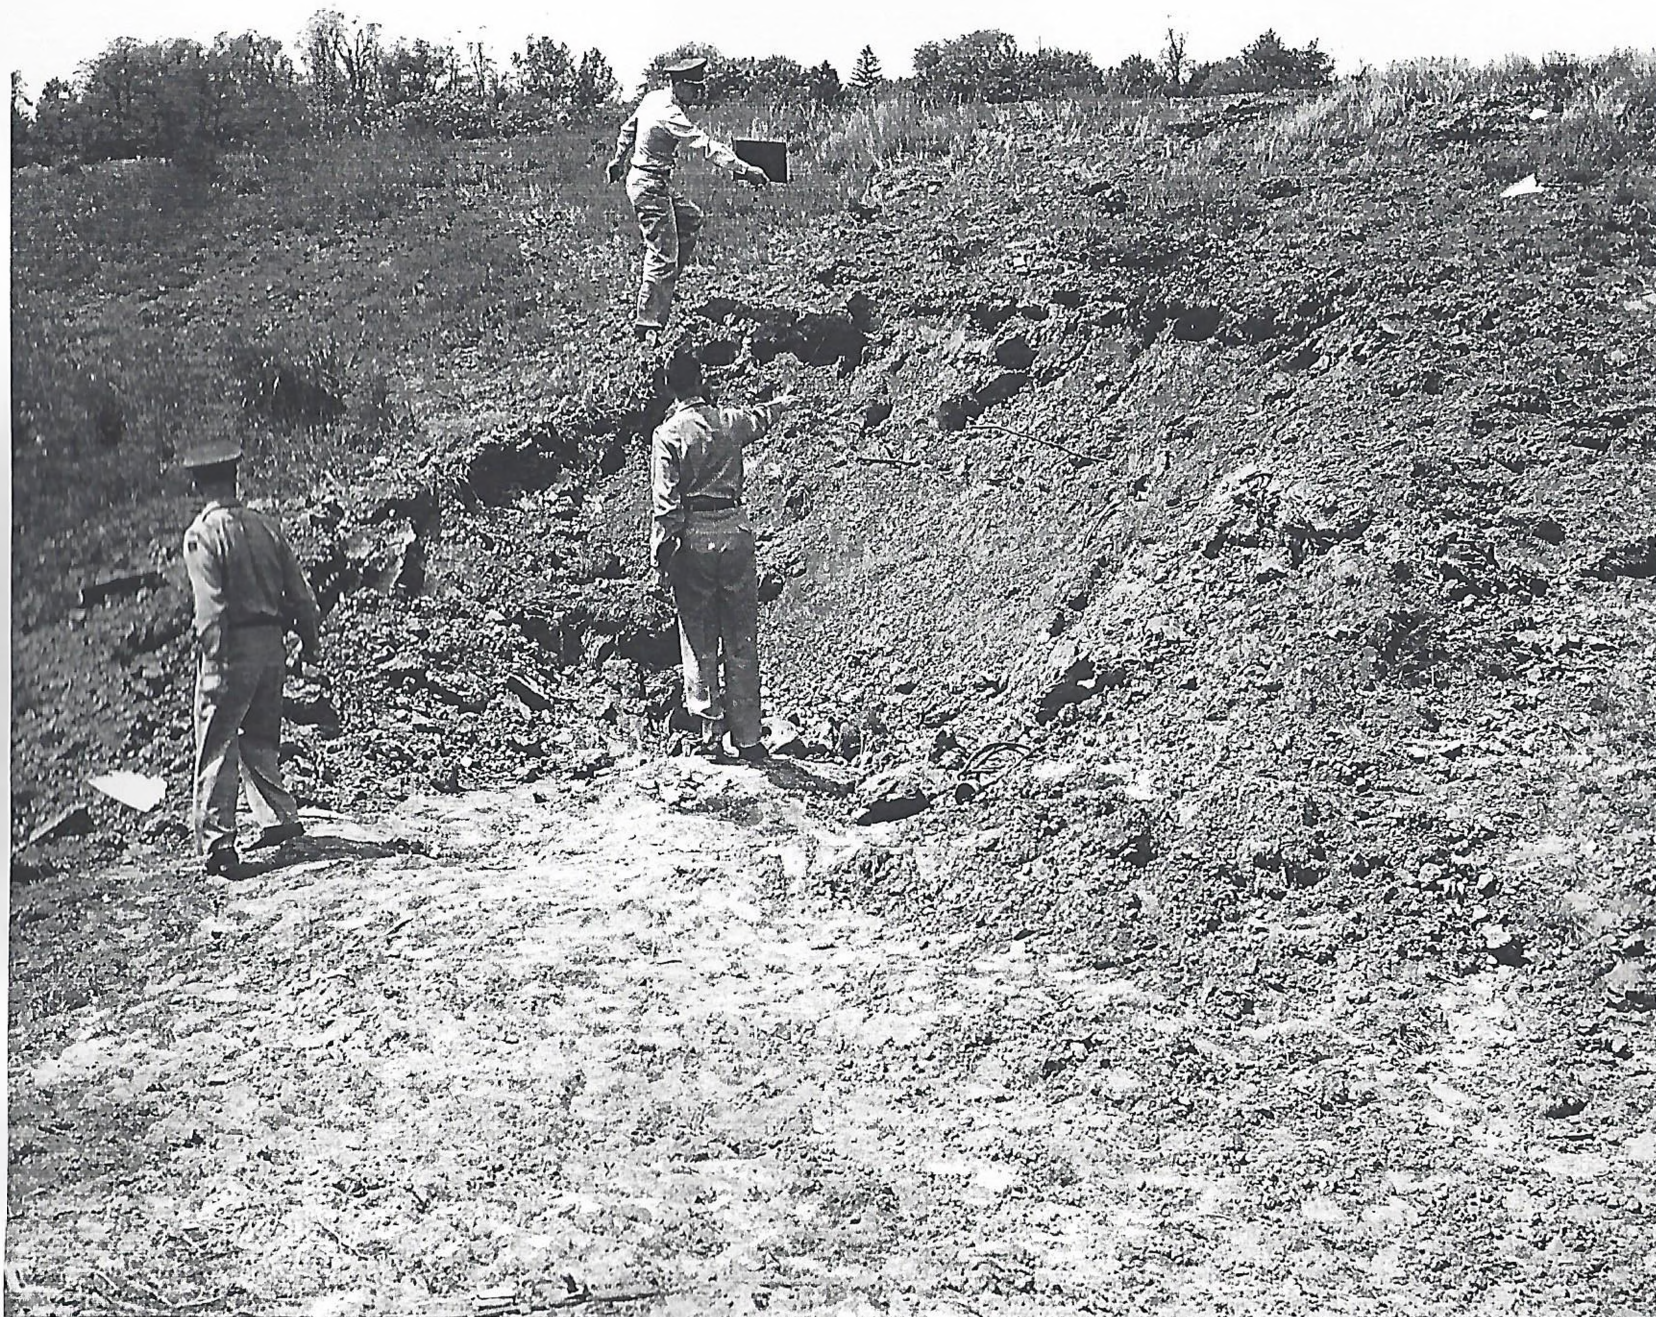
Neg No KA 1361-24.

Leonardo, N.J.
View showing hole dug in embankment.

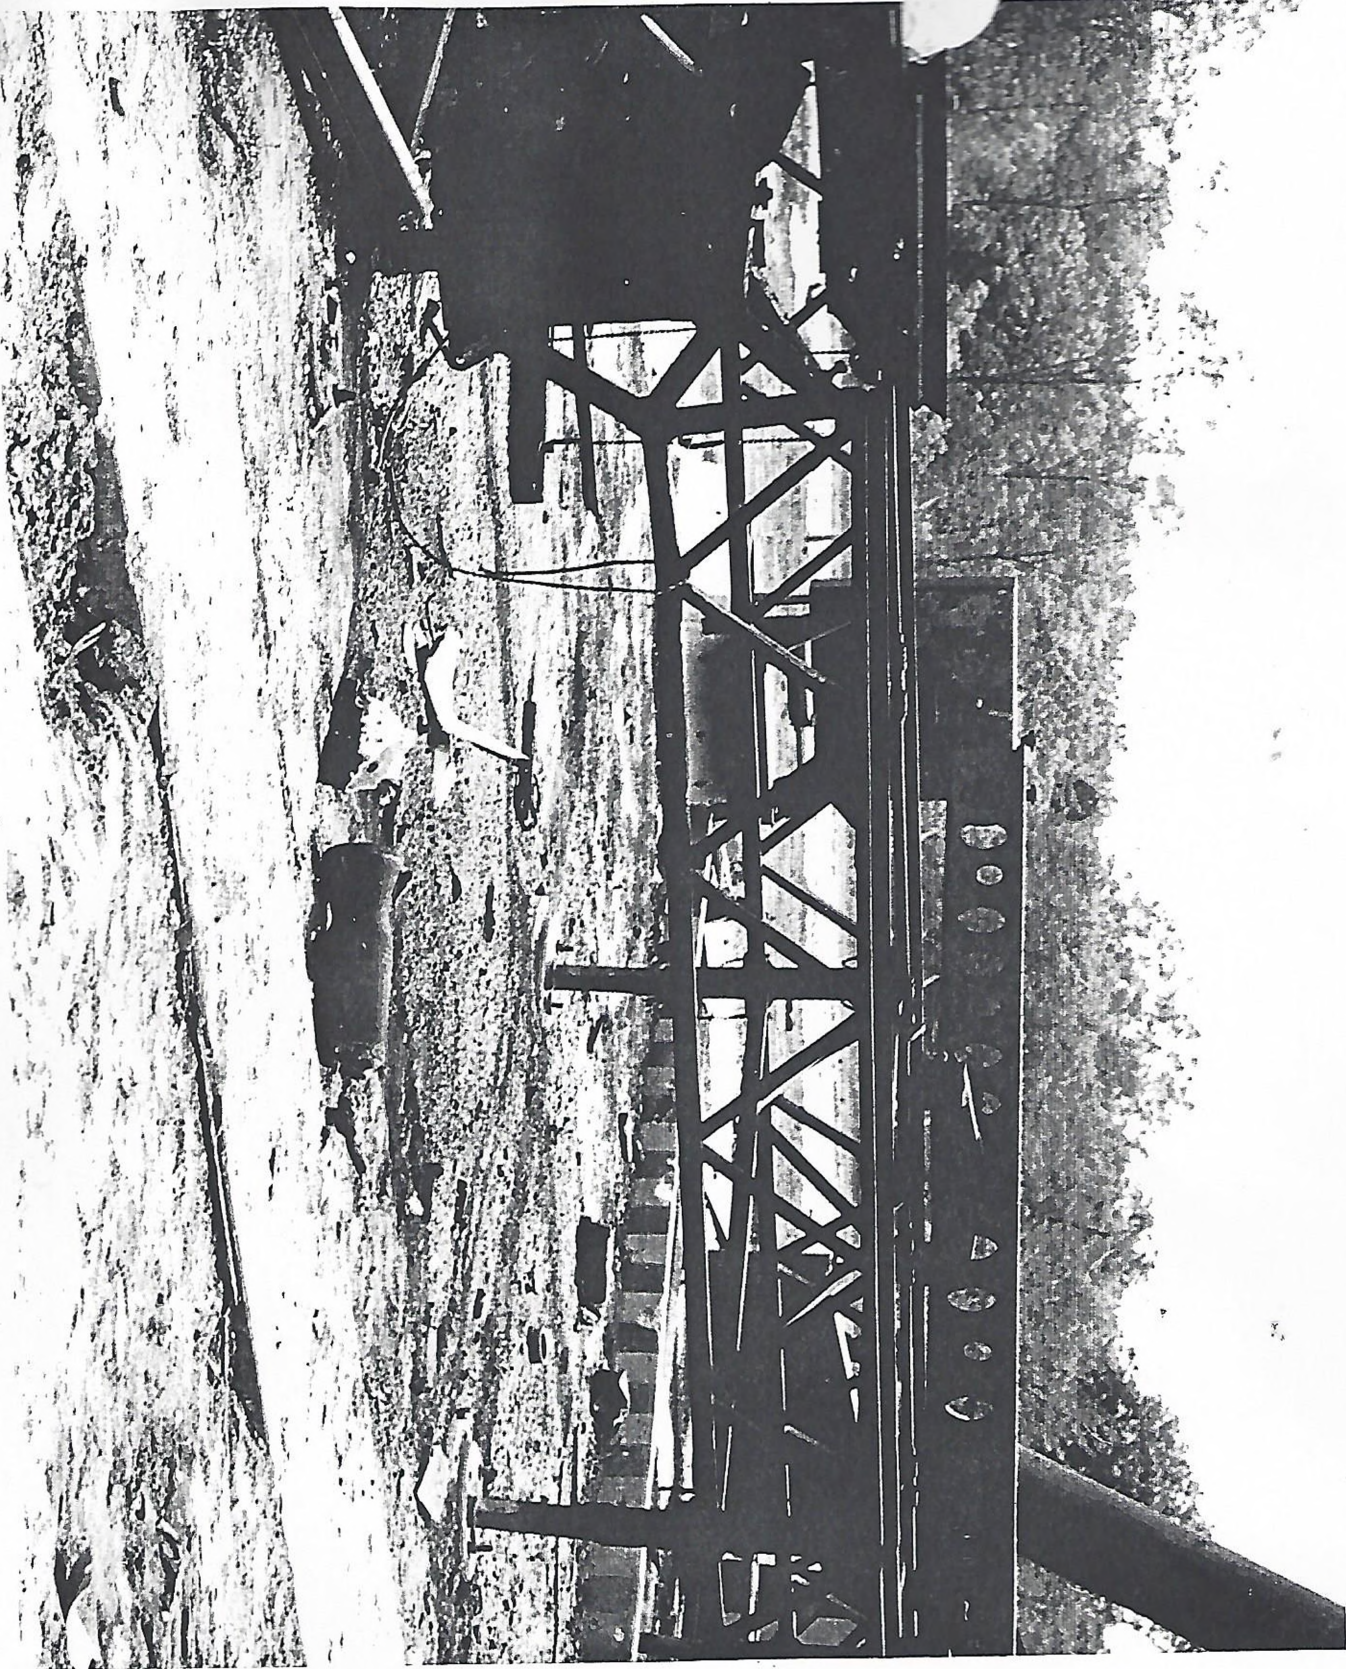
Leonardo, N. J.
Front of Launcher #3 showing damaged concrete walk
Neg No LA 1361-25

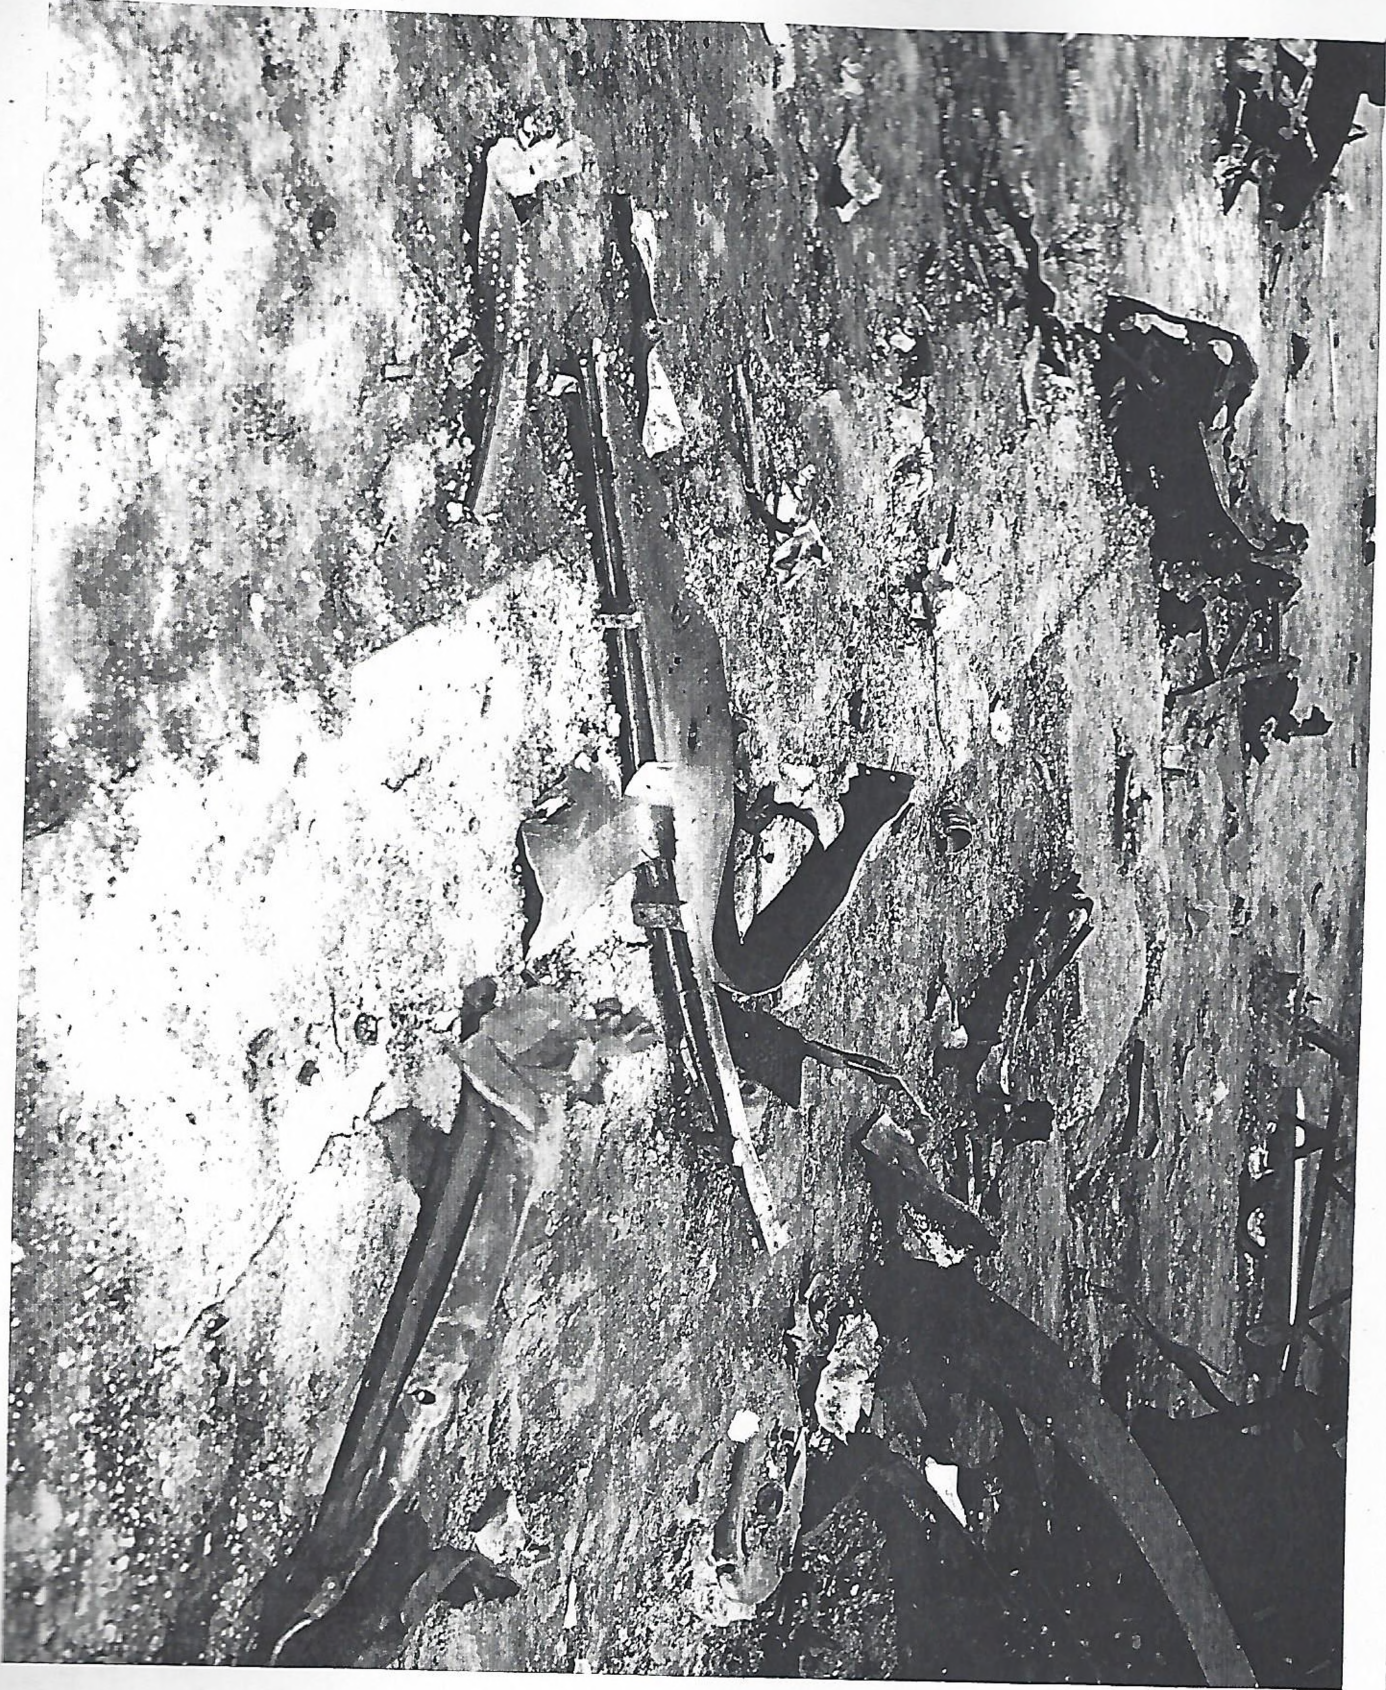
Reg No LA 1361-26

Front of Launchers showing concrete walk damaged.

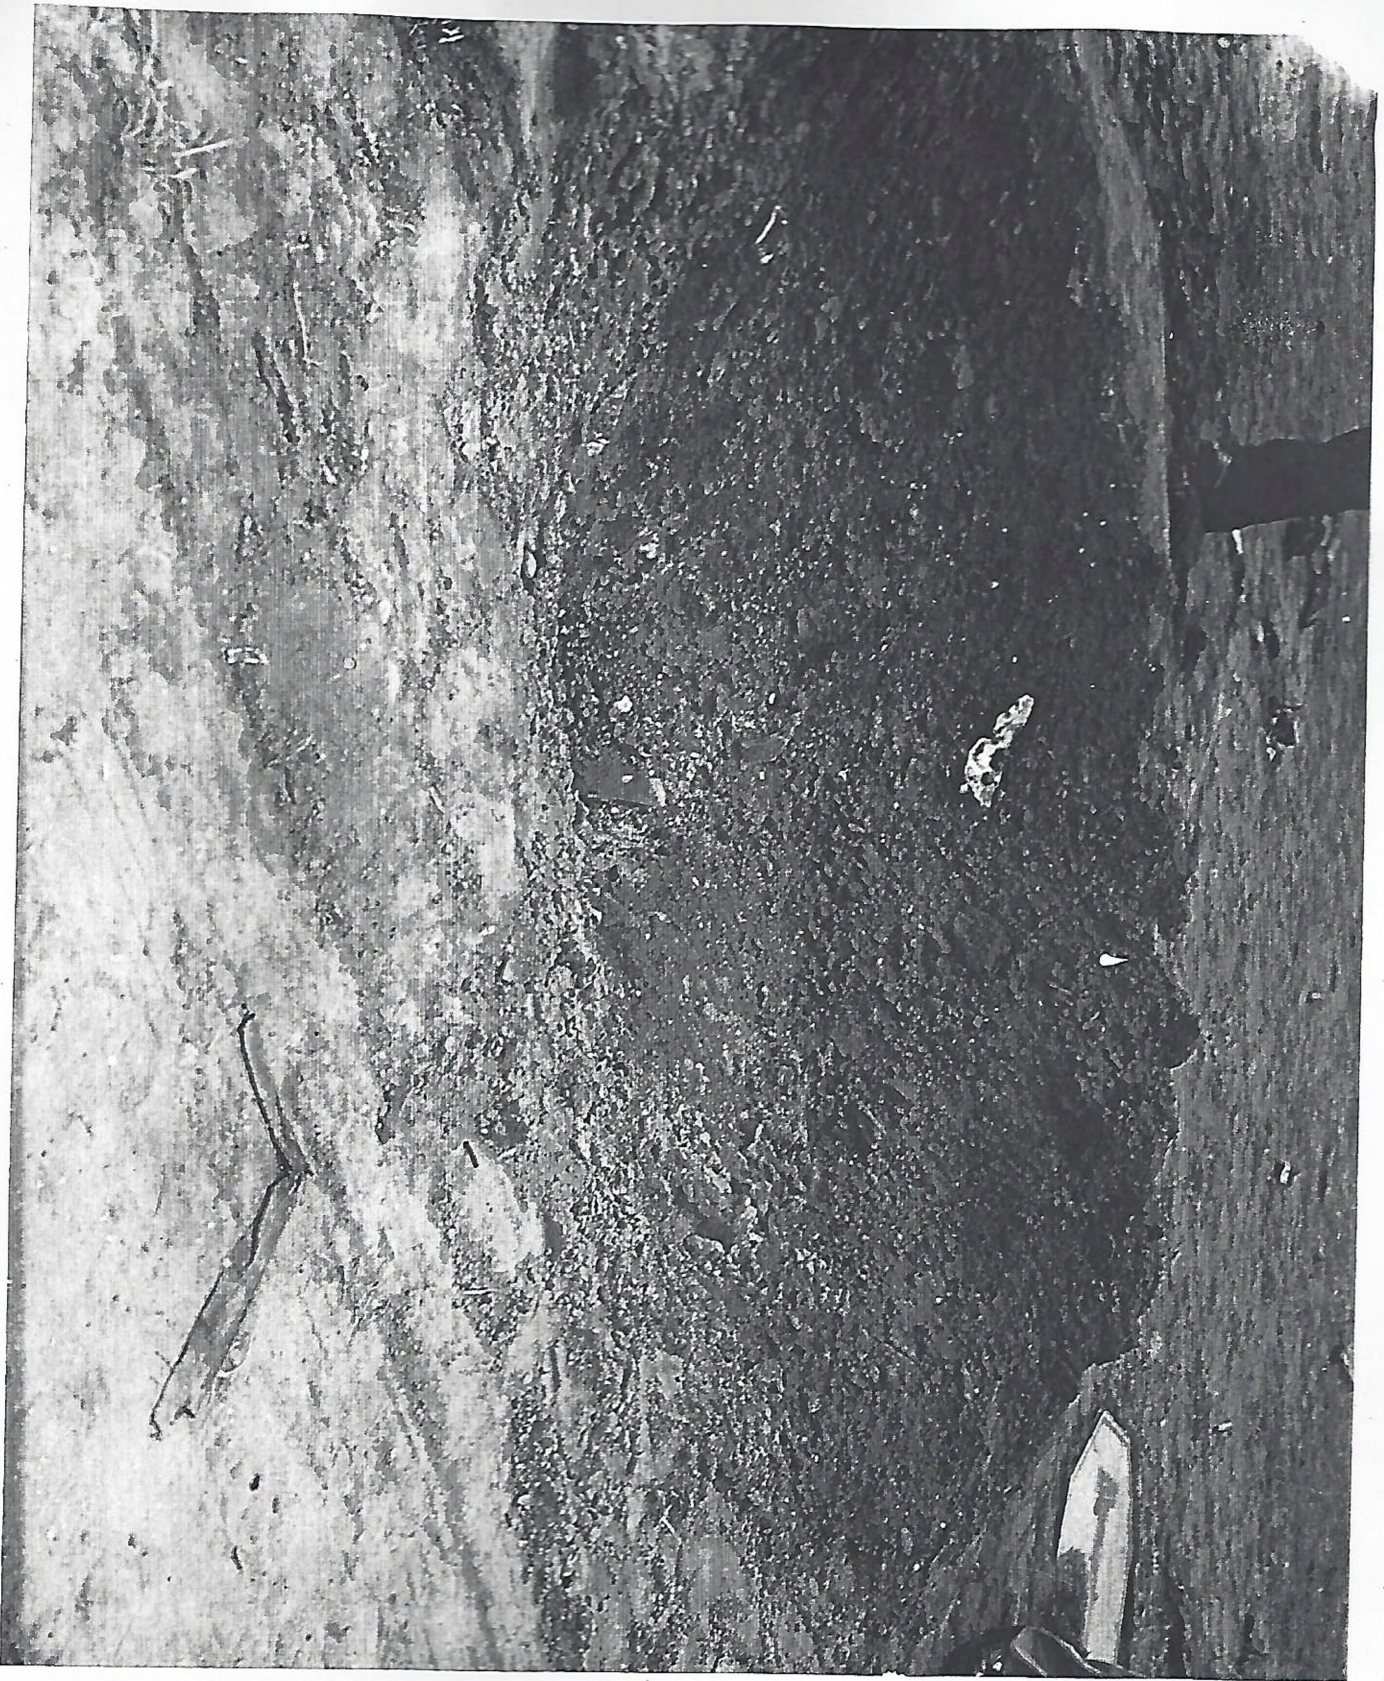
Box No RA 1361-27

View of Hol. ^{Ligonardo, M. J.} in front of launchers.

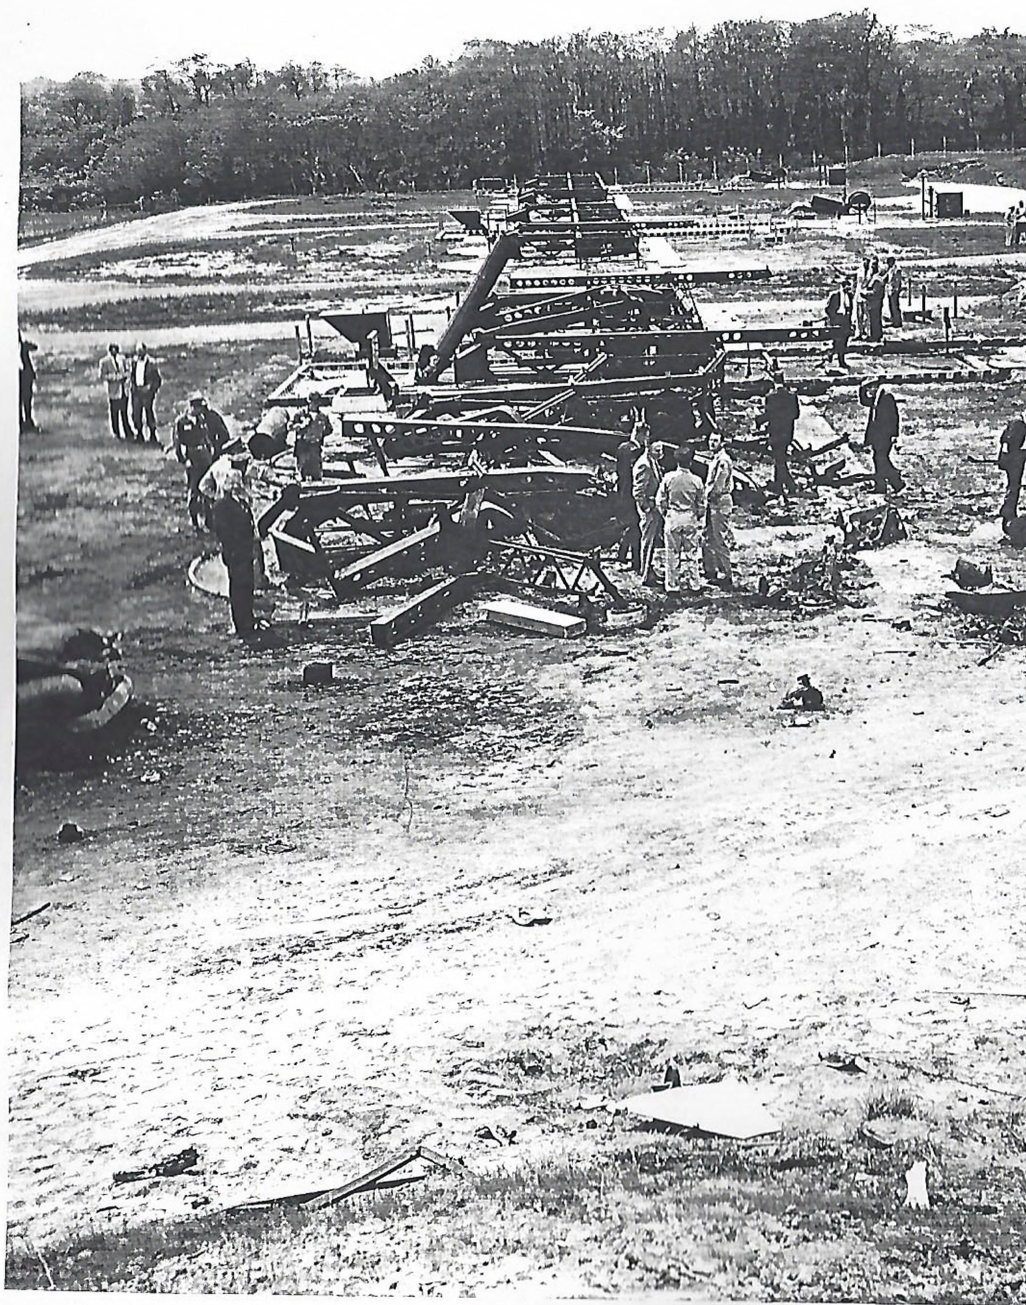
Neg No XA 1361-28

Leonardo, N. J.
Gen. view showing overall damage.

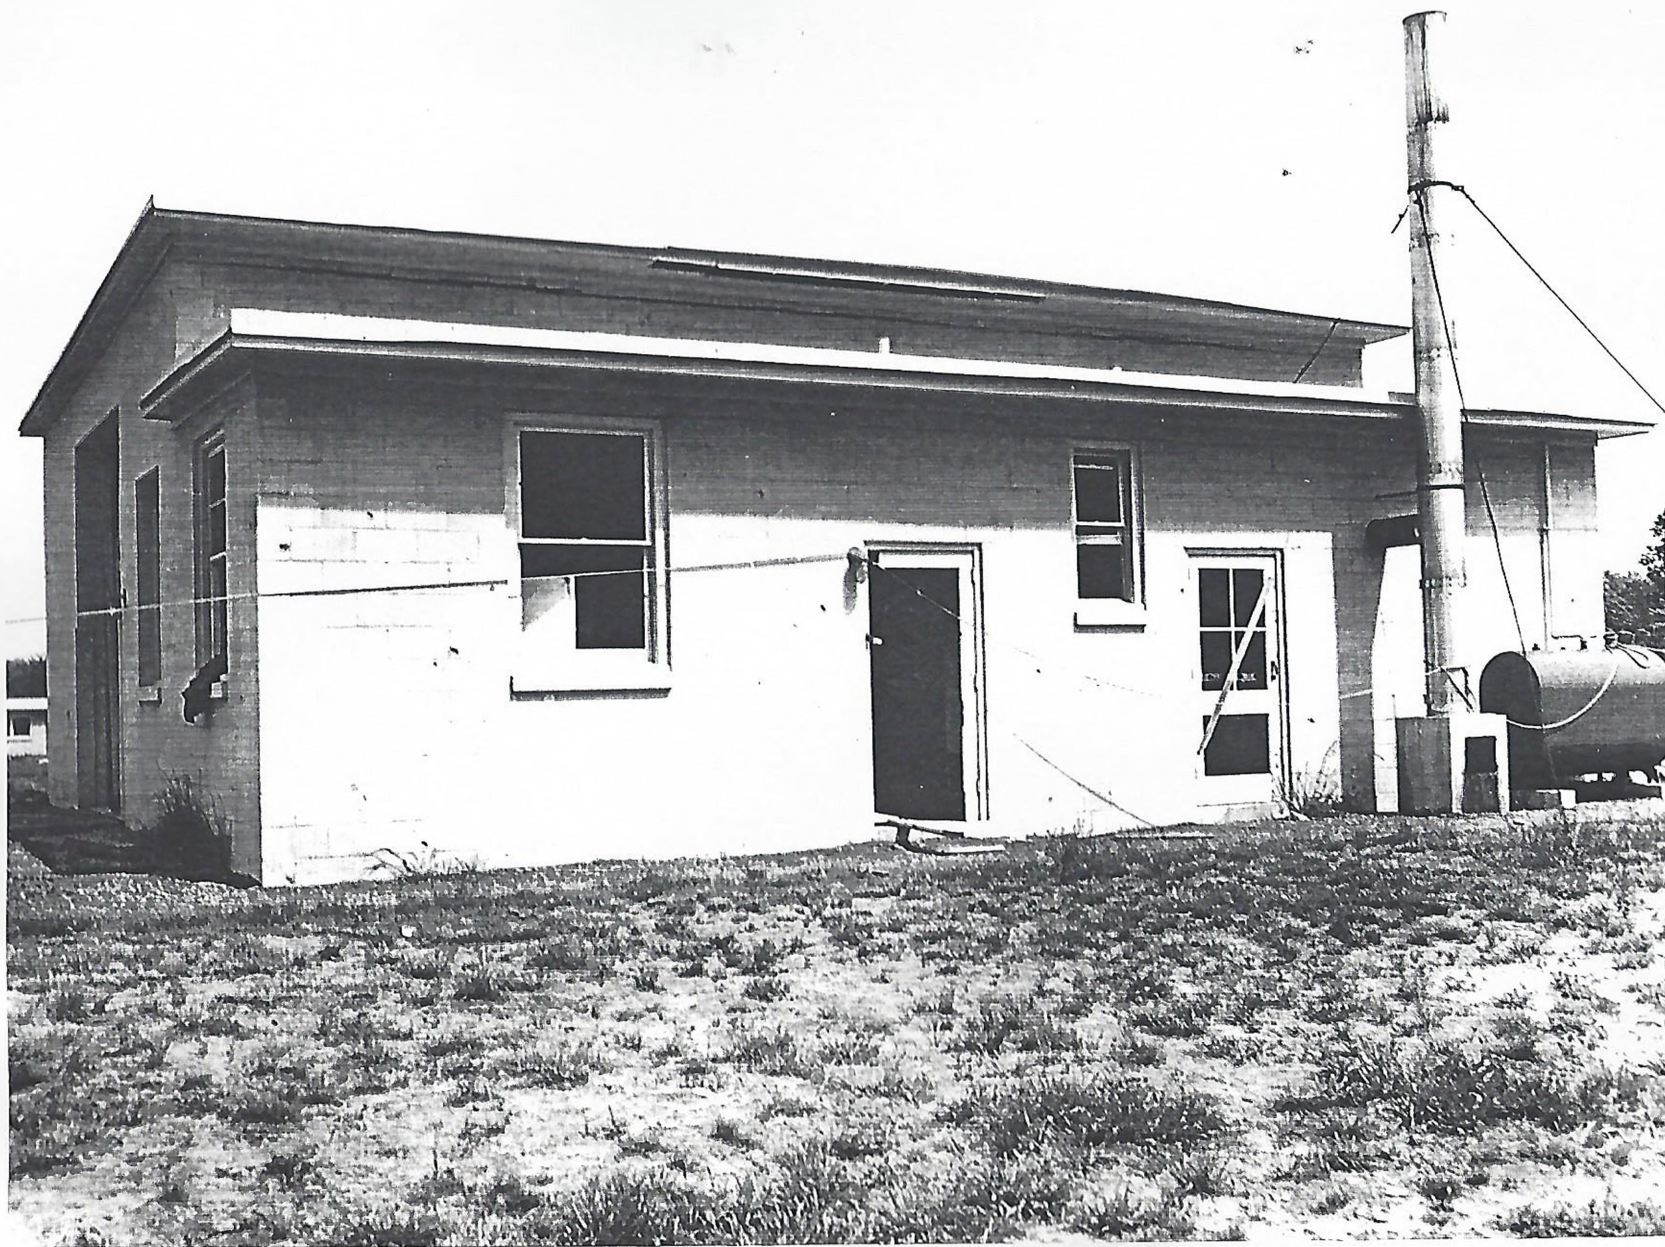
Leonardo, N. J. Neg No KA 1361-31
View of 1st and side of Missile Assembly Bldg
showing separation at roof and other damage.

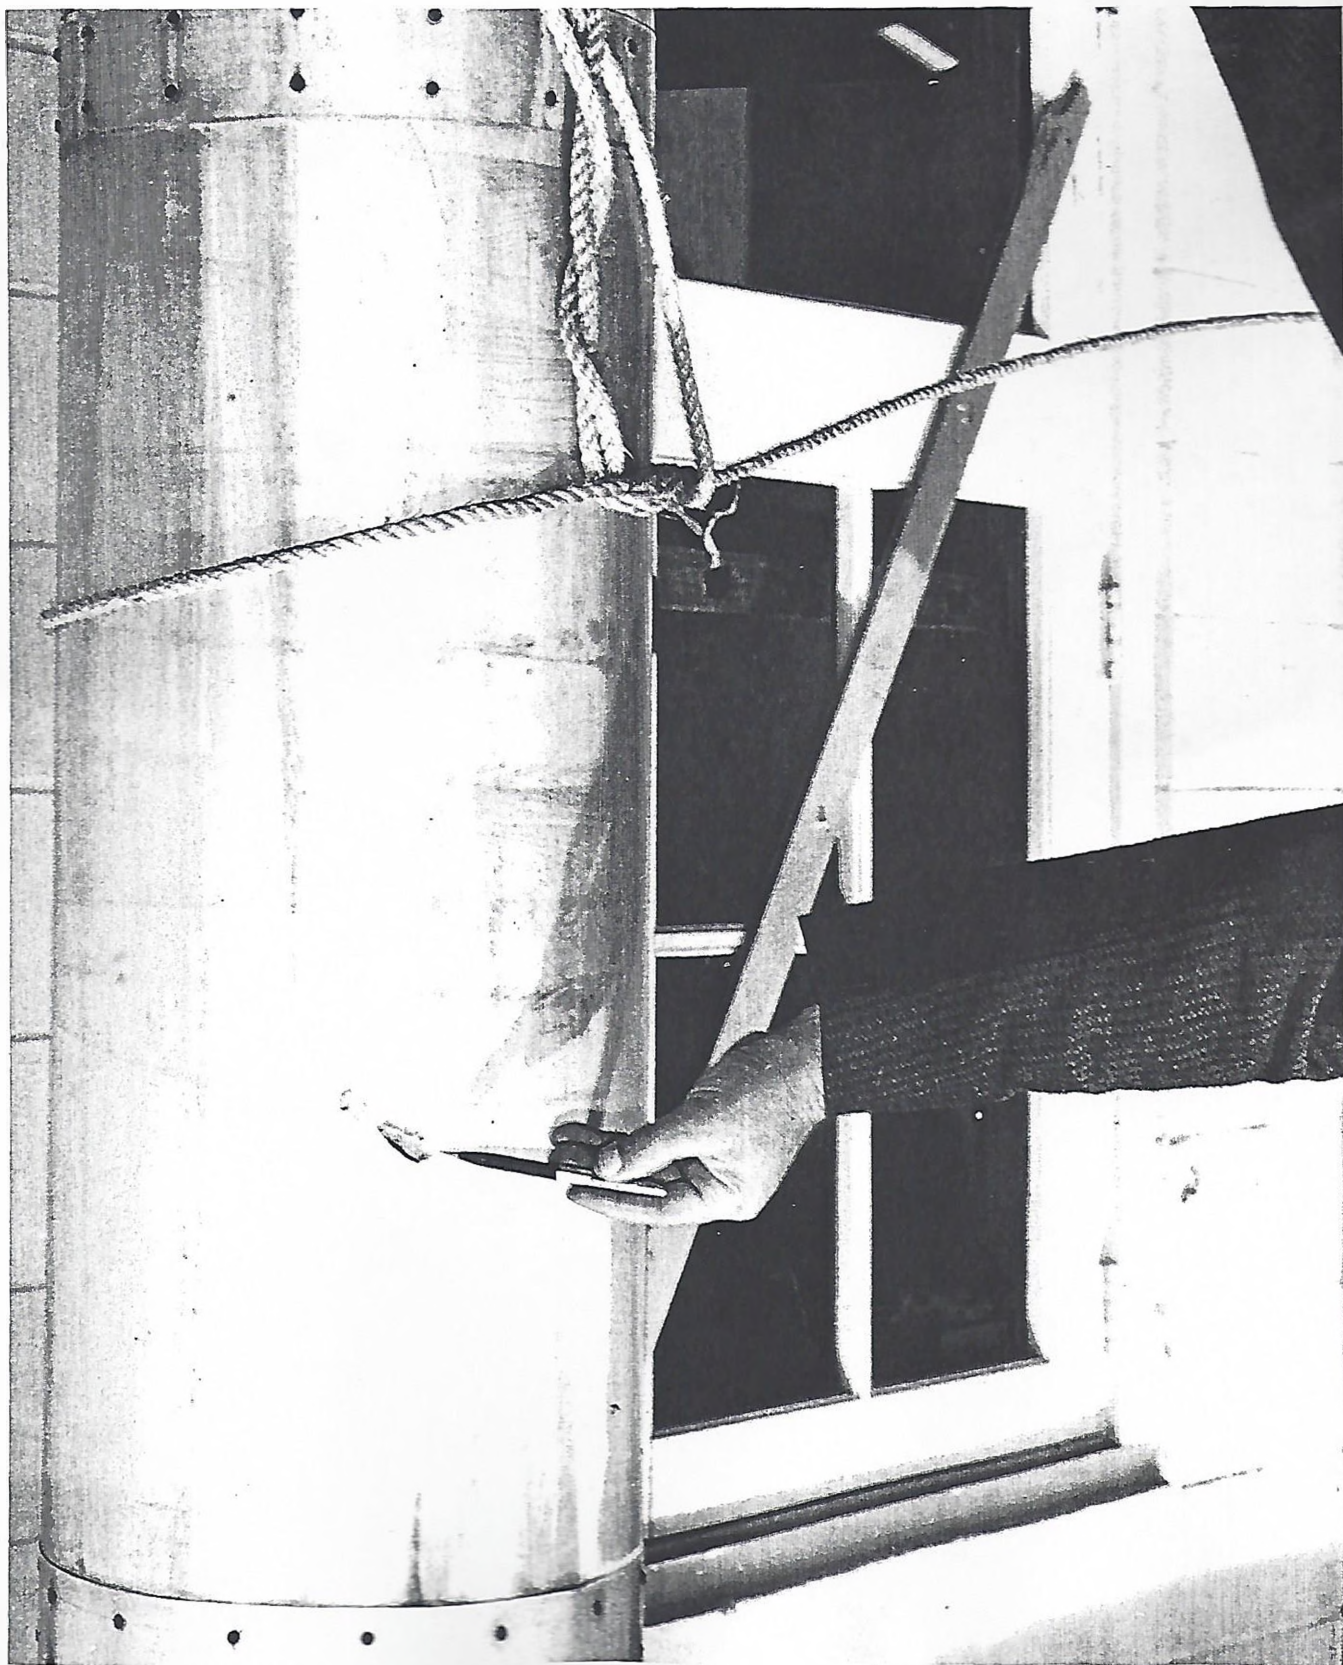
Leonardo, H.J.
Neg No KA 1671-72
View showing damage to chimney, Missile Assembly
Bldg.
