DAMAGE REPORT, LEONARDO H.A.A.
SITE

DAMAGE REPORT - ENGINEER-CONSTRUCTED FACILITIES
STORAGE EXPLOSION OF 22 MAY 1958
LEONARDO AAA SITE

1. General: Representatives of the USAR District, New York, visited the Leonardo AAA Site at 1030 hours on 23 May 1958 to investigate and report on the extent of damage to Engineer-constructed facilities resulting from the explosion which occurred in the Launcher Area on 22 May 1958.

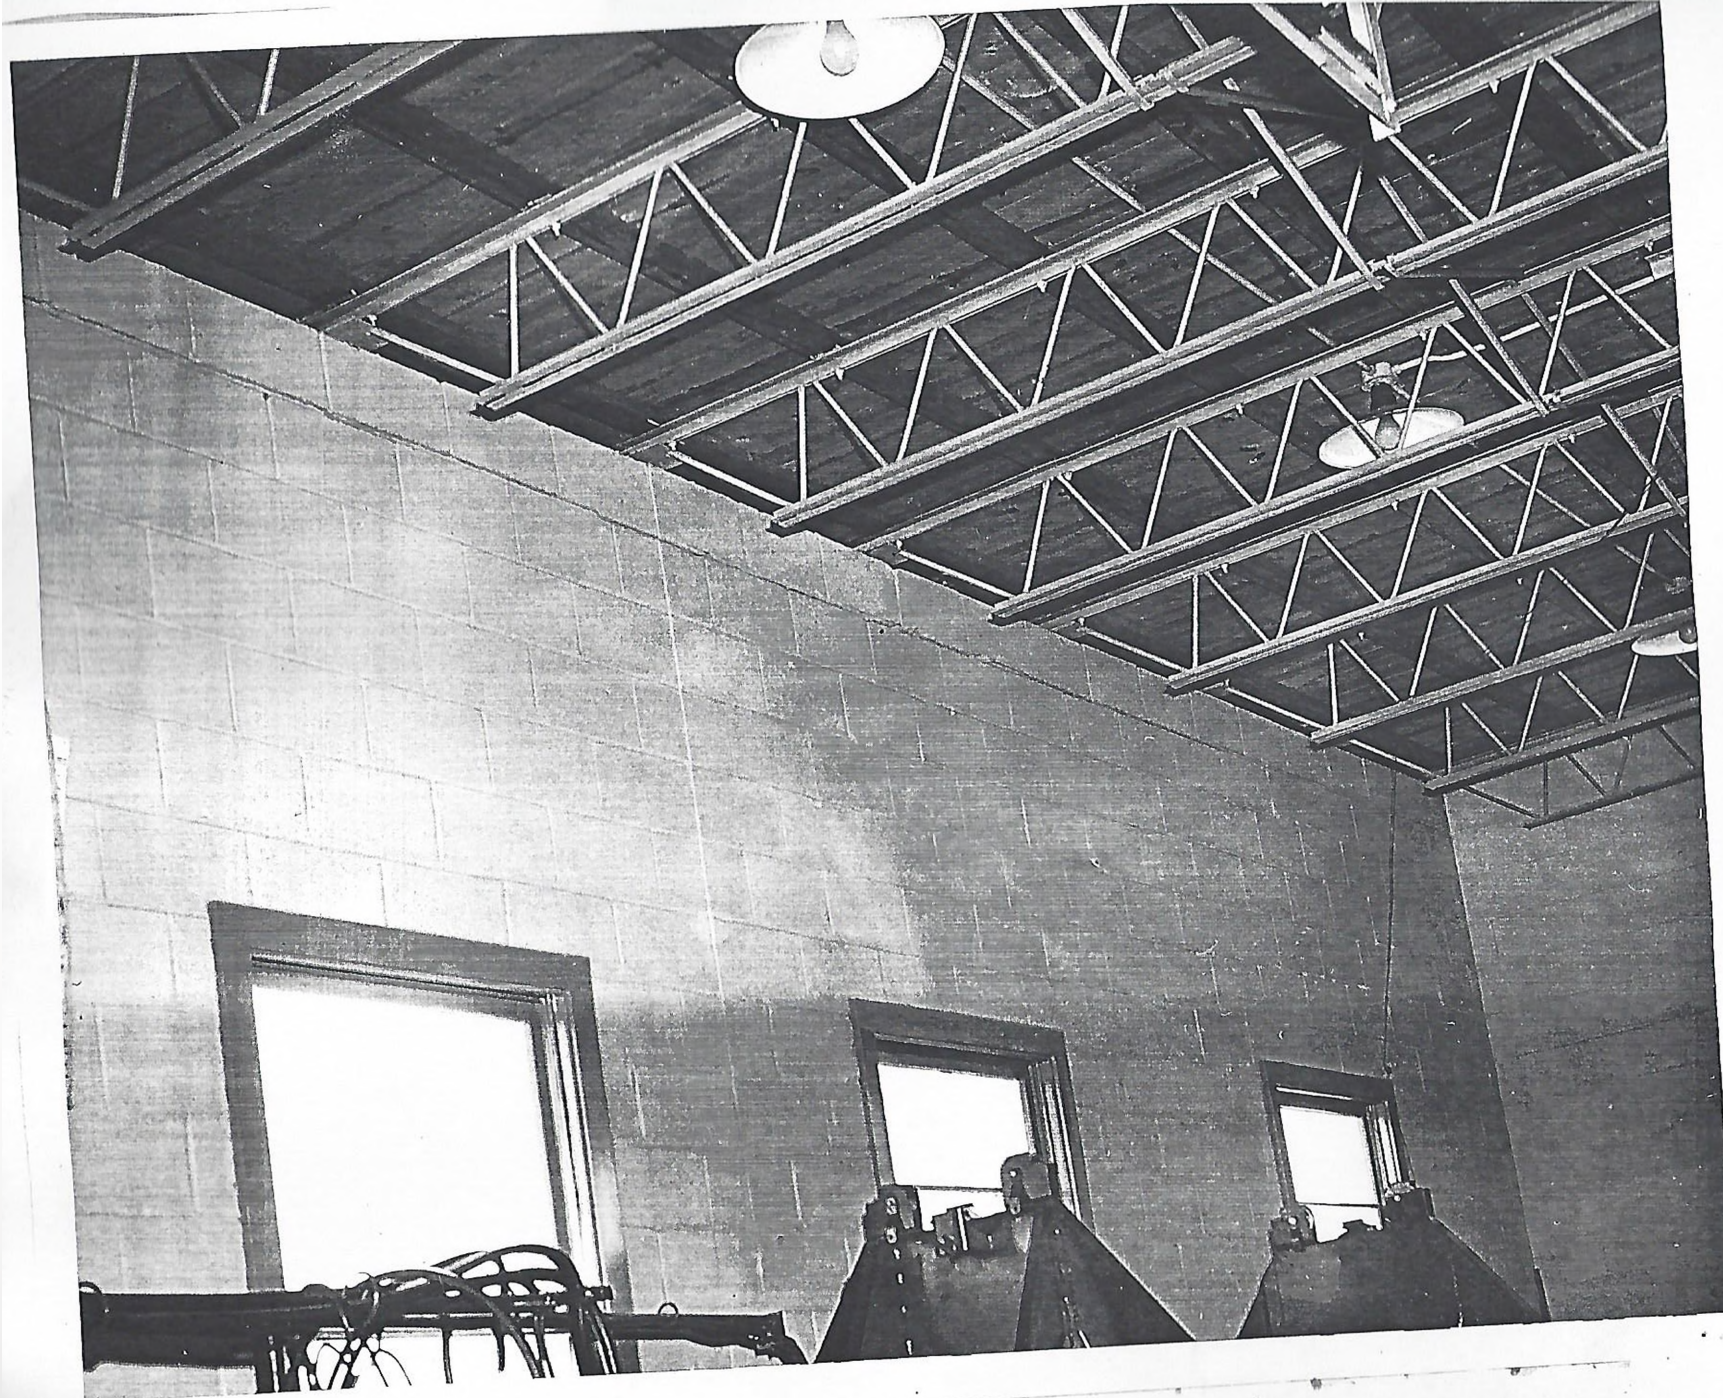
Leonardo, N. J. Neg No KA 1361-33
View showing break in wall of Missile Assembly
Bldg.

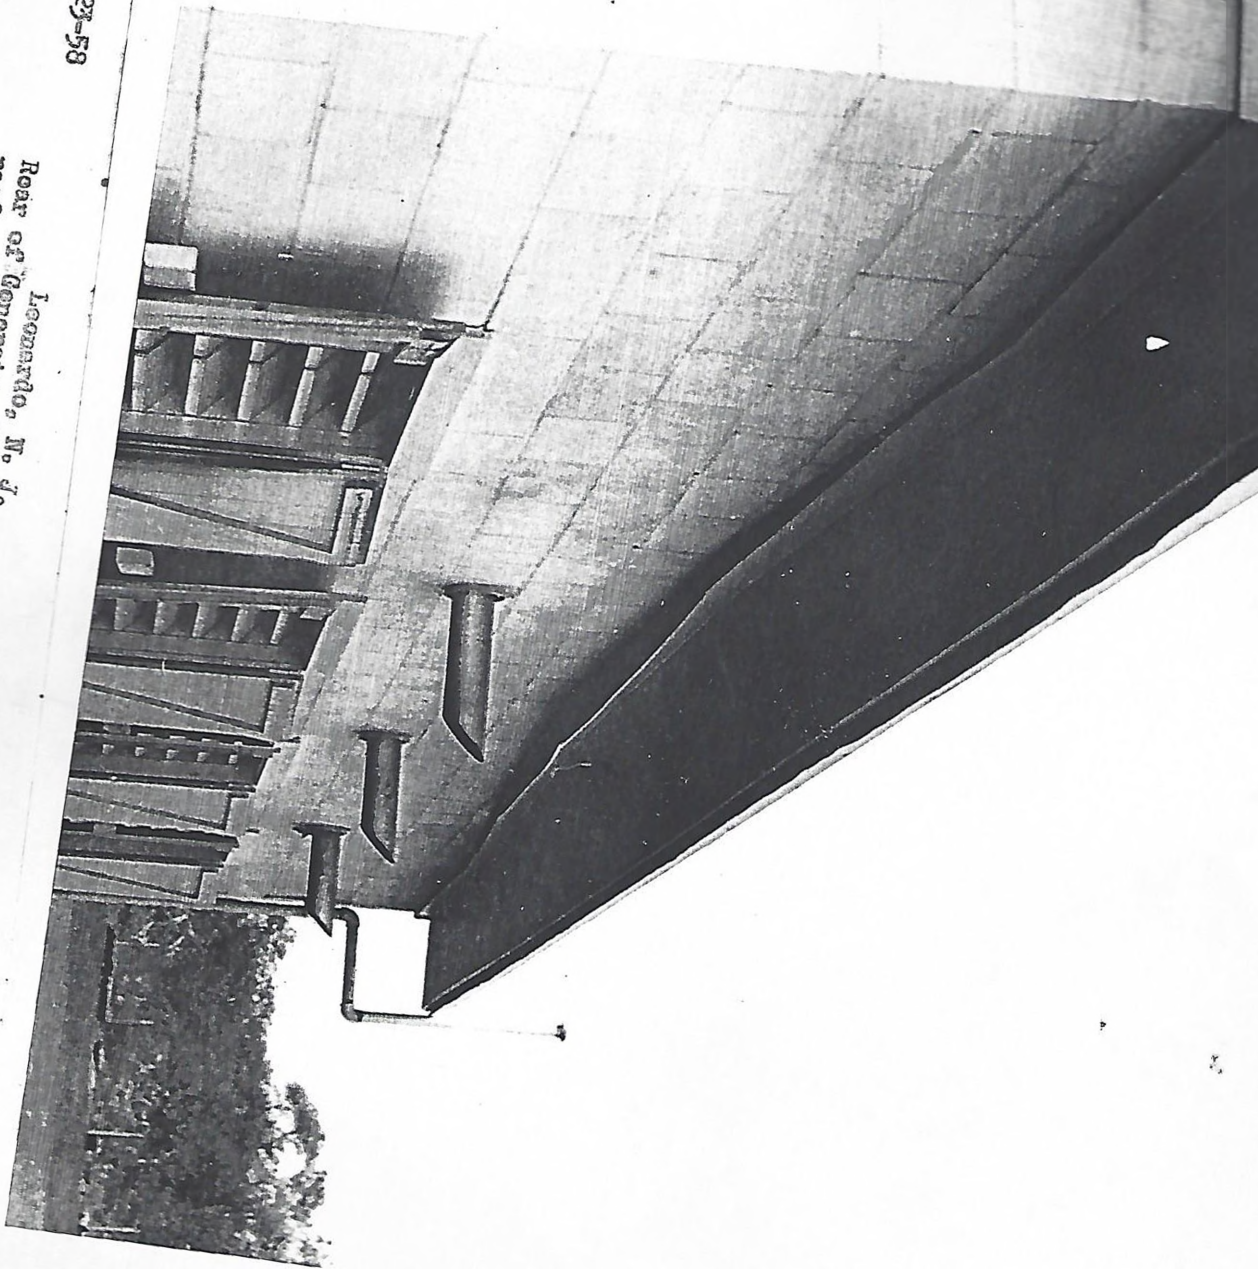
Leonardo, N. J.
Rear of Generator Hdg showing separation at
roof.
Neg No KA 1261-24
