In-Flight Breakup During Test Flight  
Scaled Composites SpaceShipTwo, N339SS  
Near Koehn Dry Lake, California  
October 31, 2014

**Aerospace Accident Report**

NTSB/AAR-15/02  
PB2015-105454

NTSB/AAR-15/02  
PB2015-105454  
Notation 8614  
Adopted July 28, 2015

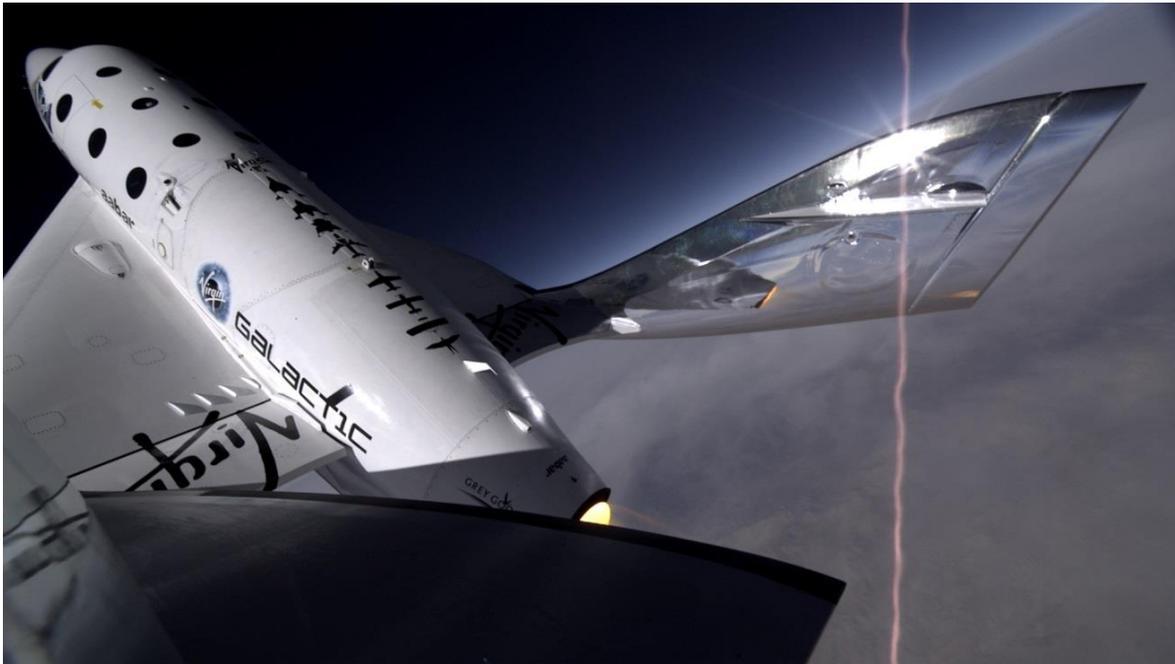
**Figure 8.** Feather position immediately before in-flight breakup.

The vehicle performance study found that, when the feather was unlocked at 1007:29.5, the total feather opening moment exceeded the total closing moment provided by the feather actuators.<sup>66</sup> At 1007:30.0, the opening moment decreased below the closing moment actuator capability. The opening moment then increased again above the closing moment actuator capability and continued increasing when the feather started to move at 1007:30.6. The oscillation in the feather opening moment was consistent with the delay of about 1.1 seconds between the unlocking of the feather and the movement of the feather toward the extended position.<sup>67</sup> Thus, the study showed that, shortly after the feather was unlocked, the feather opening moments were sufficient to open the feather by overcoming the closing moments provided by the feather actuators.

Video imagery showed that the forward end of the vehicle then began to pitch up. The pitch rate increased rapidly, and the vehicle essentially folded in half about the feather flap hinge line, causing a catastrophic structural failure. Video imagery also showed that the first evidence of the in-flight breakup occurred at 1007:32.13 (about 13 seconds after SS2's release from WK2) when the feather flap became displaced from the trailing edge of the wing, which was the beginning of a failure at the feather flap hinges.<sup>70</sup> The localized stress in the wing side of the inboard feather flap hinge fittings was sufficient to fracture the inboard hinges at 1007:32.18.<sup>71</sup> The right and left tailbooms and the torque tube separated from the vehicle between 1007:32.4 and 1007:33.4. The rocket motor case/throat/nozzle assembly and the nose and crew station separated immediately afterward (at 1007:33.5 and 1007:33.6, respectively).<sup>72</sup>

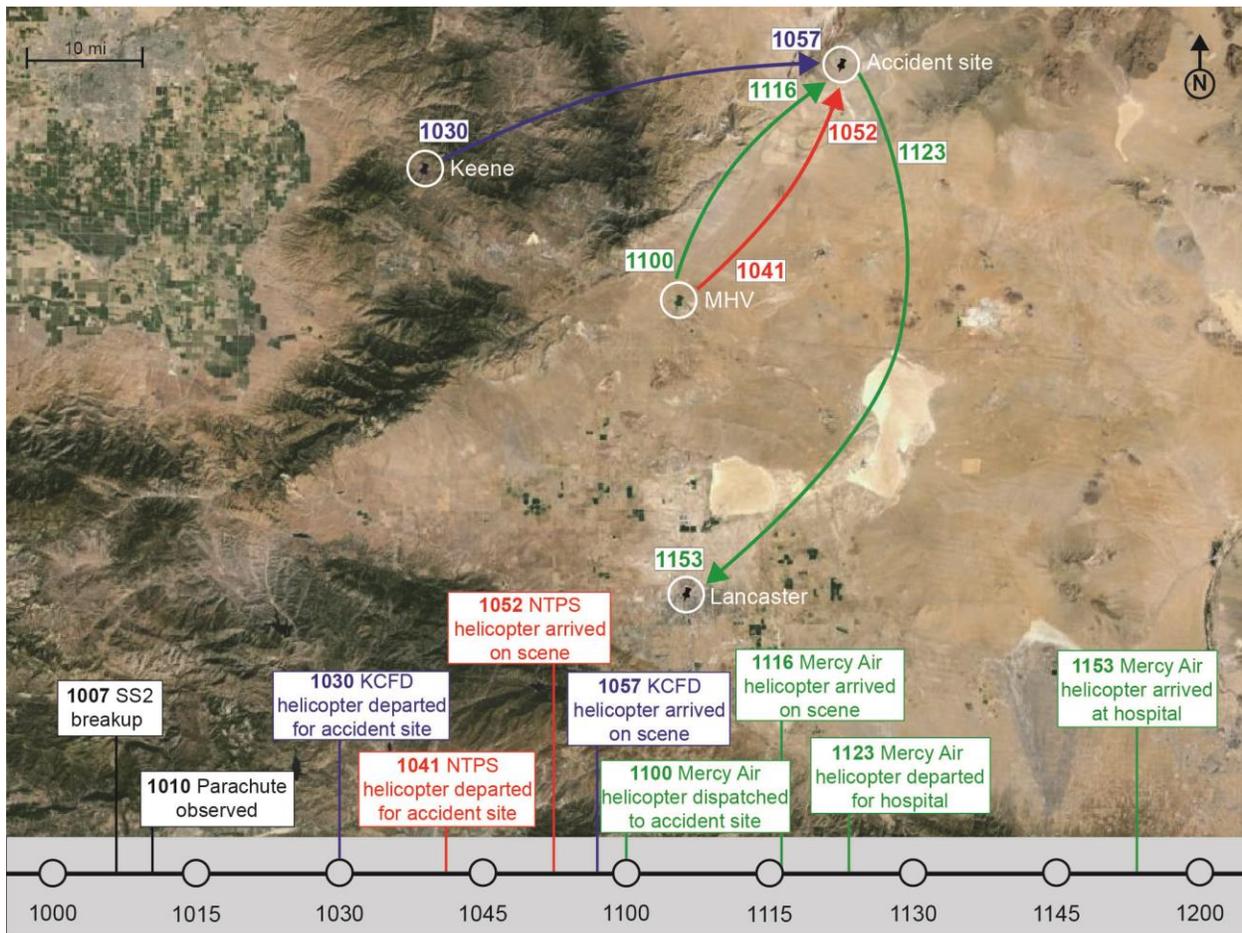
**Figure 9.** Emergency response timeline.

The NTSB is concerned that Scaled conducted a high-risk flight test without the on-airport presence of a helicopter that was specifically prepared for and tasked with supporting an emergency response. The KCFD helicopter, which was not prepositioned at MHV but was a designated asset for responding to an off-airport emergency, arrived at the injured pilot's location 39 minutes after the on-scene commander's instruction to respond to the accident. The Mercy Air helicopter, which was located at MHV and had advanced life support capabilities, arrived at the injured pilot's location 16 minutes after being dispatched, even though the helicopter was not designated to be part of the preplanned response to a potential accident. The NTSB determined that, if Mercy Air had been briefed ahead of time about the flight and dispatched immediately after the Extra EA-300L chase plane pilot observed a parachute, the Mercy Air helicopter could have arrived at the pilot's location about 45 minutes earlier.<sup>39</sup> The NTSB concludes that Scaled Composites and local emergency response officials could improve their emergency readiness for future test flights by making better use of available helicopter assets.

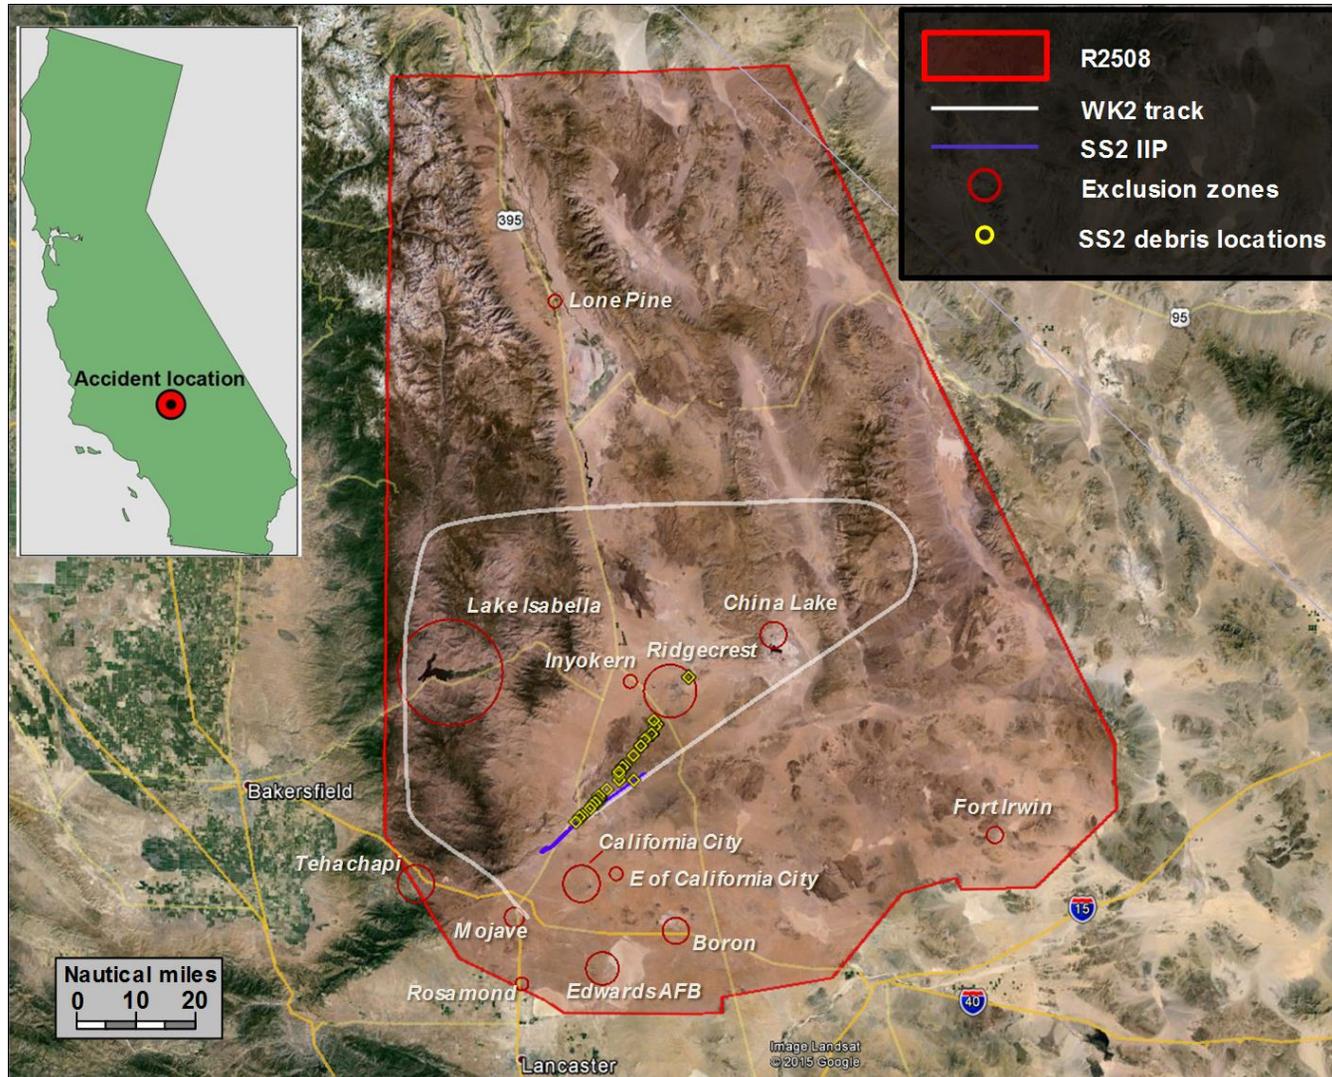
Figure 10. R-2508 operating area and main wreckage locations.

The main wreckage sites were contained within a 2.5-square mile area that was about 5 miles long by 0.5 mile wide. The main wreckage sites comprised the following major individual impact sites (from southwest to northeast): (1) rocket motor, (2) forward pressure tank, (3) cockpit and nose section, (4) left feather actuator, (5) main oxidizer tank and wings, (6) pilot's seat, (7) left tailboom, (8) torque tube, (9) right tailboom, and (10) pilot's parachute. As previously stated, smaller, lightweight pieces of wreckage were also found between the main wreckage sites and the Ridgecrest, California, area (northeast of the main wreckage sites).<sup>41</sup> The inclusion of this wreckage increased the total length of the wreckage path to about 33 miles.

<sup>46</sup> The most distant fragment was found on a golf course inside the Ridgecrest exclusion zone, but 14 CFR Part 437 regulations require that only the IIP and key flight-safety events remain outside exclusion zones.

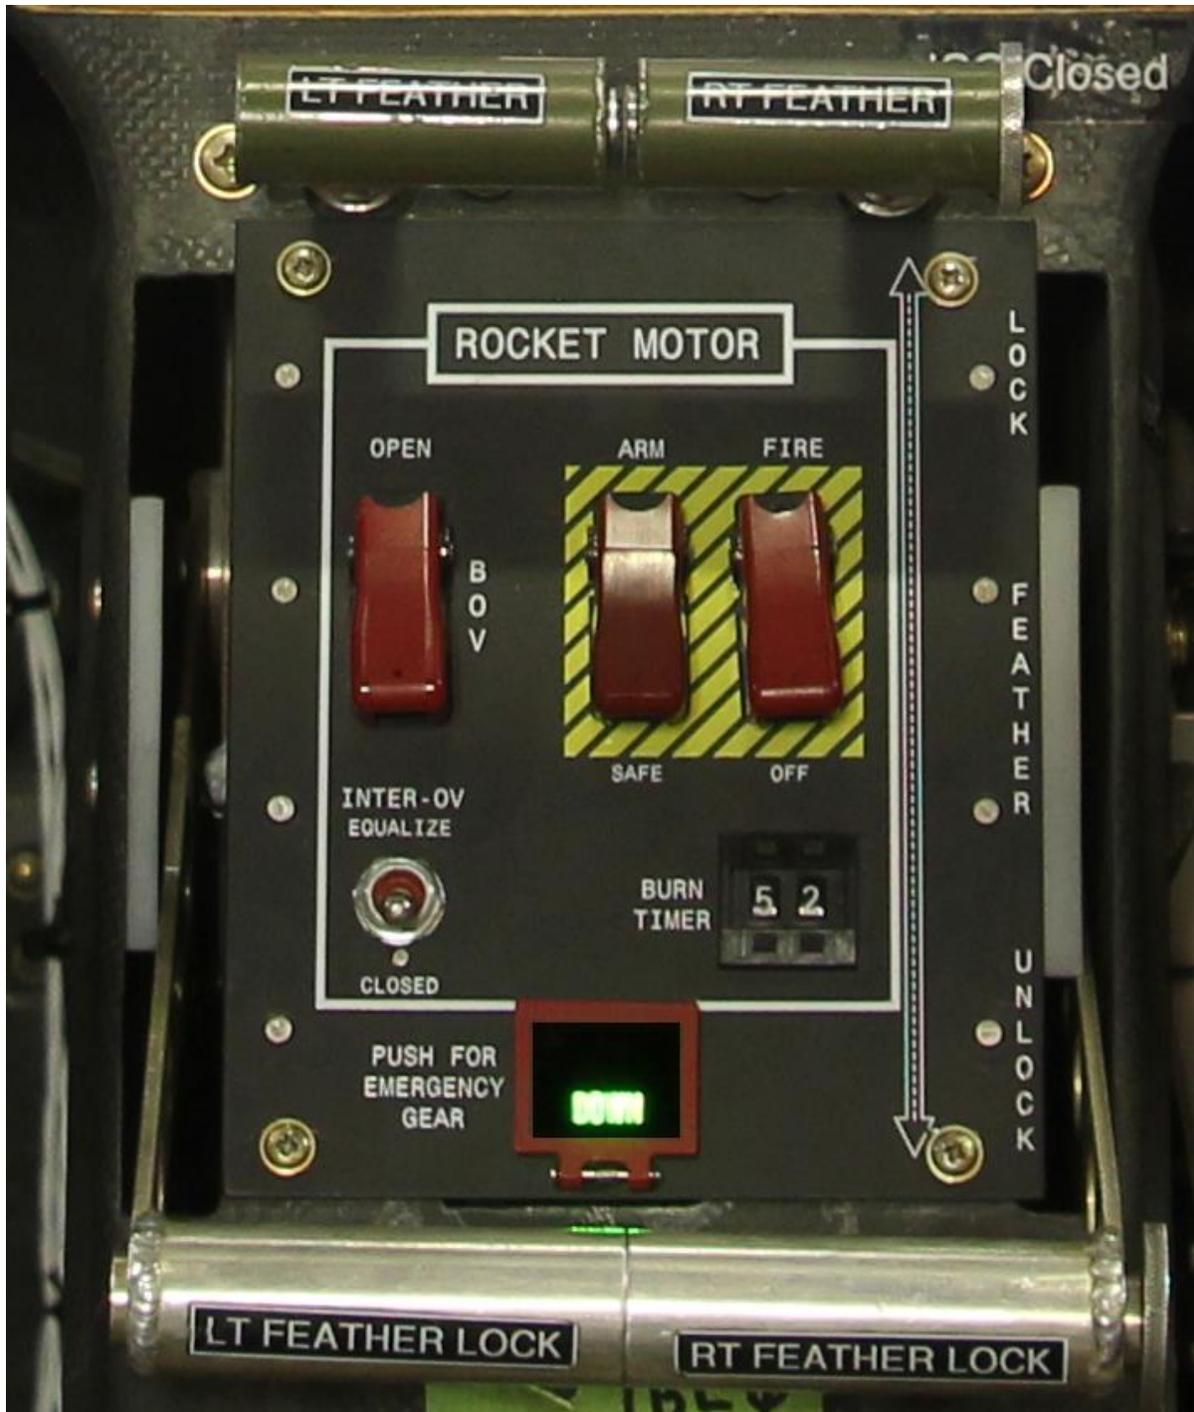
**Figure 12.** Feather lock handle and feather handle.

Both feather lock handles were recovered with the wreckage. The left handle was attached to part of the center pedestal structure, and the right handle had separated from the structure. Examination of the center pedestal structure determined that the left handle was recovered in the locked position. The position of the right handle could not be determined because of impact damage. The cockpit image recording and flight data showed that, before the feather movement, the copilot placed the feather lock handle in the unlocked position and that the lock handle remained in the unlocked position. Thus, the position of the left handle as found on scene was most likely the result of the vehicle breakup.
