FLIGHT TEST PROGRESS REPORT NO. 15
Period From 9 December Through 20 December 1953

X-1A AIRPLANE

3 FEBRUARY 1954
REPORT NO. 58-980-019

X-1A FLIGHT TEST PROGRESS REPORT

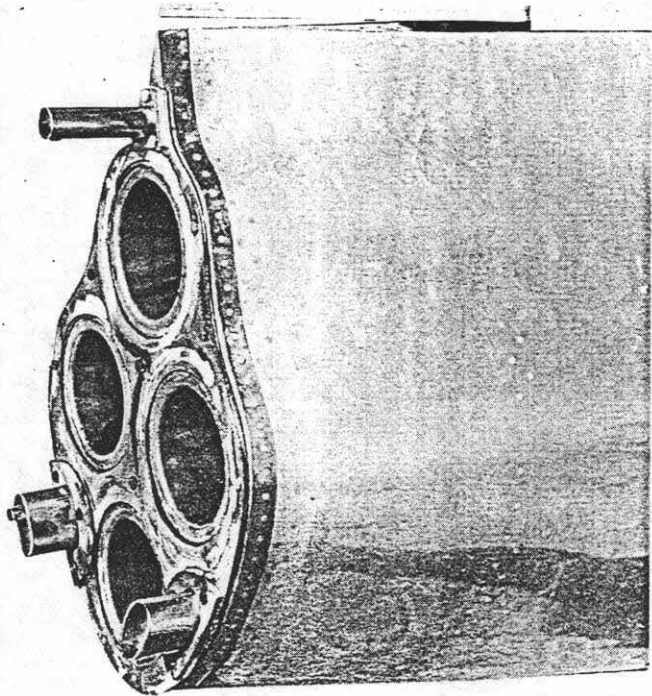
The operation of the copper flame shield was entirely satisfactory with only slight buckling occurring at the high temperature points. Tempilac paint of 2,000° F range around the thrust chambers was completely burned away showing that temperatures in excess of 2,070° F (ambient temperature plus rise) were encountered during this flight (Figure 6). A photograph (Figure 7) of the flame shield before the flight is included for comparison purposes.

Figure 6. Copper and Asbestos Flame Shield Around Thrust Chambers After Flight

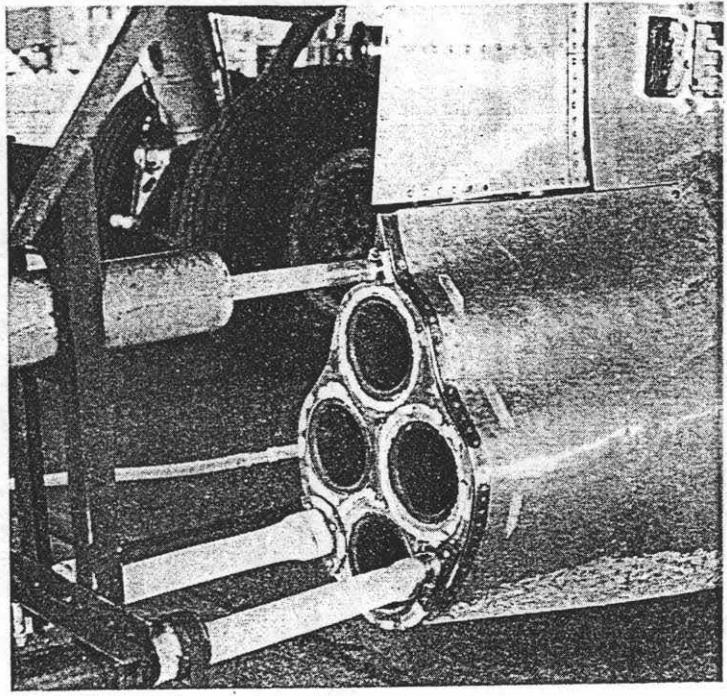
Figure 7. Copper and Asbestos Flame Shield Around Thrust Chambers Before Flight

10. Added copper and asbestos flame shield around engine exhaust of thrust chambers. (Figure 7.)
11. Weight and balance was calculated and adjusted to 16,199 pounds and 22.56 percent MAC for launch condition.

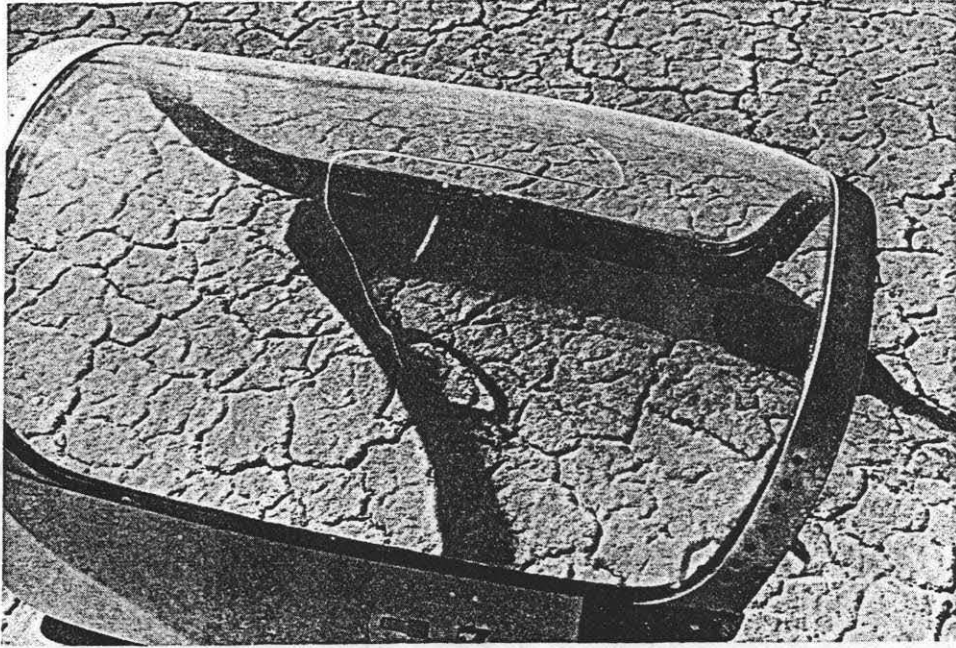
The postflight inspection revealed no damage to the X-1A Airplane except cracked inner canopy glass, a nonstructural failure caused by the helmet of the pilot's pressure suit striking the glass.

The cockpit canopy was cracked by the pilot's helmet during the violent maneuvers encountered after rocket engine shutdown (Figure 9). The pilot reported that he had not used the shoulder harness during this flight.

Figure 9. Cracked Cockpit Inner Canopy

At one point during a negative "g" load, the pilot felt the inner liner to the canopy break as the top of his pressure suit helmet came in contact with it.

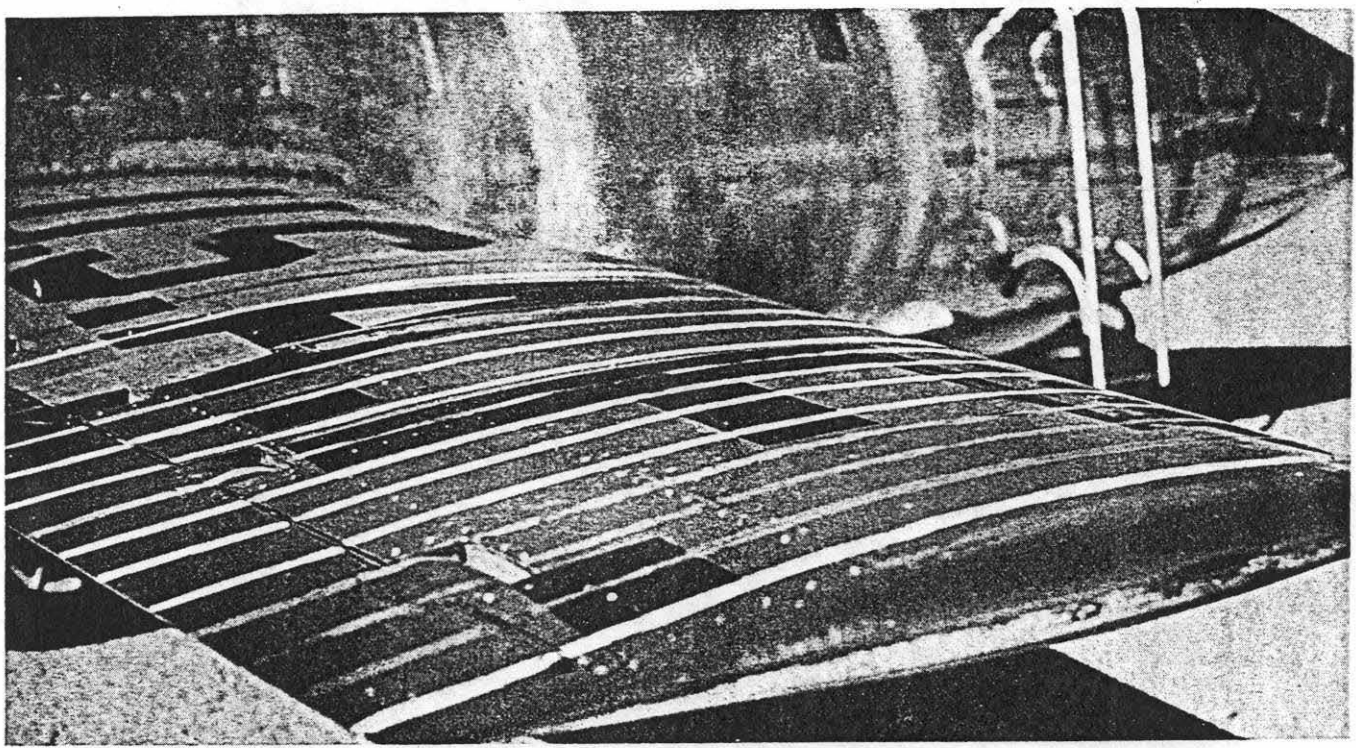
Figure 12. Tempilac Paint on Right Wing After Flight

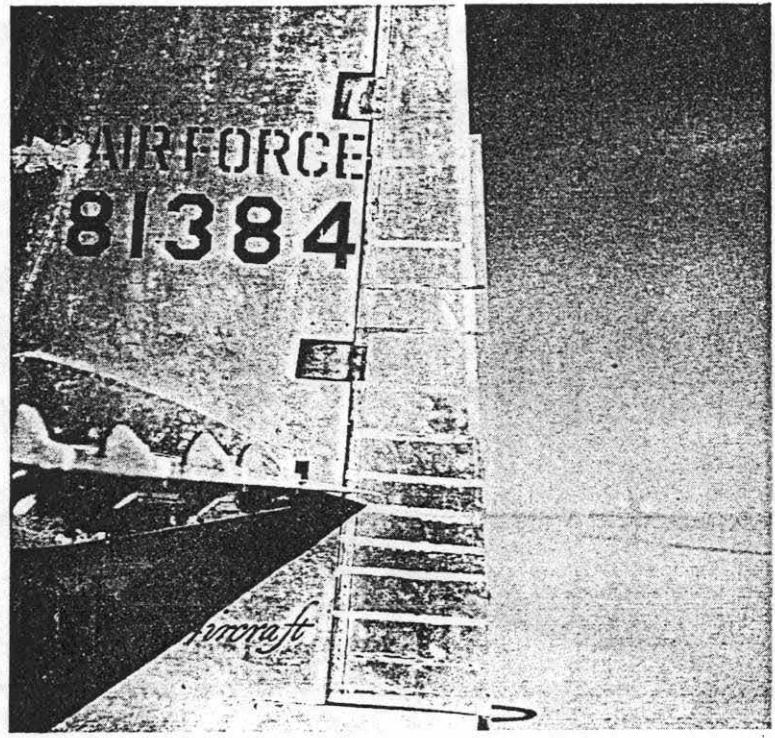
Figure 13. Tempilac Paint on Rudder After Flight

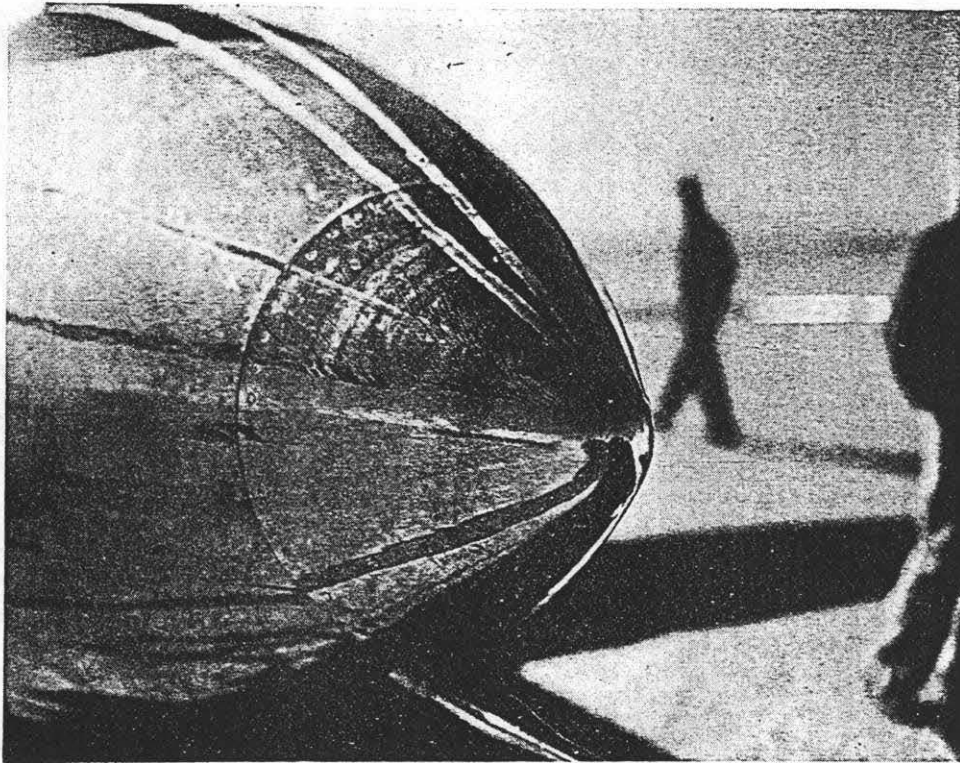
The Tempilac paint disclosed aerodynamic heating up to a 233° F rise. Adjacent internal structure to the Tempilac paint caused skips in the temperature indication.

Figure 14. Tempilac Paint on Nose Ogive After Flight

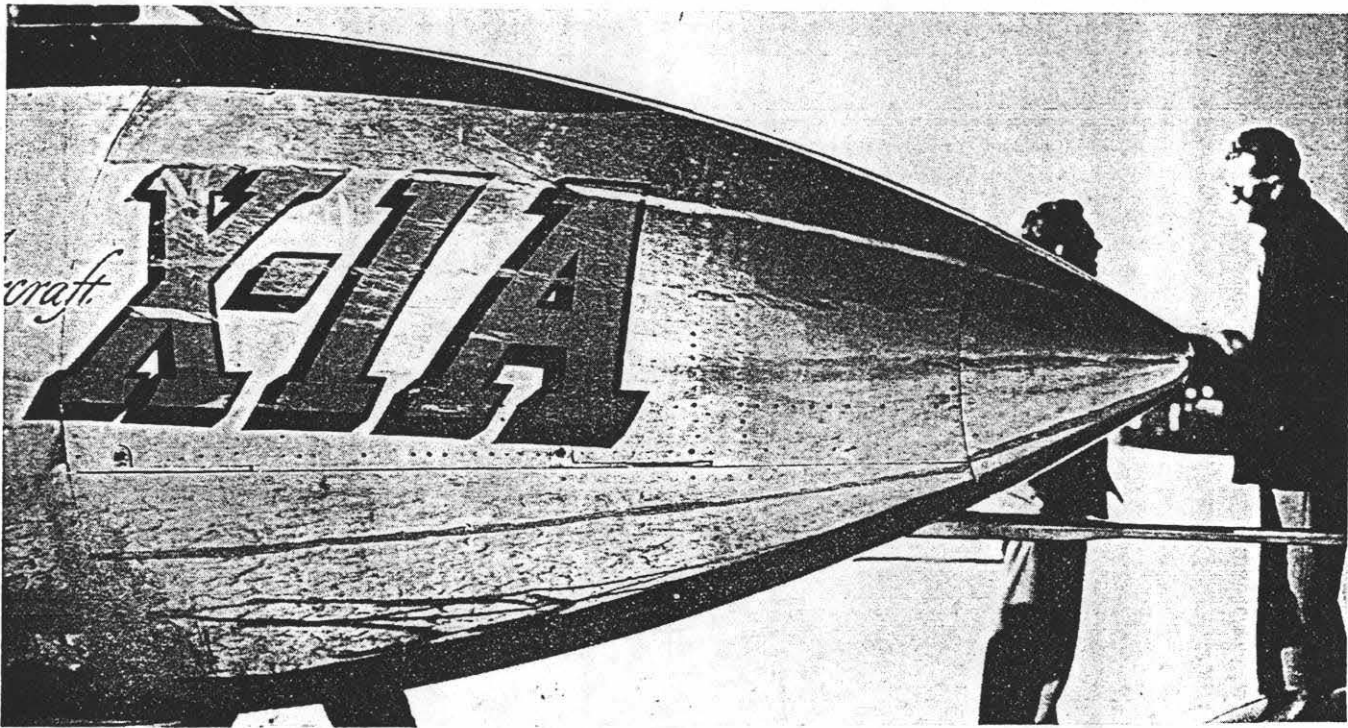
Figure 15. Side View of Tempilac Paint on Nose Ogive After Flight

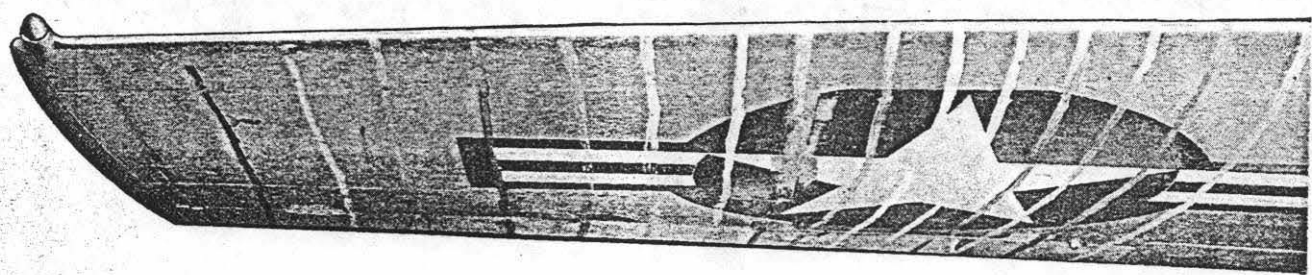
Figure 16. Tempilac Paint on Underside of Right Wing After Flight

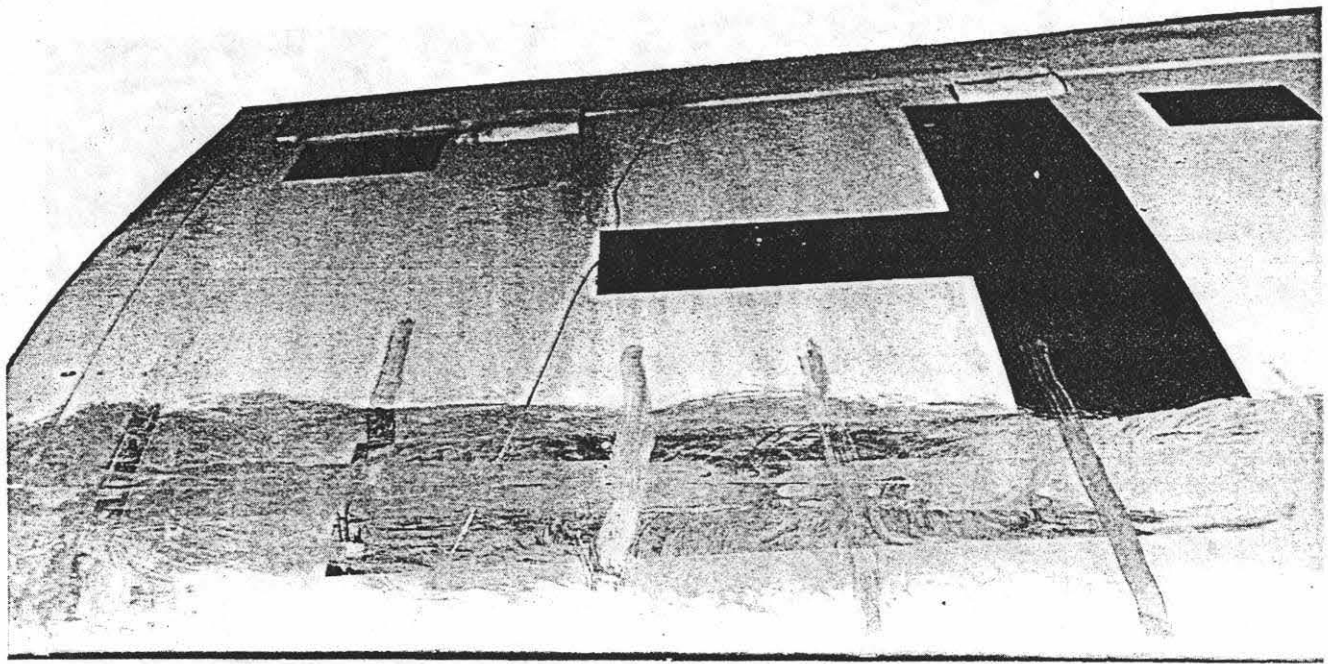
Figure 17. Tempilac Paint on Upper Side of Right Wing After Flight

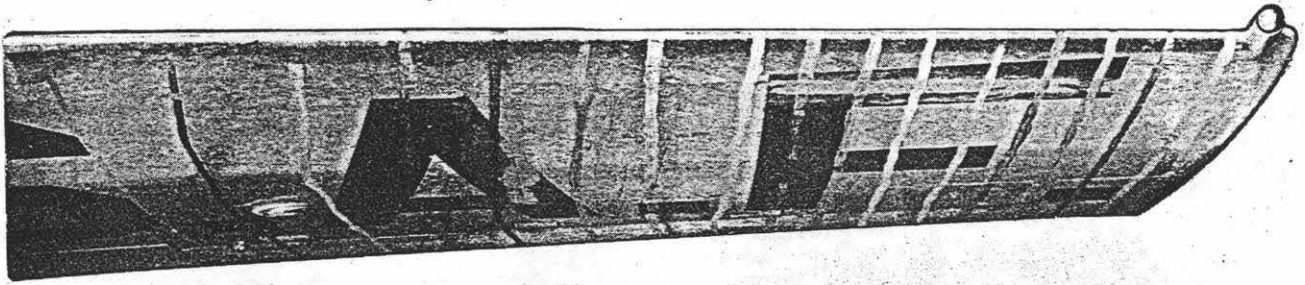
Figure 18. Tempilac Paint on Underside of Left Wing After Flight

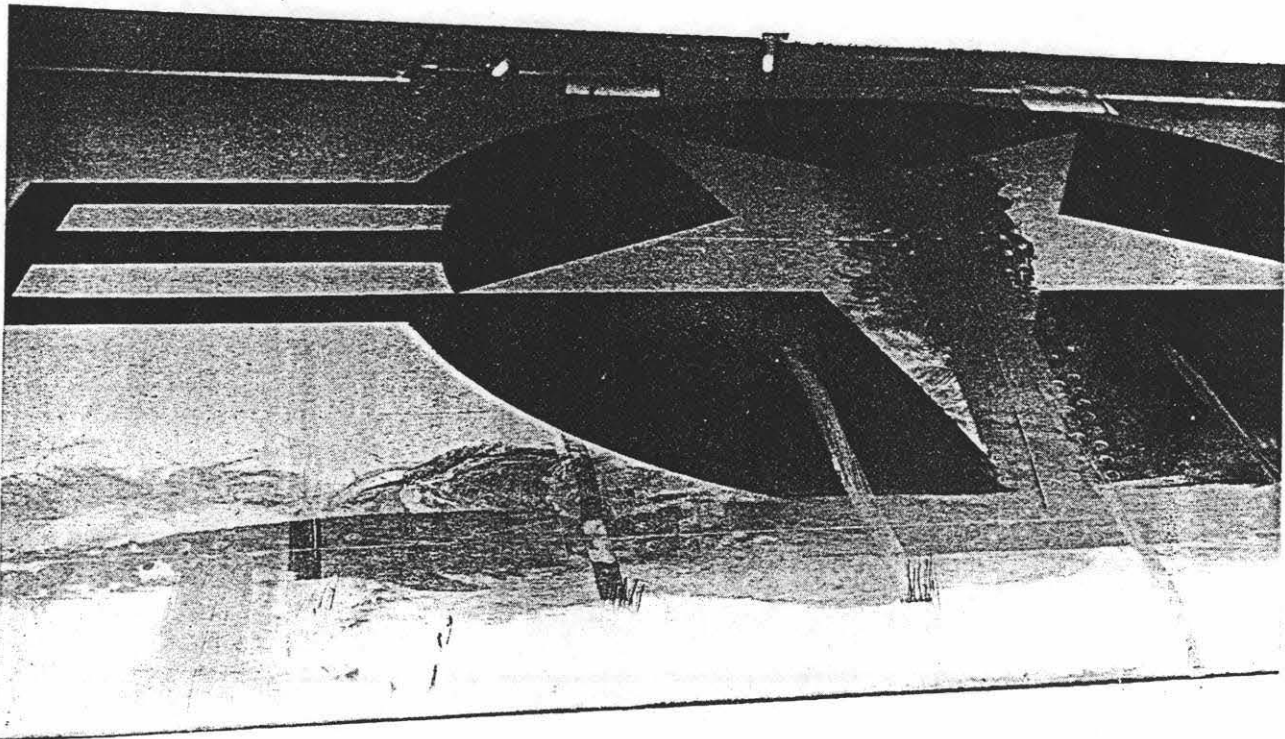
Figure 19. Tempilac Paint on Upper Side of Left Wing After Flight

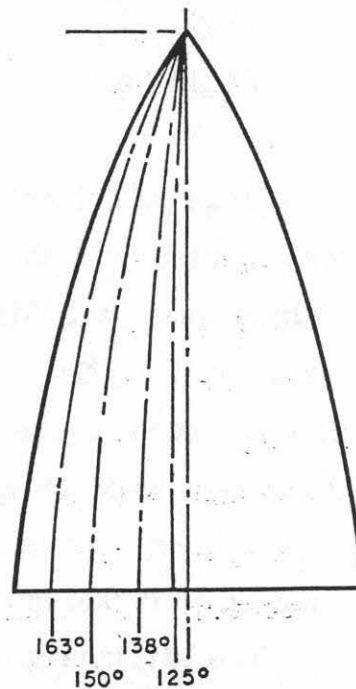
ure 11), left wing (Figure 12), and on left side of rudder (Figure 13). The appearance of these painted sites after the flight is also illustrated in Figures 14, 15, 16, 17, 18, and 19. Highest temperature rise shown by the Tempilac was 163°F paint plus ambient of minus 70°F (approximately) or 233°F rise. Temperature rise on various parts of the airplane structure can definitely be checked by the use of Tempilac paints. Various skips shown by discontinuity of Tempilac indication of heat are thought to be caused primarily by internal structure under the skin causing local heat gradients (Figure 20). 175° Tempilac on leading edge of windshield displayed no change during the flight.

Figure 20. Tempilac Paint Effects After Flight
