TEST AND EVALUATION PROJECT STATUS SHEET

PROJECT NUMBER	PROJECT TITLE		
A-18	B-58 Flight Control System Reliability Improvement (U)		
REPORT SECTION	PROJECT OFFICERS		
C-1 of Part IV	Major V. M. Kummel and Capt T. P. Crichton		
<p>PROBLEM The B-58 Flight Control System has not reached the degree of reliability desired for an operational tactical weapon system. Discrepancies are being reported on approximately 50% of all flights and occur most frequently in the autopilot or control surface dampers. Because there are numerous electronic and electro-mechanical components in the system whose failure can result in the types of discrepancies being encountered, a special malfunction analysis effort is needed so that faulty components needing improvement can be identified. (U)</p>			
REQUEST AGENCY	DATE INITIATED	COMPLETION DATE	AUTHORIZATION
43rd Bomb Wing	1 September 1960	Indefinite	AFR 80-14 SACR 80-2

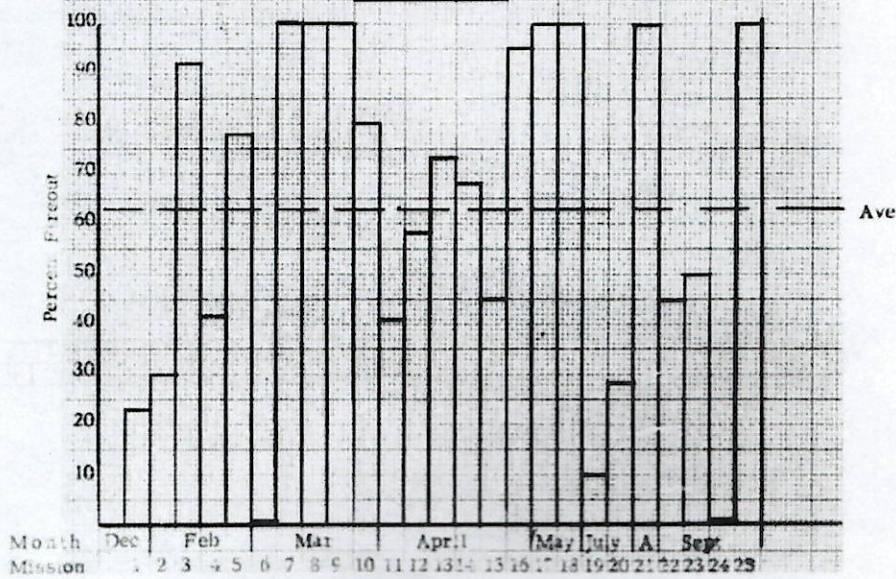
Figure 6

(c) The weapon and ammo feed system reliability is not shown as an MIBF but as a percentage of fire-out. This is necessary because the weapon and ammo feed system reliability cannot be realistically computed as a function of "on" time of the Active Defense System, but must be computed as a function of the number of rounds fired per rounds loaded. The percentage of fireout per mission is shown in Figure 6.

Percent Fireout/Mission

1. The fireout percentage per mission for the weapon and ammo feed system is shown in Figure 6.

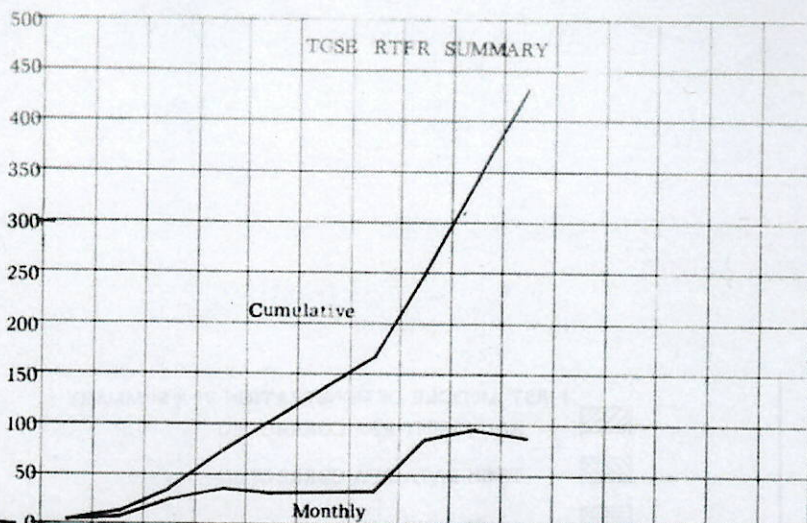
11. A summary of the Reliability and Trouble Failure Reports (RTFR) submitted by Contractor personnel collecting reliability data at Carswell AFB on TGSE is indicated on page IV-45. As of this date, no formal engineering analysis information of CAFB generated TGSE RTFR's has been received by the 43BW. In addition it has been particularly noted that Convair Reliability Synopses have been conspicuous in their lack of RTFR information from in-plant use of TGSE. In addition, there has been no apparent RTFR generation on deficient items of TGSE that have been sent to Convair (for repair and/or modification) from Carswell AFB.

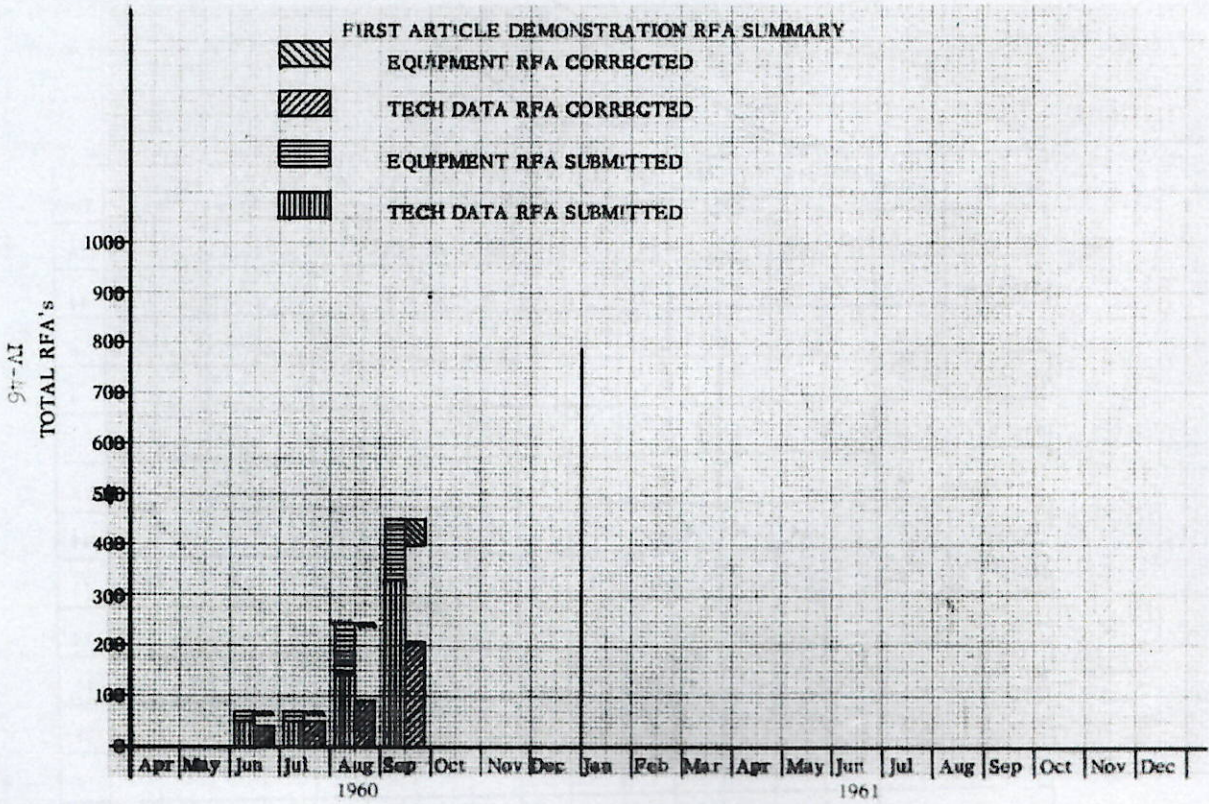
12. A graphic presentation of the RFA's (Request for Alteration) submitted during First Article Demonstrations of TGSE is presented on page IV-46. This graph shows RFA's submitted on equipment and on technical data as well as the number of RFA's that have been corrected in these areas. Technical data is considered corrected for this report if supplemental data has been received or if the formal T.O. revision has been received.
