TEST AND EVALUATION PROJECT STATUS SHEET

PROJECT NUMBER E-5	PROJECT TITLE Service test of the Improved Magnetron (L-1951/7208 for the B-58 Search Radar (U)		
REPORT SECTION C-3 of Part IV	PROJECT OFFICER SMS James R. Freeman		
PROBLEM An excessive number of magnetron failures are being experienced on the search radar system of the B-58 aircraft (U)			
REQUEST AGENCY B-58 Test Force	DATE INITIATED June 1960	COMPLETION DATE Est Jan 61	AUTHORIZATION AFR 80-14 SACR 80-2

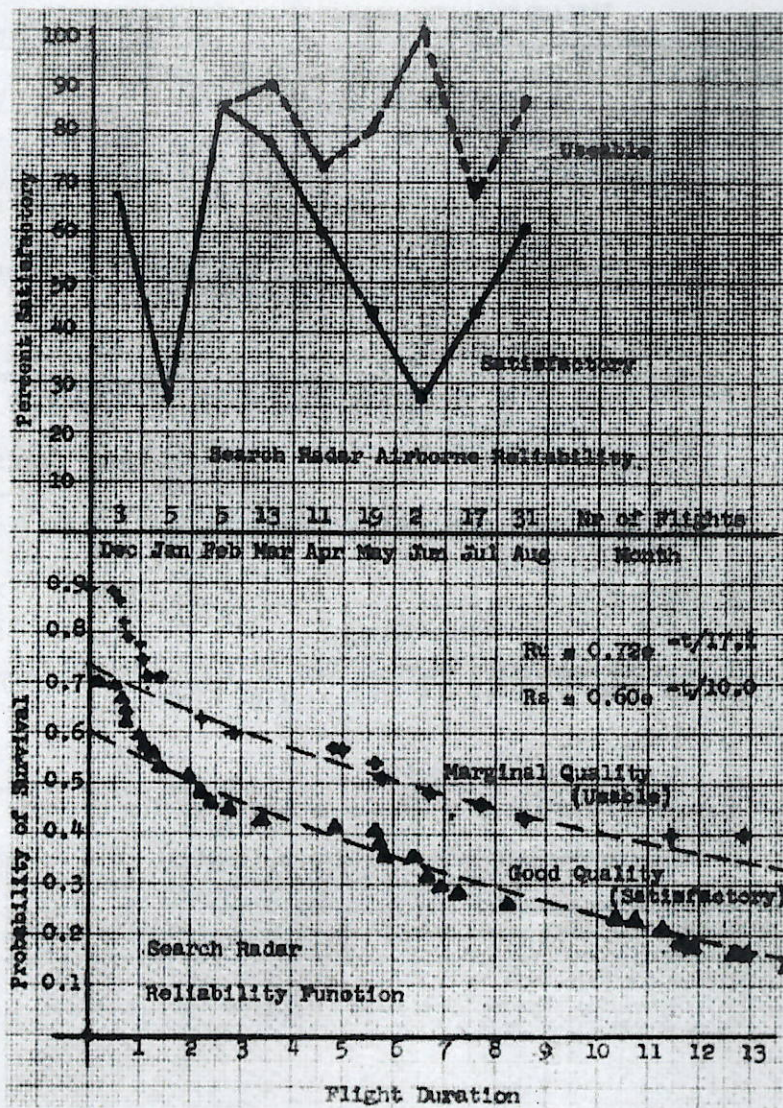
Figure 7
IV-99

The "Attrition Factor" is a constant to allow for the heavy failure attrition in the system at take-off and for the first hour of flight. This effect can be caused by two things. One is that the system is adversely affected by environmental factors connected with turn-on, taxi and take-off. The other is that maintenance is not properly preparing the systems for flight. (U)

The "Mean Life" of the radar is the mean time to the next malfunction which will either degrade the radar or make it unusable. The following table summarizes the results for the search radar. (U)
