FLIGHT TEST PROGRESS REPORT NO. 15
Period From 9 December Through 20 December 1953

X-1A AIRPLANE

3 FEBRUARY 1954
REPORT NO. 58-980-019

X-1A FLIGHT TEST PROGRESS REPORT

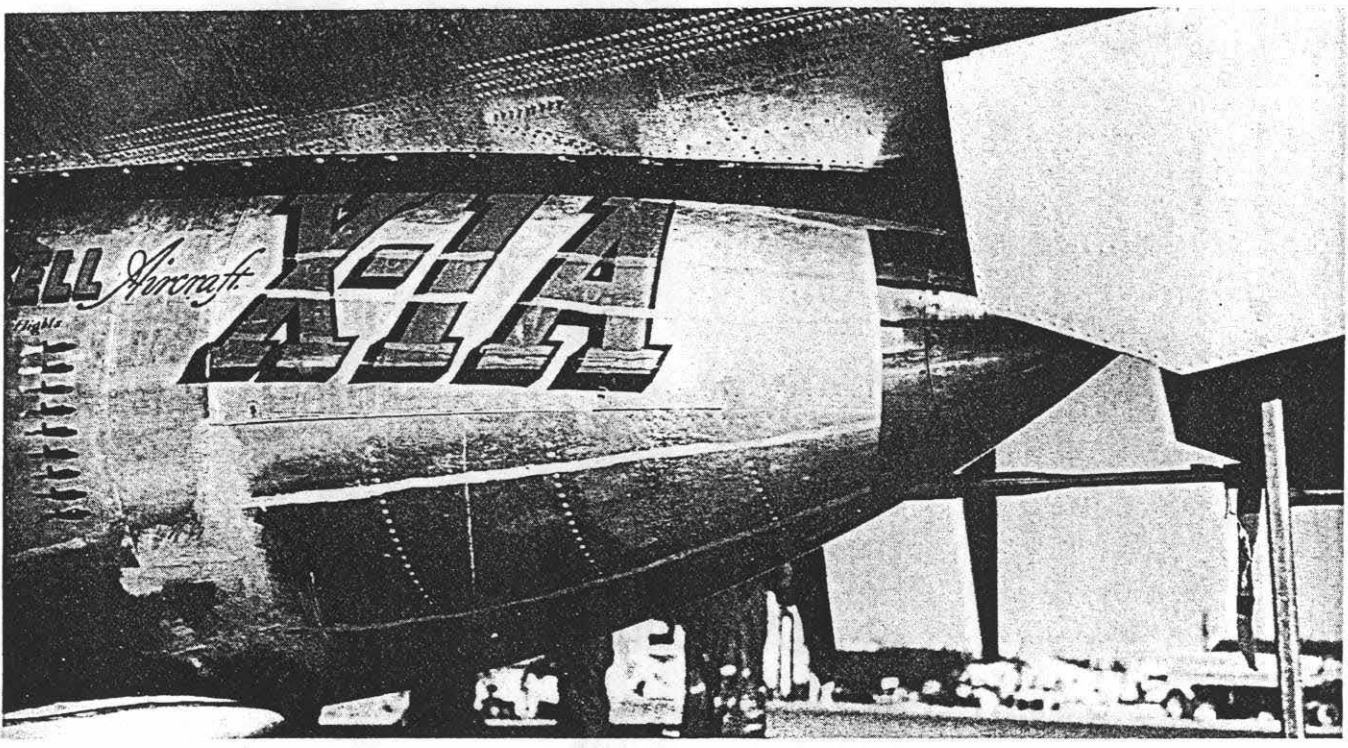
Figure 10. Tempilac Paint on Nose Ogive Prior to Flight

The Tempilac paint disclosed aerodynamic heating up to a 233° F rise. Adjacent internal structure to the Tempilac paint caused skips in the temperature indication.

An impromptu heat survey was conducted during this flight by utilizing Tempilac paint on nose ogive (Figure 10), right wing (Fig-

ure 11), left wing (Figure 12), and on left side of rudder (Figure 13). The appearance of these painted sites after the flight is also illustrated in Figures 14, 15, 16, 17, 18, and 19. Highest temperature rise shown by the Tempilac was 163°F paint plus ambient of minus 70°F (approximately) or 233°F rise. Temperature rise on various parts of the airplane structure can definitely be checked by the use of Tempilac paints. Various skips shown by discontinuity of Tempilac indication of heat are thought to be caused primarily by internal structure under the skin causing local heat gradients (Figure 20). 175° Tempilac on leading edge of windshield displayed no change during the flight.
